Applies To: **2007-08 TL – ALL**
2008 MDX – ALL

December 6, 2008

HandsFreeLink (HFL) Doesn't Work

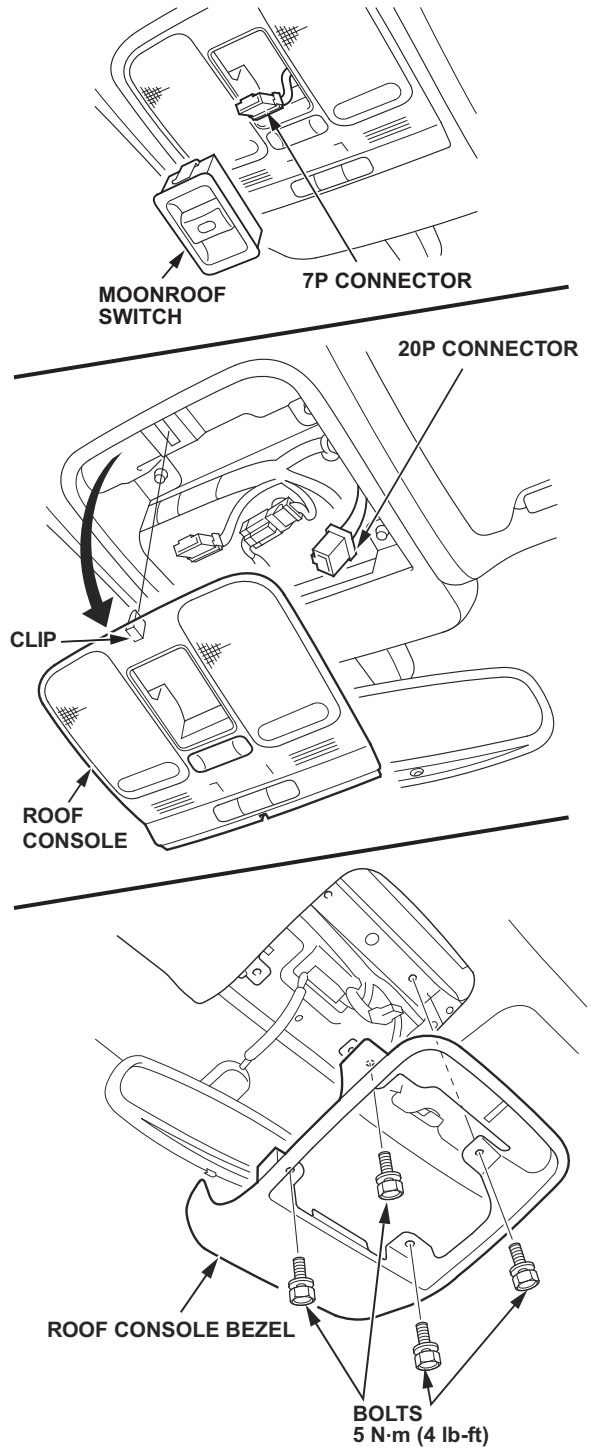
4. *MDX*: Remove the center console rear trim:
• Refer to page 20-110 of the *07–09 MDX Service Manual*, or
• Online, enter keywords **CENTER CONSOLE**, and select **Center Console Rear Trim Removal/Installation** from the list.
TL: Remove the roof console as shown.

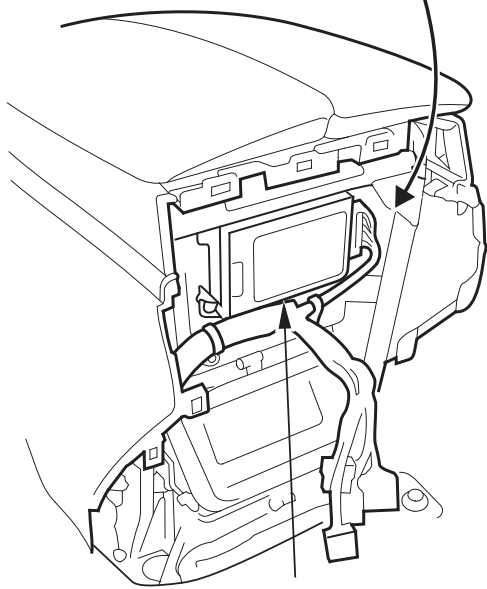
MDX:

- Without disconnecting the HFL control unit 28P connector, backprobe terminals No. 1 and No. 2 with an ohmmeter, and confirm that the resistance changes while pressing the HFL TALK/BACK buttons:

- Replace the HFL control unit:
 - MDX:** Refer to page 23-296 of the MDX service manual, or
 - TL:** Refer to page 23-284 of the TL service manual, or
 - Online, enter keywords **HFL INPUT**, and select **HandsFreeLink Control Unit Input Test/Replacement** from the list.
- Check the vehicle's battery, and charge or replace it if needed.
