Applies To: **2007–09 MDX – ALL**

MID or Navi Shows a Check Engine Oil Level Message, Low Oil Pressure Indicator May Be On

(Supersedes 09-012, dated June 17, 2009, to revise the information marked by the black bars)

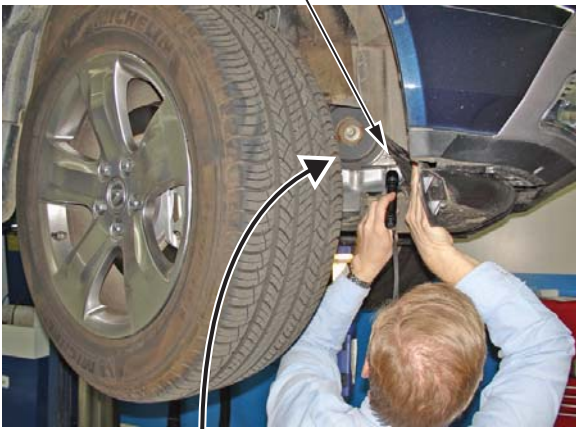
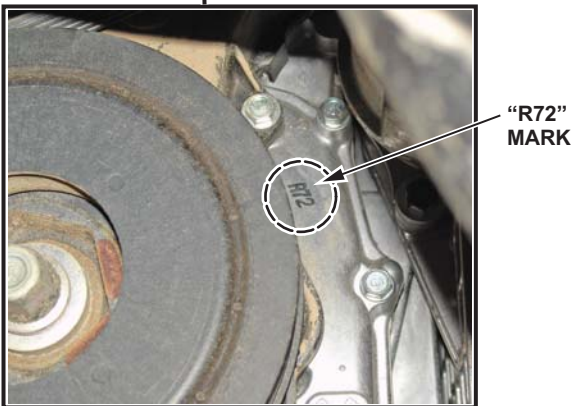
Look for an "R72" mark on the right side of the oil pump.

1. Start the engine, turn the steering wheel fully to the right, then shut off the engine.
2. Raise the vehicle on a lift, and make sure it's securely supported.
3. Detach the front clip from the right front inner fender. Pull back the edge of the inner fender, and look for an "R72" mark on the right side of the oil pump:
 - If the oil pump has the "R72" mark, use P/N 37240-R72-A01 for the new engine oil pressure switch.
 - If the oil pump does not have the "R72" mark, use P/N 37240-RDM-A01 for the new engine oil pressure switch.
