## Water Leak at the Rear of the Moonroof

(Supersedes 08-015, dated May 13, 2008, to revise the information marked by the black bars)

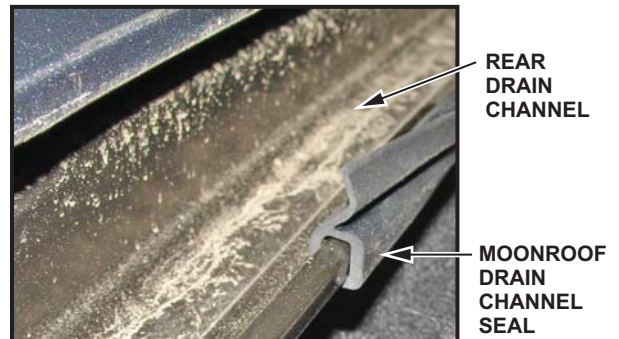
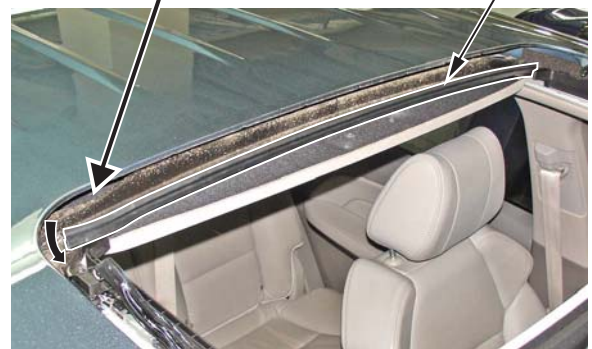
Water enters the vehicle through the rear section of the moonroof.

Water splashes out of the drain channel into the interior of the vehicle.

Install a moonroof drain channel seal.

1. Remove the moonroof glass to gain access to the rear drain channel:
  - Refer to page 20-65 of the *07–09 MDX Service Manual*, or page 20-63 of the *2010 MDX Service Manual*, or
  - Online, enter keywords **MOON GLASS**, and select **Moonroof Glass Replacement** from the list.
2. Install a new seal on the front edge of the rear drain channel:
  - Attach the lower lip of the seal starting at one corner of the drain.
  - Roll the seal up and rearward over the lip until it is installed all the way across the drain channel.
  - Make sure the seal is centered.
