Applies To: **2011–12 MDX with Navigation** – Check the iN VIN status for eligibility
2011–12 TSX with Navigation – Check the iN VIN status for eligibility
2012 ZDX with Navigation – Check the iN VIN status for eligibility

April 6, 2012

Product Update: CD or DVD (RES) Restarts When the Ignition Switch Is Turned OFF and ON

(Supersedes 11-032, dated December 15, 2011, to revise the information marked by the black bars)

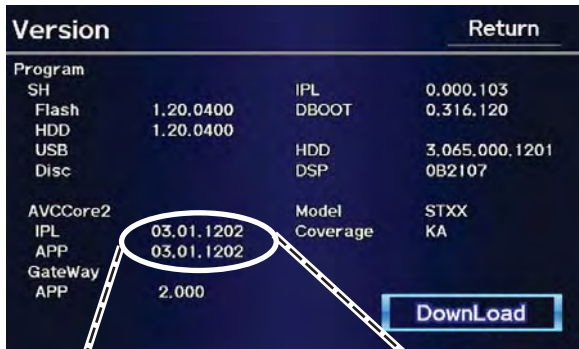
6. Under AVCCore2, check that the fourth digit of the IPL and APP version numbers is **1**.

NOTE: If it is a 2, the AVC software was already updated. Select **Return** to go back to the **Detail Information & Setting** screen, then go to step 5 of the **CD Drive Update**.

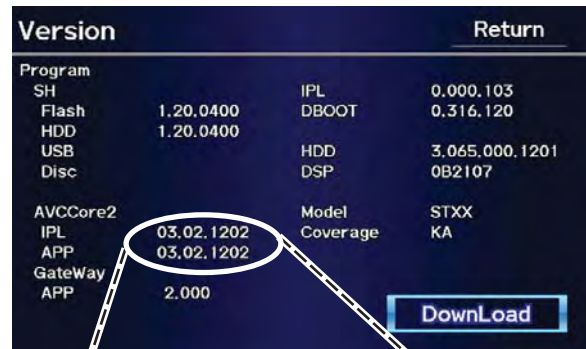
12. Under AVCCore2, check the fourth digit of the IPL and the APP version numbers.

- If it is still 1, turn the ignition switch to LOCK (0), then go to step 1, and repeat the update.
- If it is now 2, turn the ignition switch to LOCK (0), then go to **CD Drive Update**.

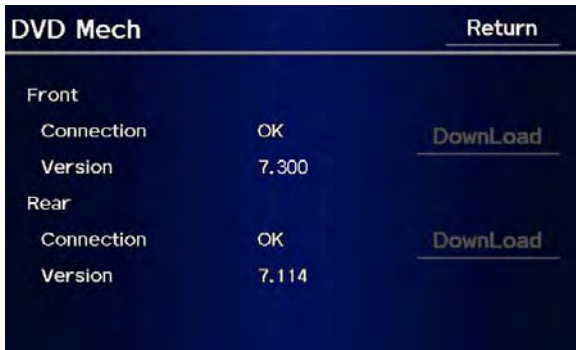
- Confirm that the front mech software version is **7.300**.

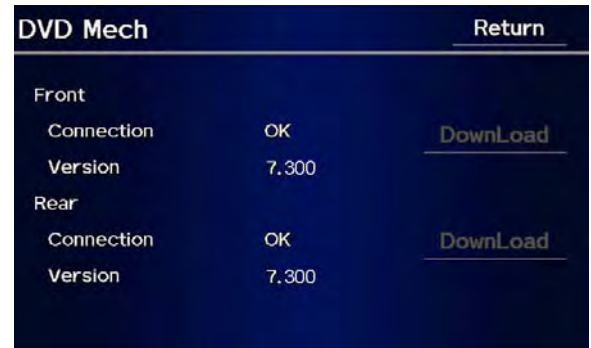
- Confirm that the rear mech software version is **7.300**.
