**DRIVE BELT SQUEAKS****TECHNICAL SERVICE BULLETIN**

Reference Number(s): 10-035, Date of Issue: July 24, 2012

ACURA: 2007-12 MDX; 2007-08 TL; 2010-12 ZDX

CATEGORY: Engine

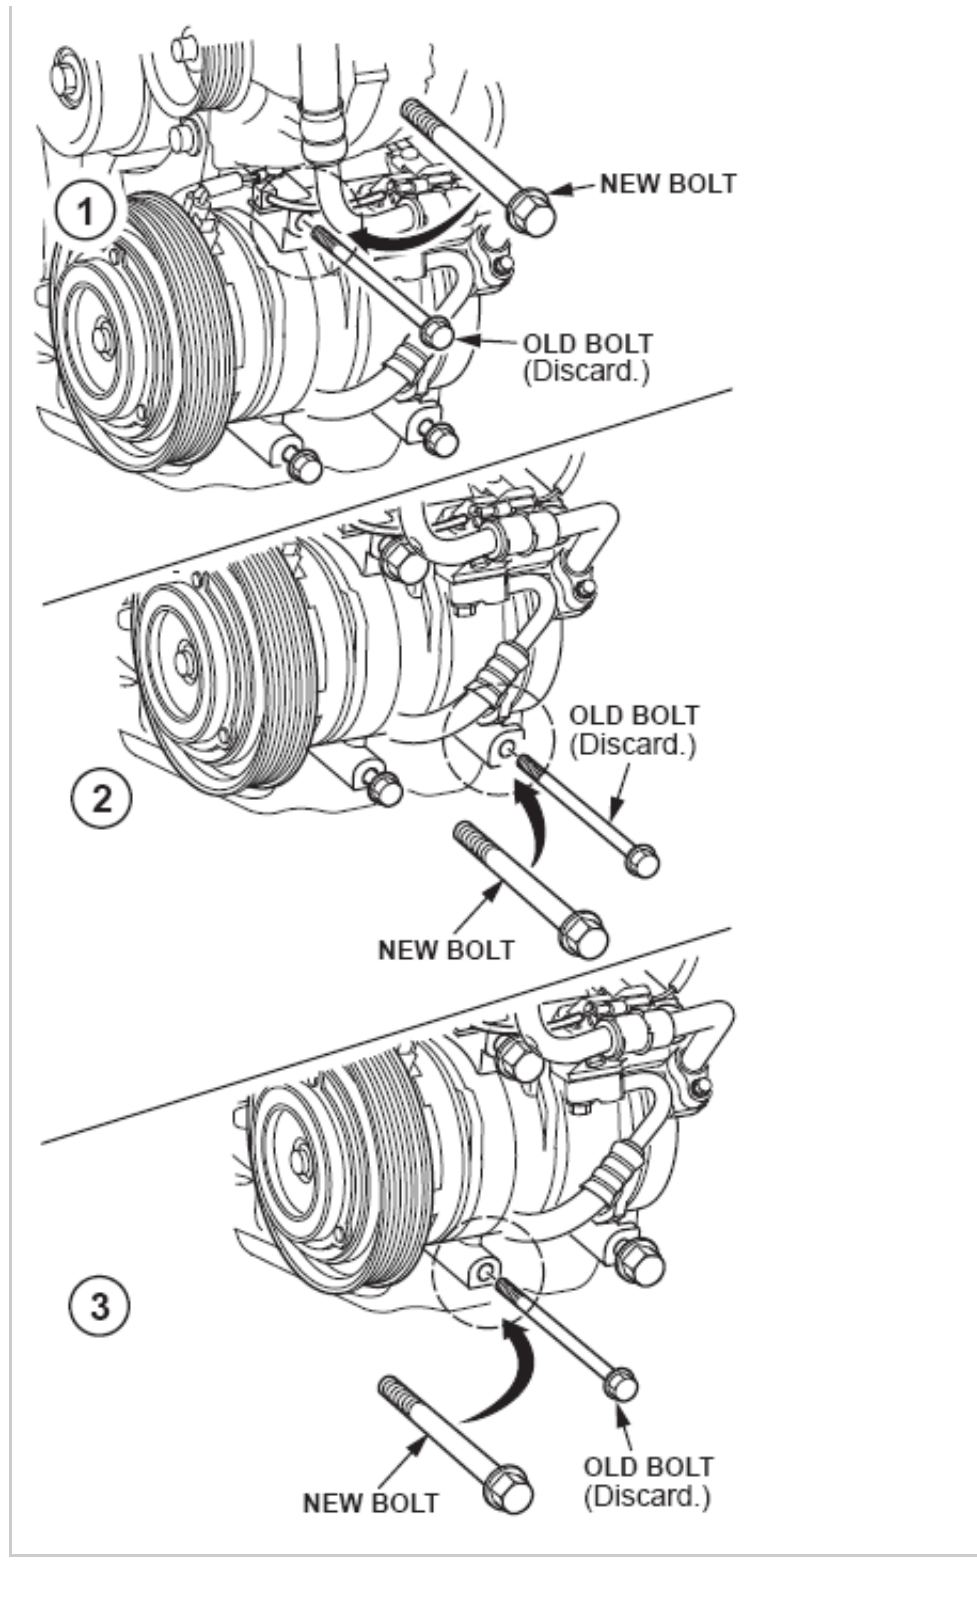
The construction of the drive belt and the alignment of the A/C compressor may cause the drive belt to create a squeaking noise when the engine is idling. This usually occurs when the engine is cold or first started.

9. Replace the A/C compressor bolts with new bolts, one at a time. Tighten them finger tight. (TL shown)

1. MDX - Replace the four compressor mounting bolts as shown.
2. TL and ZDX- Replace the **accessible** compressor mounting bolts.
