Having replaced the worn eyebolt and pin on my RDX to fix a P2263 code I was thinking of a way to overcome the worn pin problem when replacing the eyebolt so the pin doesn't need to be replaced as well because replacing the pin with turbo still in the car makes the job far more difficult. The pin is 15mm OD and at 170K miles on my car the variable boost linkage pin had about 1.75mm of wear. The eyebolt had approximately 2mm of wear so replacing the eyebolt would still leave about 1.75mm of play at the pivot point. This may not generate a code but what if you could also get rid of this play too without replacing the pin.

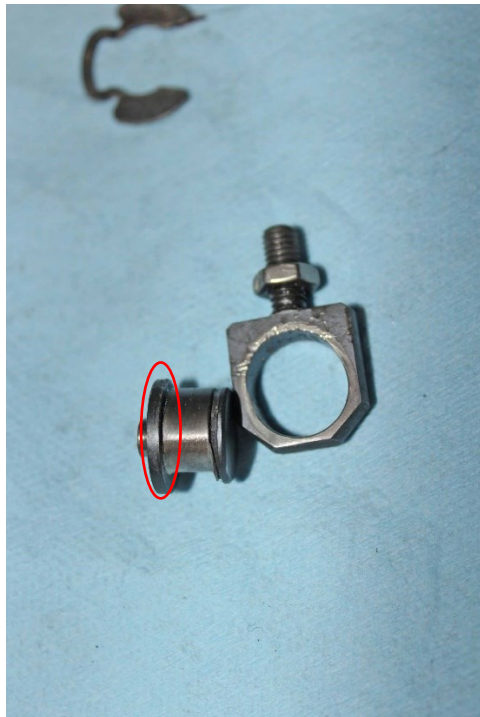
There's an 18mm OD 2mm wide flange on the inside of the pin next to the linkage arm and this flange can be used with an off-the-shelf 18MM ID 2mm thick bronze thrust washer to take up the downward play due to the worn pin.

The 2mm thick thrust washer with an 18mm ID can be installed over the pin flange and in between the eyebolt and linkage arm. The one modification needed to the thrust washer is a measurement and cut to the washer to provide an edge for the actuator arm (nut and washer) to push on the thrust washer flat during the downward stroke. The cut to the washer is based on the pin wear and the location of the top edge of the eyebolt with the eyebolt positioned in the upper most position, where the eyebolt bottom is contacting the pin and all the gap between the worn pin and eyebolt is in the upper most position.

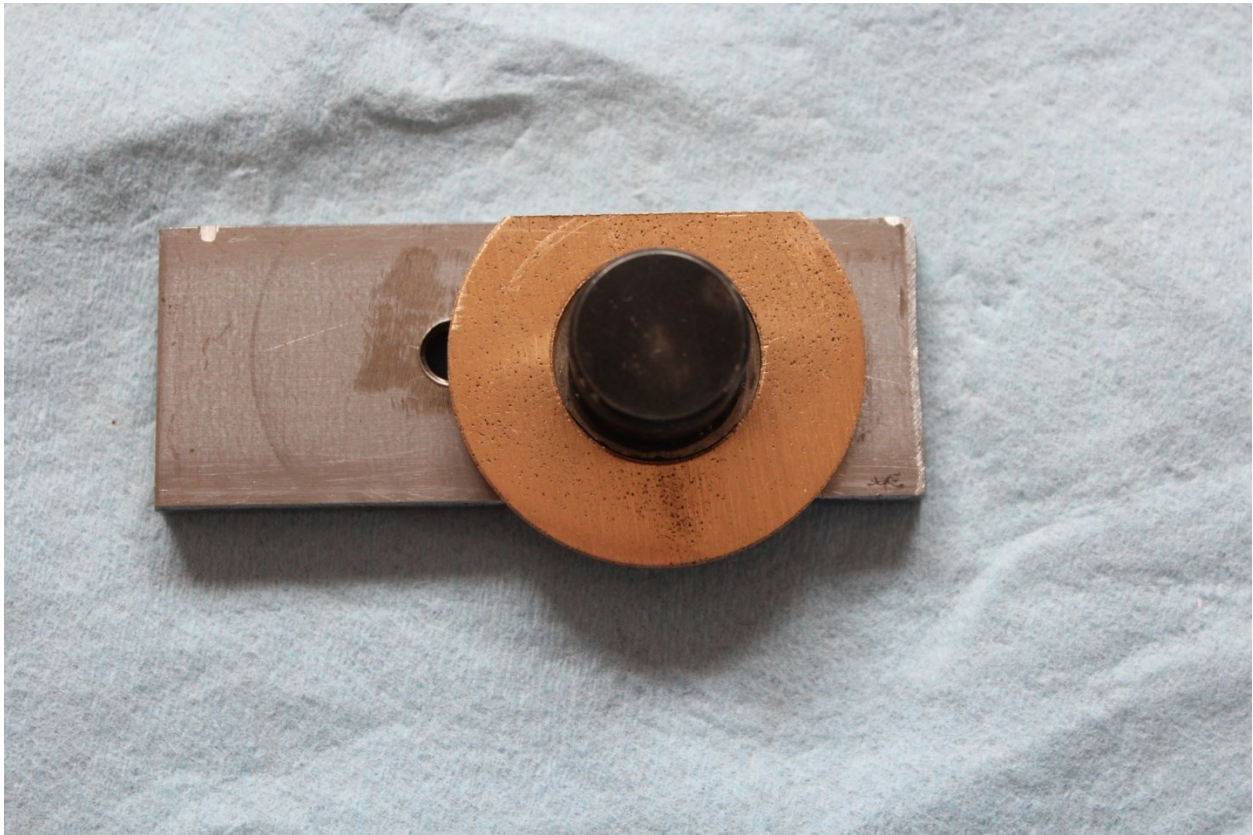
Here the washer is installed over the pin flange before the eyebolt is installed. The actuator will push down on the thrust washer top flat section and move the linkage arm downward. The rectangular metal piece shown is used to represent the turbo linkage arm (not the same size). See next page for more details.

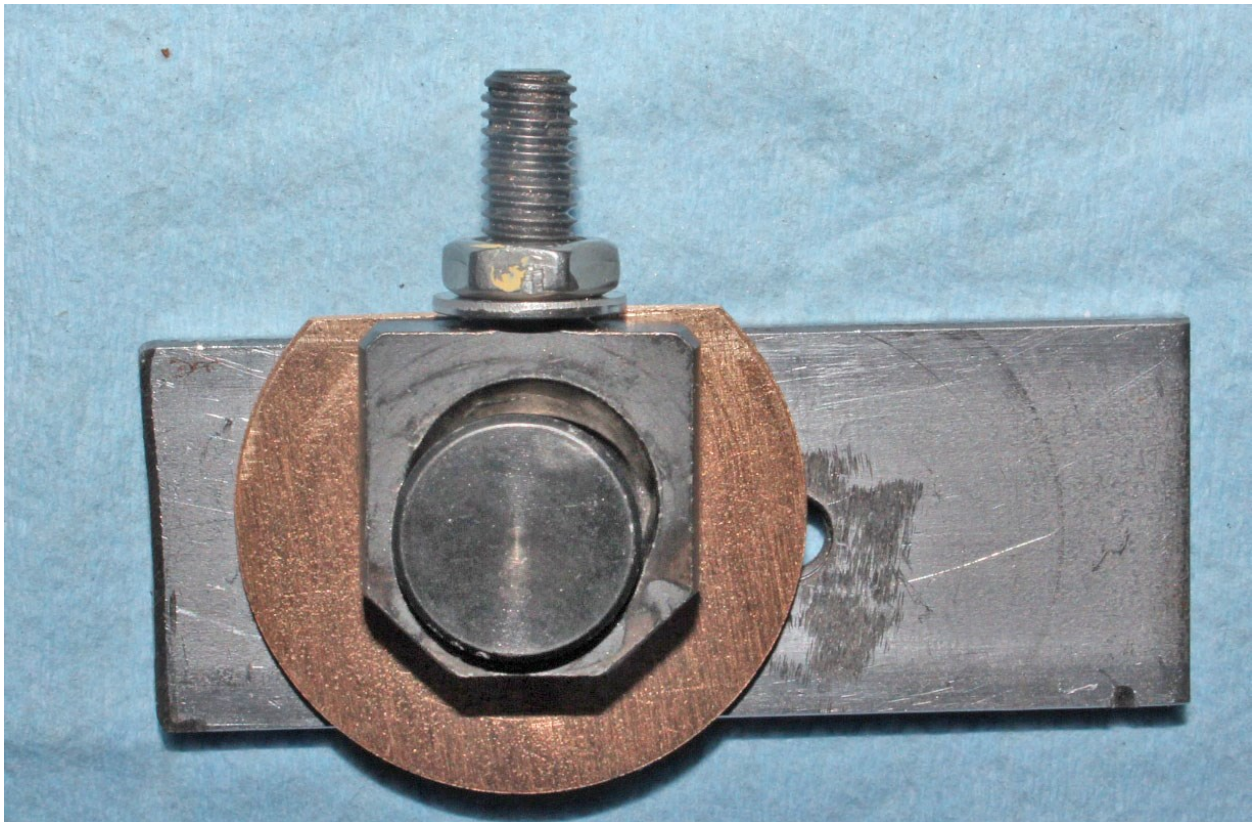
With the thrust washer flat cut based on the amount of pin wear and eyebolt positioned as shown; the nut and added washer on the eyebolt threaded will push on the flat of the thrust washer so the play from the worn pin and between the eyebolt and pin doesn't change on the downward stroke of the actuator. The thrust washer pushes directly on the pin flange and rotates as the linkage moves up and down. The reason I think this will work over the long run without much wear is because there's not a lot of pressure on the thrust washer or flange area during the downward stroke, the exhaust pressure naturally opens the flap and not much force or pressure is required by the actuator on the downward stroke to open the flap. Washer flat cut is marked with the eyebolt in place on the pin and in the uppermost position so the pin contacts the bottom of the eyebolt and any wear will show up as a gap in the upper pin and eyebolt location as shown below. The thrust washer and nut/washer holds the eyebolt in this position to keep the pin wear and gap from creating slop during the downward stroke. Washer flat cut should be measured and cut so the top edge of the eyebolt is flush with the flat portion of the washer with the eyebolt position up against the bottom of the pin with all wear gap above the pin as shown. Not sure if the bottom area of the thrust washer needs to be trimmed for clearance.

It there is any binding the thrust washer thickness may need to be filed or sanded down a slight amount.

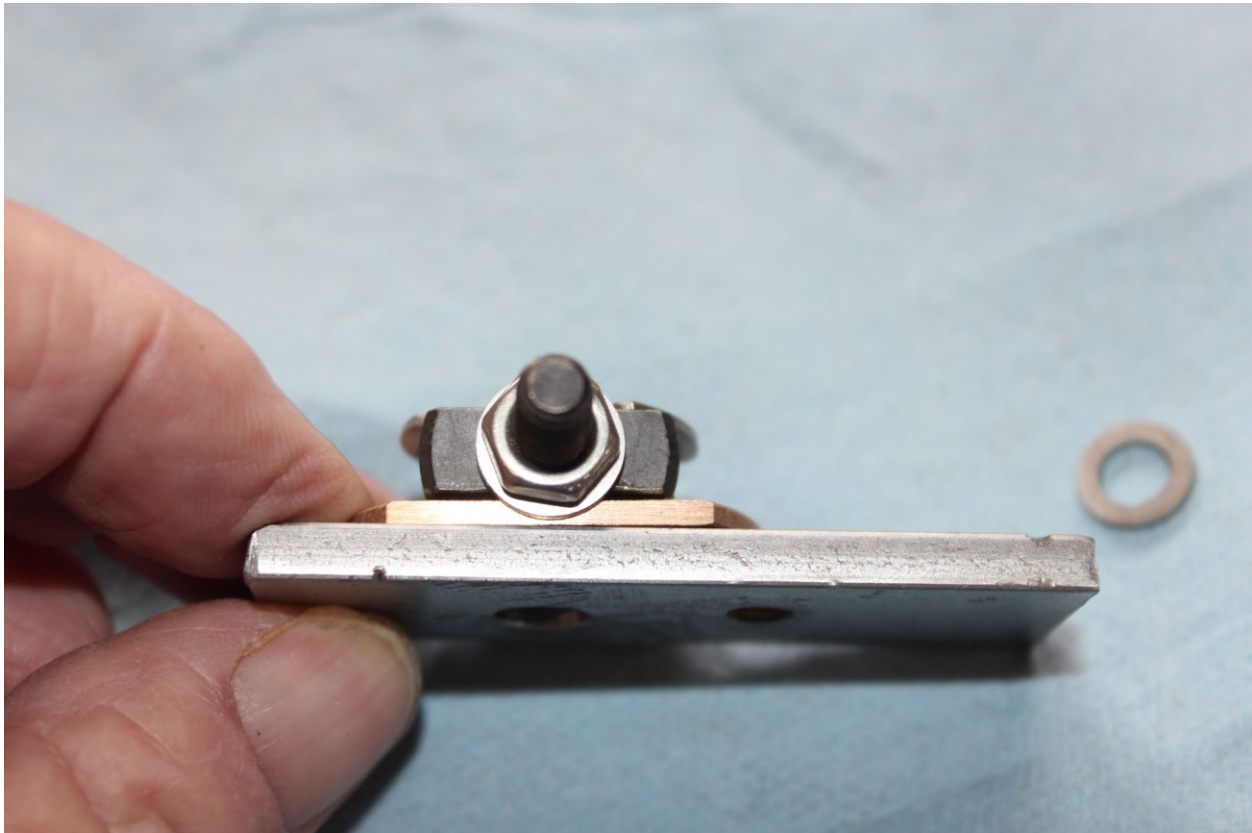
Shown is the added washer, 11mm OD installed below the adjustment nut of the eyebolt. The existing jam nut should be hand tightened against the washer flat and held in this position when the actuator barrel adjusting nut is locked in place with the nut. The nut should just take up any play between the washer and washer flat. On the downward stroke the actuator pushed down on the top of the thrust washer which transfers the force through the inner flange of the pin so no play on the downward stroke. The upward force of the actuator rod will still be the eyebolt in contact with the pin. Adding high-temp dry lube should help prevent future wear. I haven't actually tried this idea out but I think it should work as long the washer is cut in the proper location and there's no binding in the pivot point.

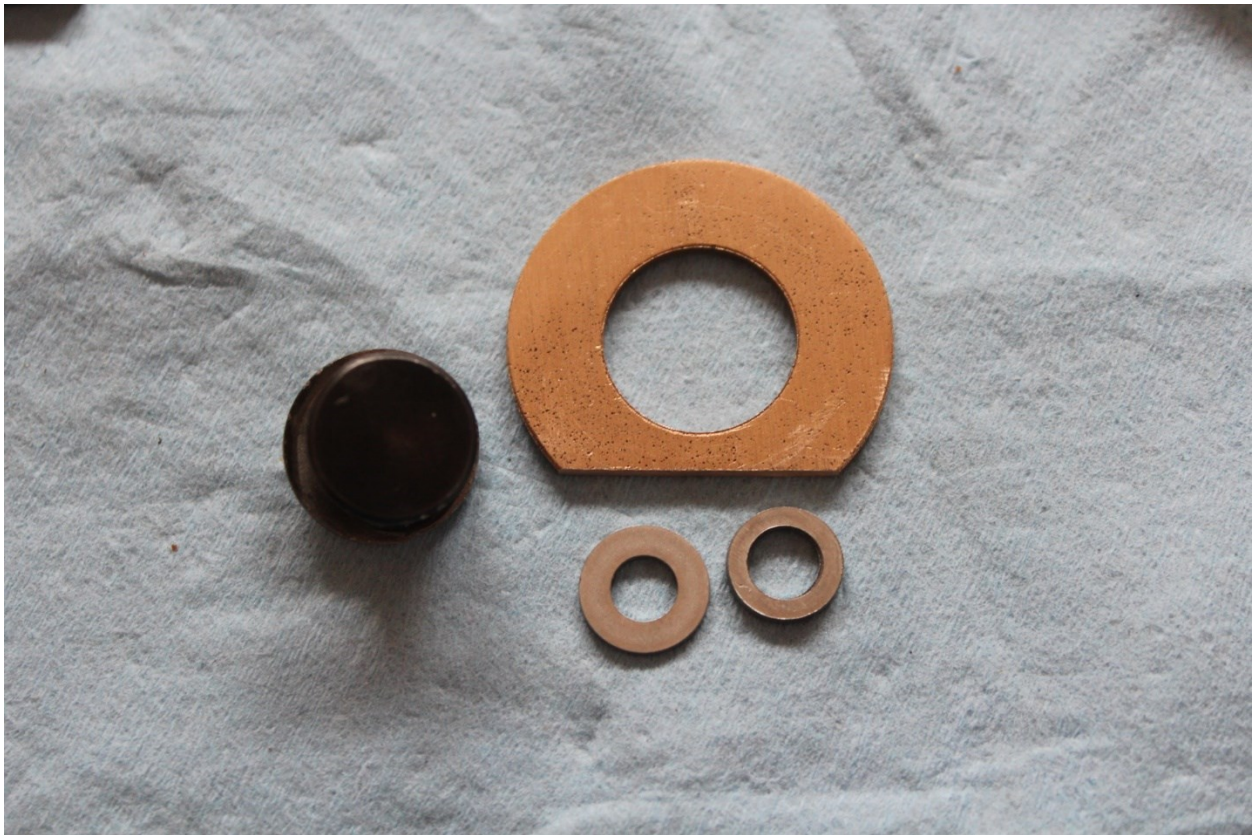
Parts needed, 18mm OD x 2mm thick thrust washer McMaster Carr part number 2011N123 and an 11mm OD M6 washer. 11mm M6 washer McMaster Carr part number is 98689A115 . Thrust washer marked and cut using a hacksaw based on pin wear and files or sanded as needed for best fit. Thrust washer purchased is shown after the needed flat cut was made. Pin shown for reference and a larger 12mm OD washer is shown in the photo(not used). Only the two parts needed.
