Applies To: **1996-01 3.5RL – ALL**
2002 3.5RL – From VIN JH4KA9...2C000001 thru JH4KA9...2C006092

October 1, 2001

Intermittent Electrical Problems

(Supersedes 98-028, *Security System Sounds Intermittently*, dated September 28, 1998)

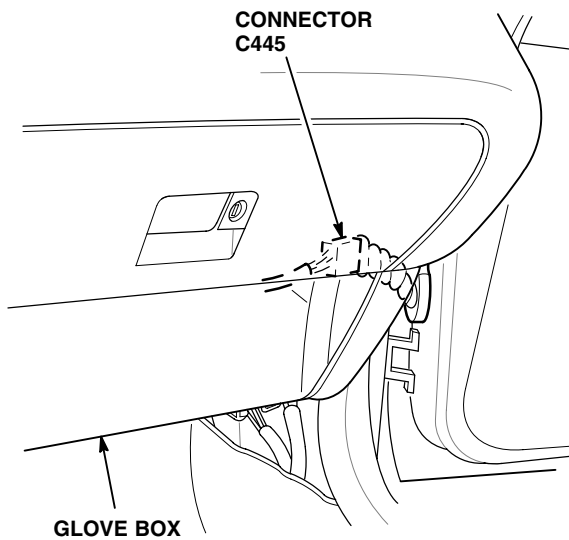
5. Through the access holes, inspect for water in the front pillars and on connectors C445 (passenger's side) and C412 (driver's side).
 - If you find a water leak, do REPAIR PROCEDURE A and REPAIR PROCEDURE B.
 - If you do not find a water leak, do REPAIR PROCEDURE A only.
