MODEL  
2.5TL  
3.2TL

BULLETIN NO.  
**95-023**

## Key Stuck in the Ignition Switch

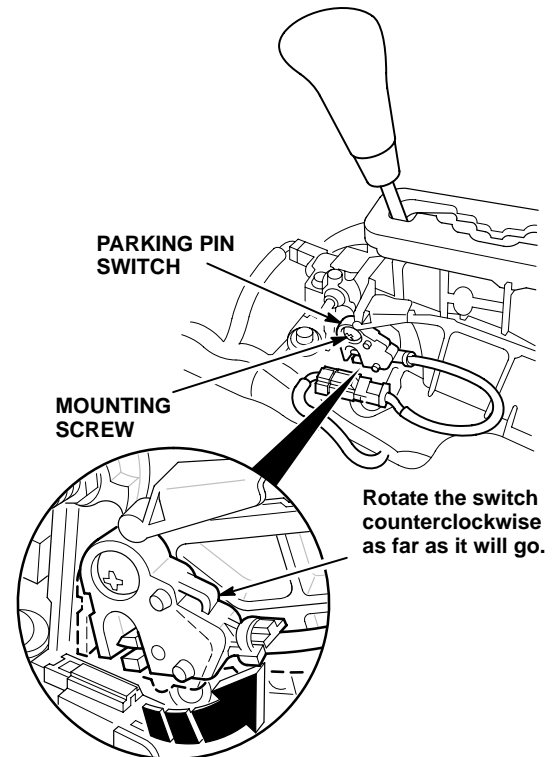
The pin on the shift lever does not fully engage the parking pin switch. Because of this, the switch does not deactivate a solenoid in the ignition switch that allows the key to be removed.

2. Loosen the parking pin switch mounting screw. Rotate the switch counterclockwise as far as it will go (about 0.5 mm), then tighten the mounting screw.
