MODEL
2.5TL
3.2TL

BULLETIN NO.
96-037

Wind Noise From the Moonroof

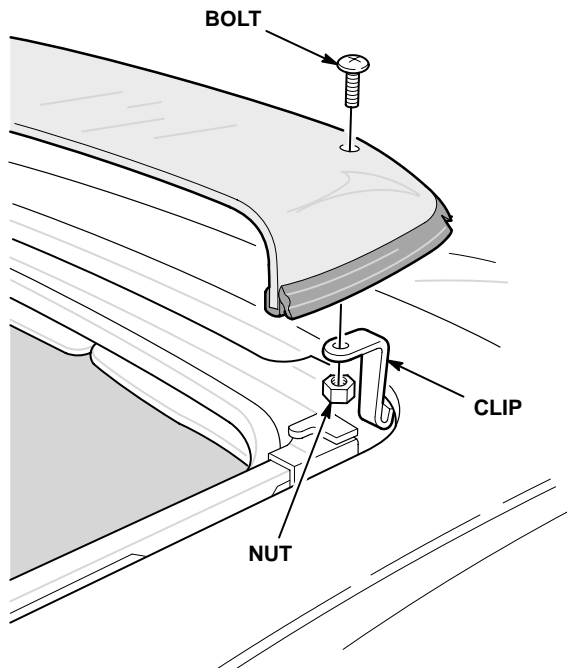
With the moonroof closed, a whistling noise comes from that area at highway speeds.

The mounting clips do not clamp the accessory moonroof visor tightly, allowing it to lift at highway speeds.

Replace the moonroof visor clips and mounting hardware with the new parts in the kit listed under PARTS INFORMATION.
