February 8, 2018

Version 1

Flickering Lights, Multiple Indicators Coming On, Jerky Steering and/or Voltage-Related Fluctuations**AFFECTED VEHICLES**

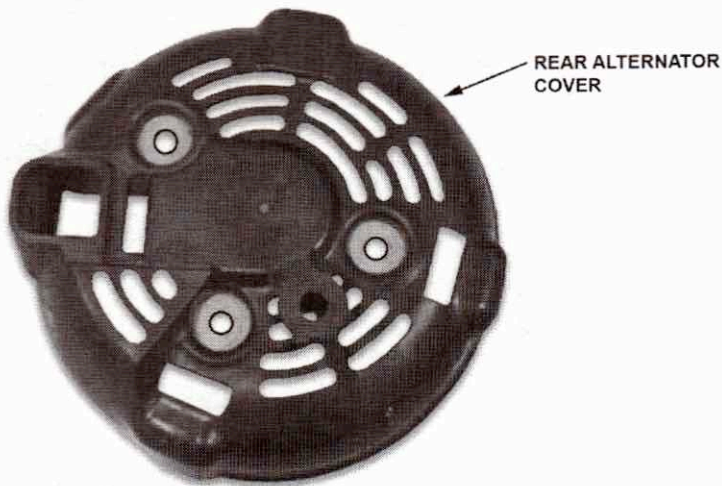
The B+ sensing screw on the alternator is not torqued properly.

1. Disconnect and isolate the negative cable with the battery sensor from the battery. Refer to the service information.
2. Remove the #4 spark plug ignition coil to give you better access. Refer to the service information.
3. Disconnect the alternator connector.
4. Remove the three 8 mm nuts holding on the rear alternator cover, then remove the cover.
