**Front Accessory Power Socket Lid Won't Stay Closed**

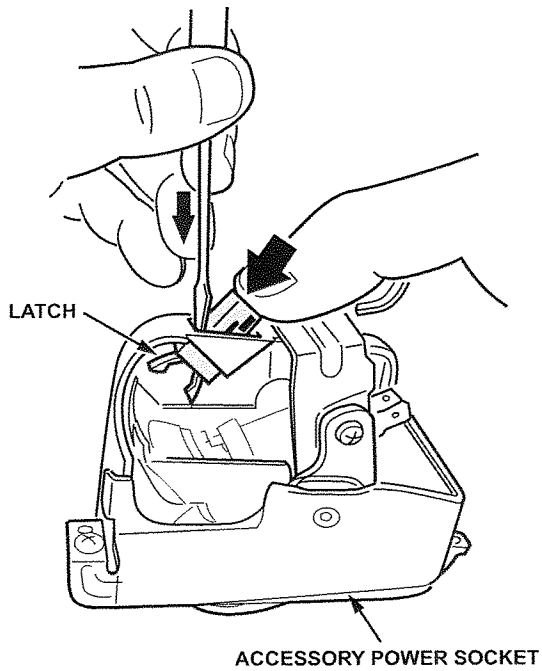
The center console power socket lid latch is broken.

3. Remove the latch from the accessory power socket.
