Applies To: **1999-03 3.2 TL – ALL**
2001-03 3.2 CL – ALL

April 27, 2006

Blower Motor Does Not Work

(Supersedes 06-006, dated February 14, 2006 to update the information with the black bars)

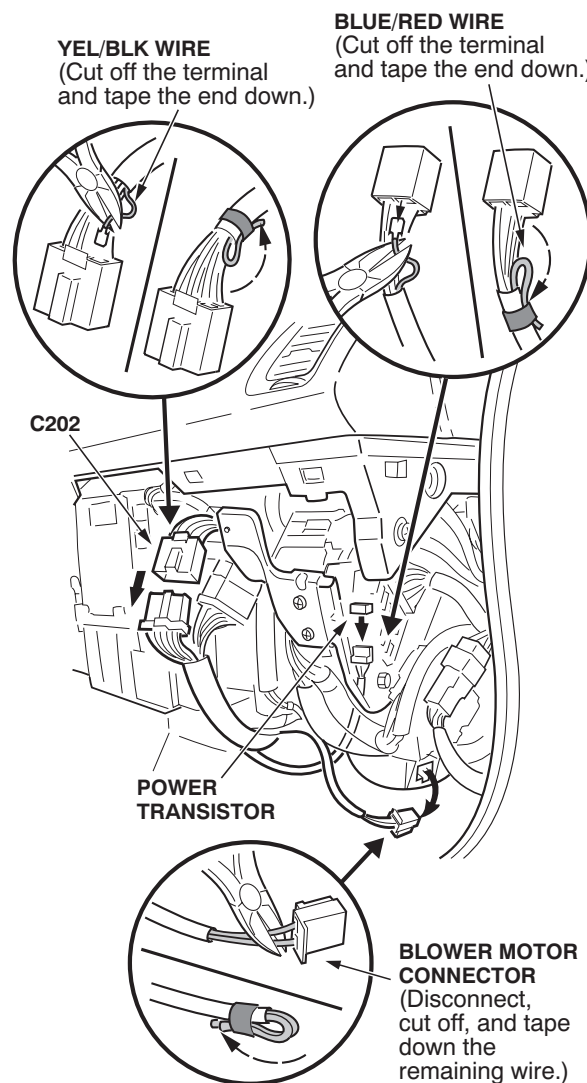
Poor connection at the blower motor caused by tension on the wiring harness.

2. Disconnect the brown 7P connector (C202) from the main harness. Remove the YEL/BLK wire terminal from cavity 3 of connector C202. Cut off the terminal, and tape the remaining end of the wire to the harness.
