February, 2010

Honda 740 Codes: Torque Converter Forensics

Ed Lee

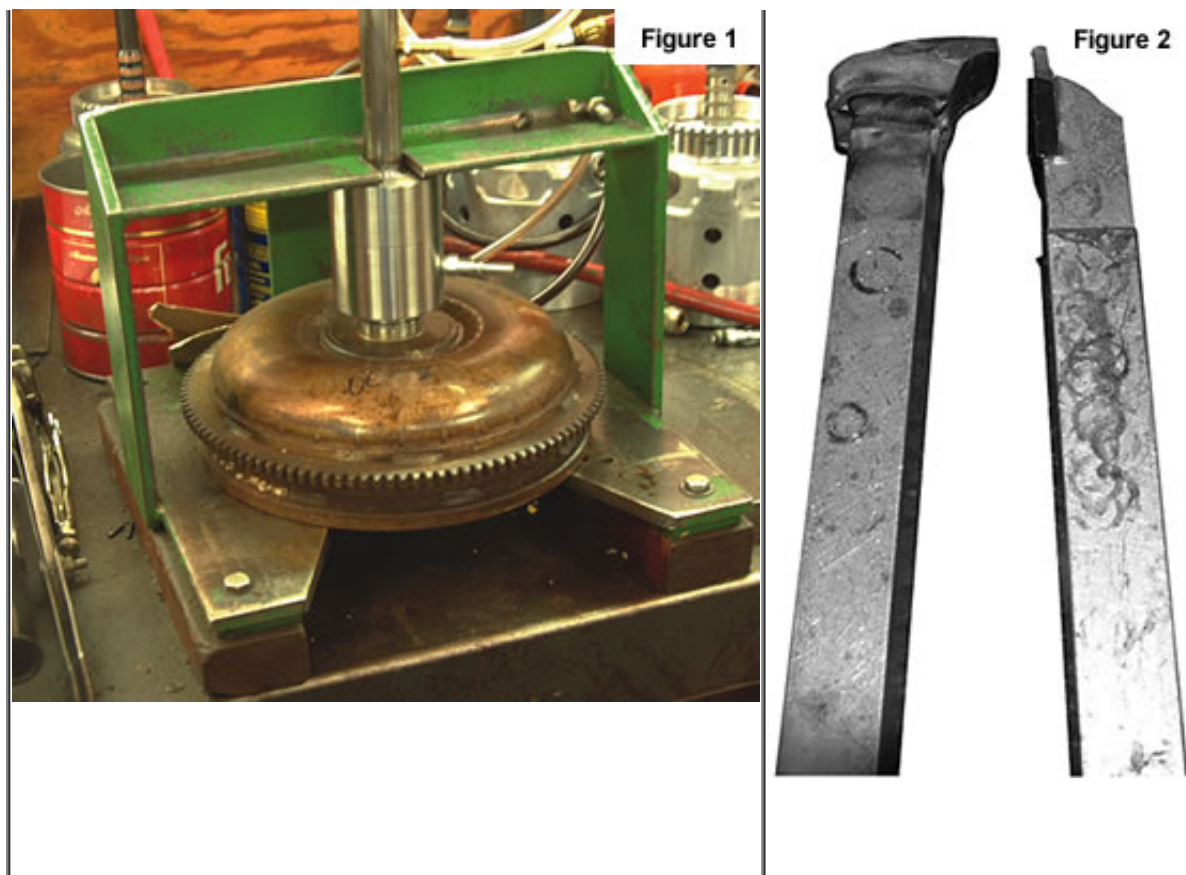
When the "failed" units were tested with this method, they all tested good. A better test method appeared to be in order. An equal number of known good converters were collected and another series of tests were performed on the combined samples. This time, each unit was tested by applying varying amounts air pressure/clamping force. The pressure used for the test varied from 10 psi to 40 psi and was stepped up in 5 psi increments. When the tests were completed, there was a clear division in the 20 to 25 psi range that separated the good converters from the converters that had set a 740 code. Converters that previously tested good at 40 psi were now failing in the lower pressure range.

An additional piece of information was also discovered during these tests. Converters with the least amount of clamping force had the largest volume of oil escaping from the exhaust hose on the test fixture. This proved that the poor clamping force was the result of an internal leak. Leaking converters were cut open and inspected. There are three possible areas for the leaks to occur. One is where the friction material of the TCC (torque converter clutch) piston mates to the cover. Since a positive seal is possible in this area, the focus of the inspection moved to the two areas where there is no provision for a positive seal. The other two areas (turbine shaft to turbine hub and turbine hub to TCC piston) rely on the clearance between the mating parts to establish their seal. The most likely area for the leak seemed to be between the turbine shaft and the turbine hub, but to be certain, individual flow tests were performed on both areas on all converters. The leak between the input shaft and turbine hub on all converters (both known good and known bad) would flow between .2 gpm (gallons per minute) and .5 gpm. The leak between the turbine hub and the piston, on the other hand, would flow .8 gpm to 4.5 gpm. This leak was obviously a lot more severe.

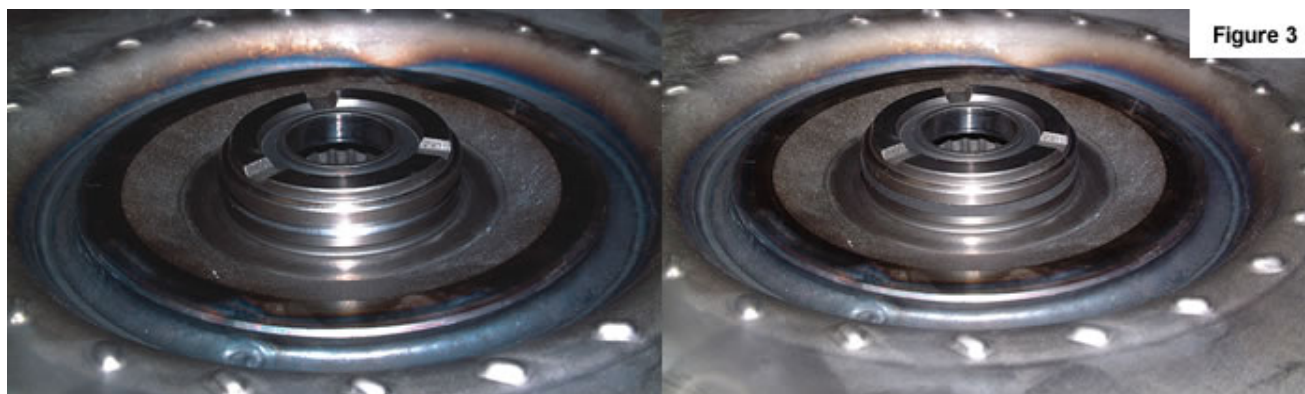
This test also explains why Honda started using a scarf cut PTFE seal in this area on its later model converters. Since the diameters of the turbine hubs on the earlier and later model converters were the same, it would be possible to use the later model seal if a groove could be cut into the hardened surface of the earlier turbine hubs. To cut the groove a special tool was fabricated from a carbide grooving tool. The end of the tool was cut off, rotated 90 degrees, and re-welded (**Figure 2**).

machined easily. **Figure 3** shows a turbine hub after the groove is cut (left), and the same hub with the late model seal installed (right).

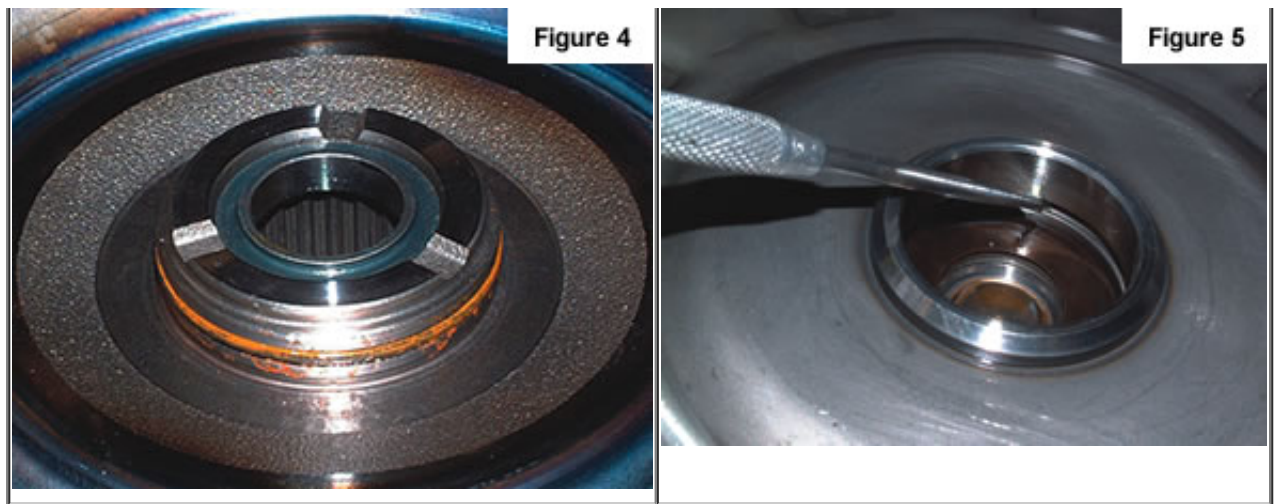
Even though the seal cured the test converters, some of the late model Odyssey converters that already have the OE seal, still have lockup problems. The problem with these converters has turned out to be a clearance issue.

In the past, converter technicians who were removing the bearing from the front of the 4R100 turbine hubs to make the clutches apply like the E4OD converters learned that .080" to .090" clearance was necessary between the hub and cover. That same clearance is needed for most of the converters that use the E4OD style stack up. The bottom line is that you need sufficient clearance to allow the piston and/or hub to come to a complete stop on lockup apply before contact is made with the cover. When GM 's testing proved that the piston was stopped before it contacted the cover on the early 245 and 298mm converters, they reasoned that it was safe to remove the friction material stops near the I.D. of those TCC pistons. Some Honda converters have as little as .045" clearance between the piston and the bearing that rests in the cover. Any machining of the clutch apply surface on the cover or clutch bonding surface on the piston will make this clearance even less. **Figure 5** shows the proper clearance between the piston and bearing race. The outer bearing race normally protrudes out of the cover about .030". If the piston comes into contact with the outer bearing race before the piston comes to a complete stop during lockup apply, it will rotate the race in the cover. On occasion the rotation of the race will recess the race down to a point that the top will be flush with the cover. This will affect both the overall height and clutch release clearance of the converter. To get the piston to bearing clearance to the proper tolerance, measure the clearance between the piston and bearing outer race, then machine the front of the piston at the I.D. It is usually only necessary to remove about .030" to .040".
