September, 2011

Overheated Honda Converters/740 Codes

Ed Lee

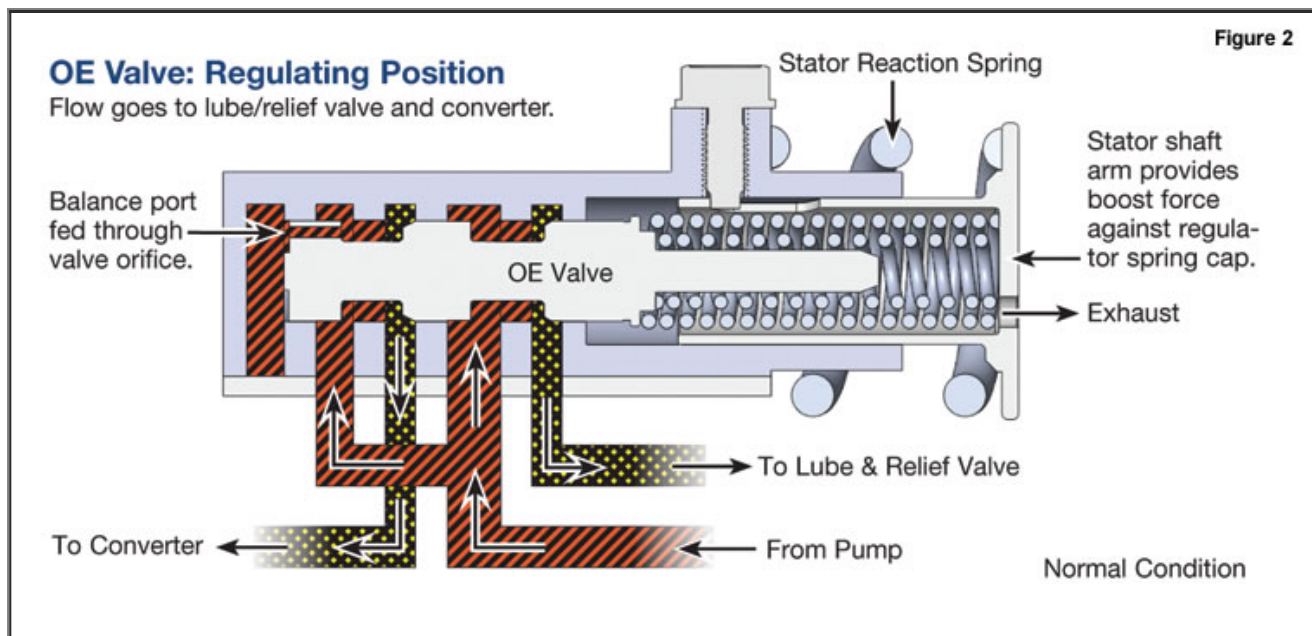
Typically, the PR spring and any available boost pressures push the PR valve in one direction and balance pressure opposes or pushes from the opposite direction until the valve reaches its regulating position. When the PR valve approaches its regulating position, charge oil (TCC release oil) begins to flow and continues to flow as long as the valve remains in the regulating position (Figure 2).

In many systems, a modest base line pressure is established by the PR springs, with higher pressures coming as a result of some demand-related boost system. As you can see in **Figure 2**, Honda does not use a conventional line pressure boost system. In the Honda system, more substantial PR springs and a stator load-related boost system establish a much higher base line pressure from the outset with modest boost increase at max pressure.

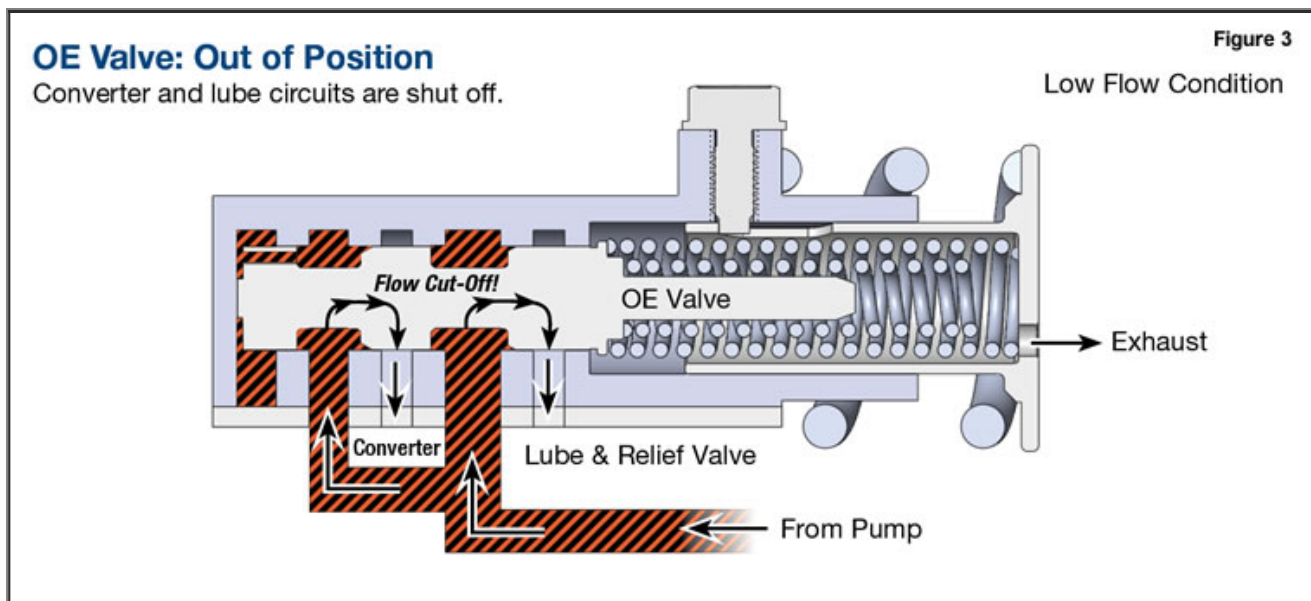
Under low pump output conditions, balance line pressure cannot overcome the stout PR spring and boost force. This causes the PR valve to move out of its regulating position (also referred to as a PR valve being "out of balance"). Under this condition, although line pressure is available (as noted by Sean), the valve has stroked over and shut off flow to the converter charge/cooler circuit. The result: TCC dragging on the cover, little or no cooler flow to control that heat, and all those cooked converters in your core pile (**Figure 3**).

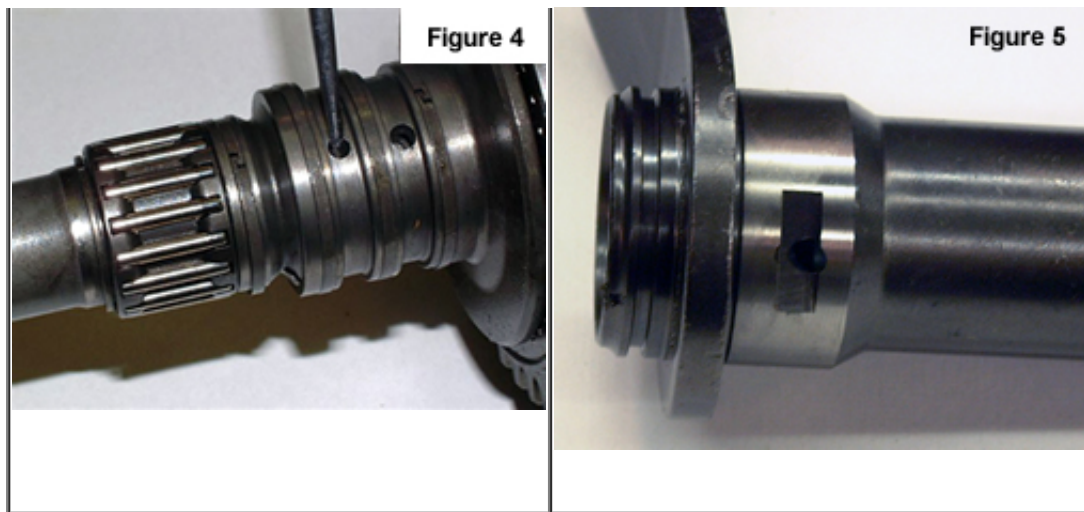
This circuit is generally fairly tight. The parallel circuit, on the other hand, does not have a positive seal where the stator support passes through the valve body (**Figure 5**).

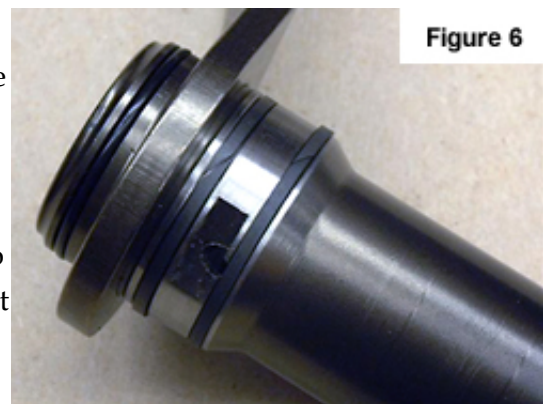
This parallel circuit is prone to leak and does have some effect on flow. Not all shops will be able to address this leak, but the overheated converter issue can be resolved without fixing this leak. If you are able to address this leak (**Figure 6**), you will add about .2 of a gallon to your cooler flow.
