## Product Update: Windshield Side Trim Retainer Is Loose

The windshield side trim retainers may come loose from the A-pillar, allowing the trim to be loose.

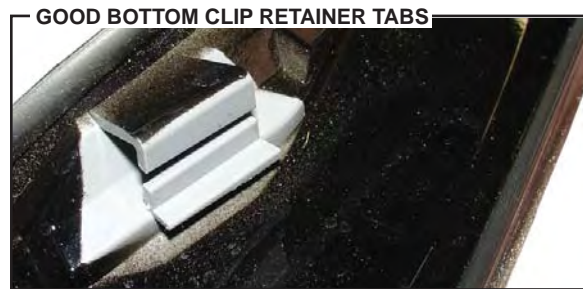
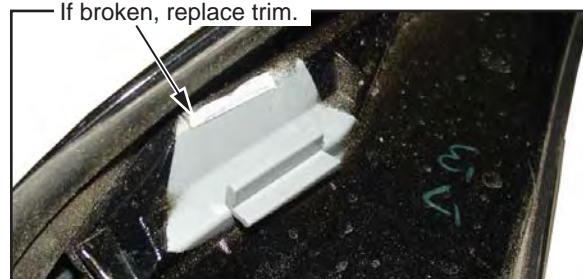
3. Inspect the bottom clip retainer tabs on the windshield side trim.

- If the bottom clip retainer tabs are broken or stress-whitened, discard the trim and use a new windshield side trim to complete the repair, then go to step 9.
- If the bottom clip retainer tabs are OK, go to step 4.

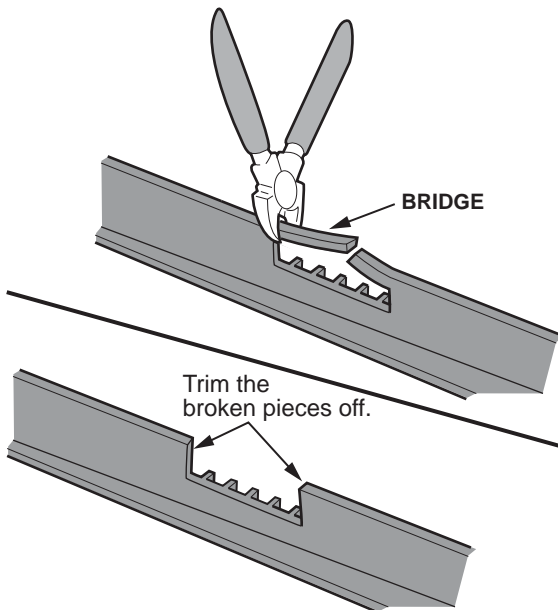
5. Inspect the windshield side trim for broken or cracked bridges. If a bridge is broken or cracked, use diagonal cutters and trim it as shown.

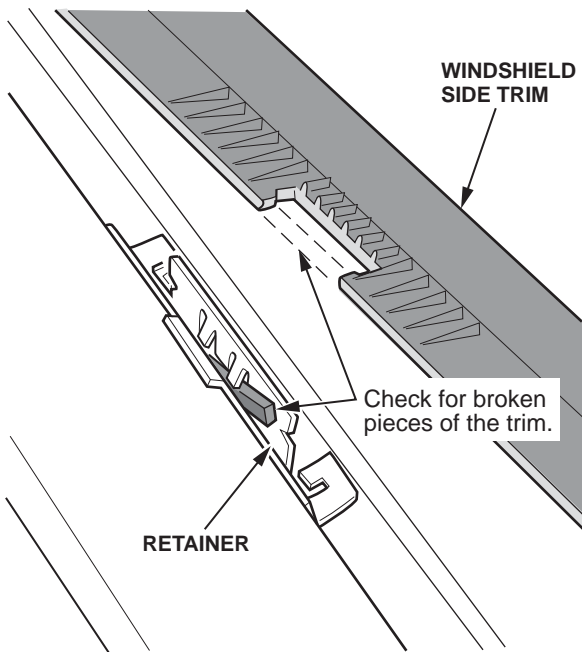
9. Inspect the retainers on the vehicle:

- If any retainers are missing or loose, go to step 11.
- If any retainers are firmly attached to the A-pillar, remove any plastic trim pieces from them with a flat-tip screwdriver. Go to step 10.
