January 22, 2015

01273 Version 1

Rattle from the Second Row Passenger Seat on Rough Roads

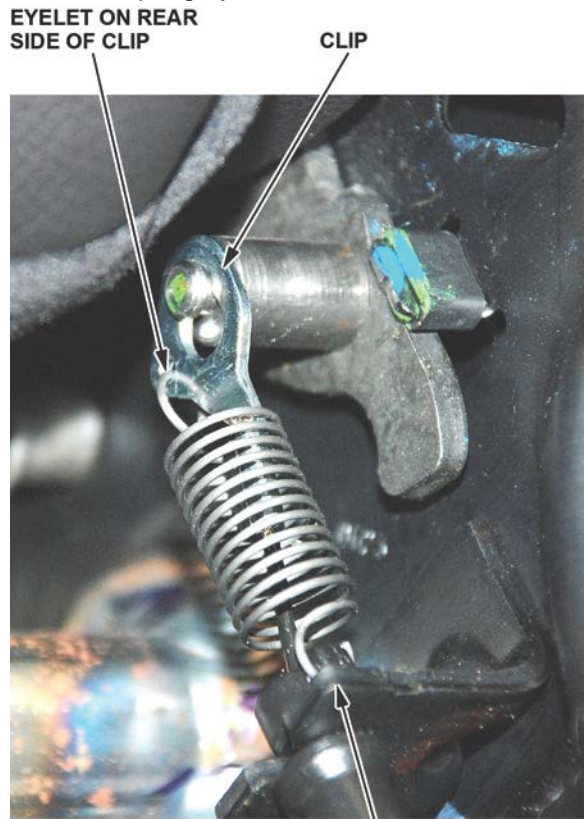
7. Inspect the spring and how it is hooked on the clip.

- If the spring eyelet is on the rear side of the clip, this bulletin does not apply.

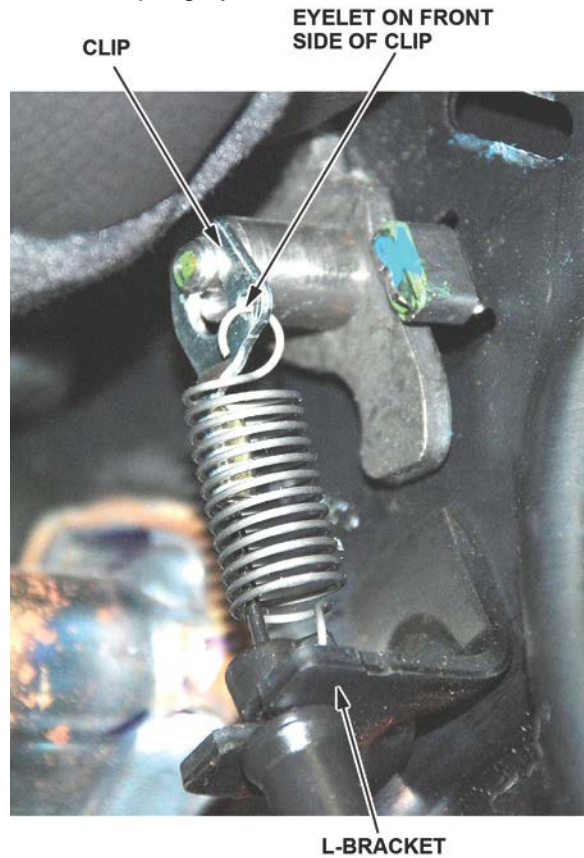
A cable link inside the seat is rattling against the frame.

- If the spring eyelet is on the front side of the clip, go to step 8.

Turn the clip around on the second row passenger seat so that it is facing to the rear.
