## Pop Coming from Both Sides of the Rear Roof Area

Year	Model	Trim Level
2019–22	RDX	ALL

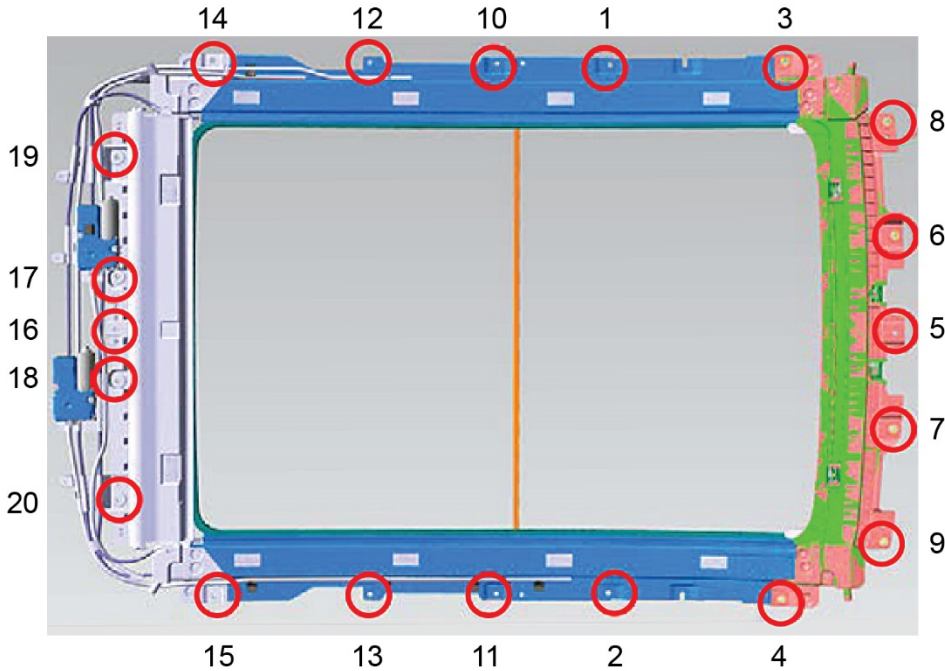
We are getting reports of a popping noise coming from the left and right sides of the rear area of the roof near the panoramic sunroof assembly.

Follow the service information procedure, **Headliner Area Removal** to remove the headliner. Once the headliner is removed, all 20 sunroof assembly bolts will be accessible. Then, by following the torque pattern below, make sure each bolt is torqued to spec **9.4 N.m (6.9 ft-lb)**.
