## Shift Pointers

**•Subject:**  
Erratic 2-3 shift, code P0780

**•Unit:**  
BAYA 5-speed automatic

# What's Causing Third-Clutch Failures in Honda Five-Speeds?

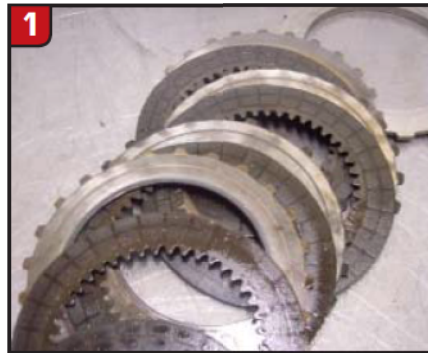
For a while now I have been interested in finding out what is causing third-clutch failures in Honda five-speed transmissions. An opportunity finally presented itself when a customer brought in his 2003 Honda LX with a 3.0L engine and a BAYA five-speed automatic transmission. We had overhauled this transmission three years ago when the vehicle had 60,000 miles. Now with 134,000 miles the vehicle had an erratic 2-3 shift and code P0780 "Problem in Shift Control System." When we disassembled the unit the only problems we found were burnt third clutches (Figure 1) and badly burnt fluid.

I wanted to put the transmission as close as possible to the condition in which it came in but in a workable state to obtain the readings we wanted, so we repaired the transmission only. That is, we replaced the third clutches and steels with Honda original equipment, installed an aftermarket rebuilt converter and thoroughly cleaned the valve body. We did this to find the original cause of the failure.

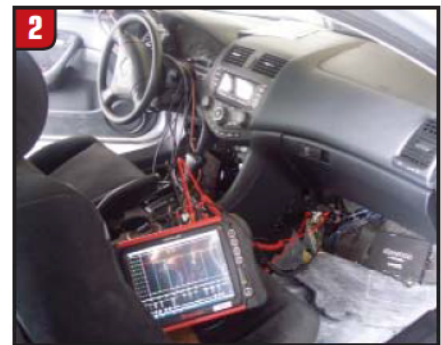
I connected our test equipment to the vehicle (Figure 2) to obtain as much data as possible. I obtained main line-pressure readings
