Applies To: 2004-06 TL – ALL

April 4, 2006

Power Window Main Switch Button is Damaged or Missing

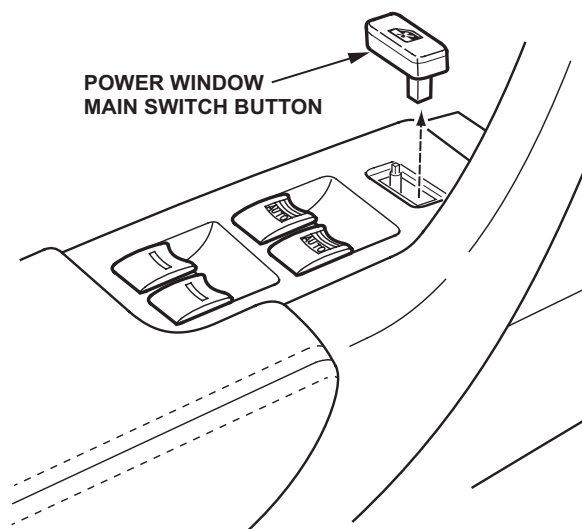
1. Remove the power window main switch button from the power window main switch.

2. Look down into the switch for any remaining broken lock tab pieces from the button. If there are any, remove them with a pick or a vacuum cleaner.
3. Install the new button, and check the operation of the main switch and the power windows.
