2006 Acura TL repair challenge (four day run for a hopeless ball)

Background: 2006 TL with unknown mileage, used US engine was installed 2 year ago I changed ATF on this car 6 months ago which took care of shifting issue.

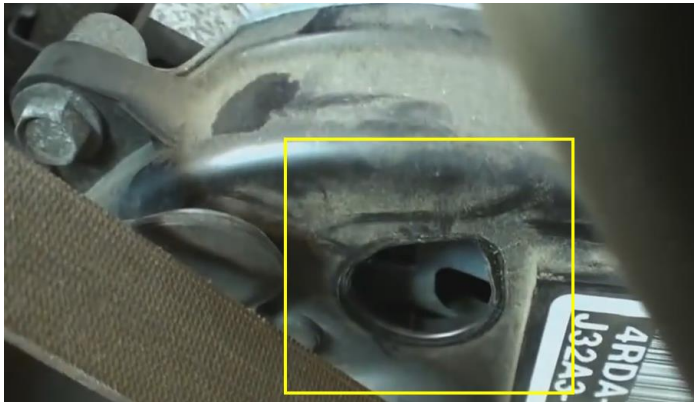
I pulled the rubber inspection cap in the front upper timing cover to expose a part of the cam sprocket and asked owner to briefly crank the engine.

During the cranking the cam sprocket remained stationary confirming my suspicion of broken timing belt and possible interference valve damage.

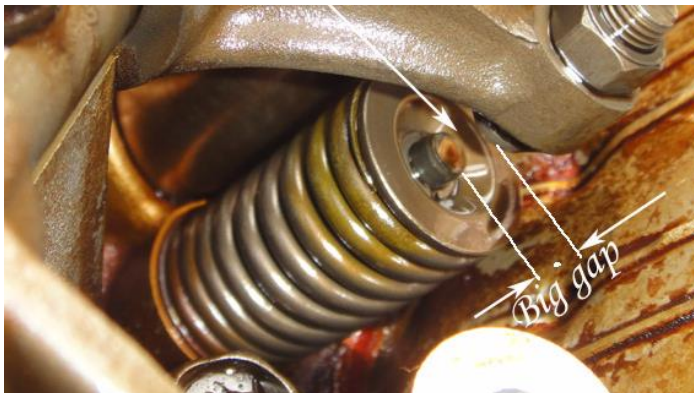
Incompetent expert's analyses: Later this day I've found an article [1] about using visual valve train inspection to confirm a valve damage (that will be indicated by excessive valve lash); more accurate inspection calls for measuring of each spring with precision rule and comparing it to specks (after rocker arm assembly removal).

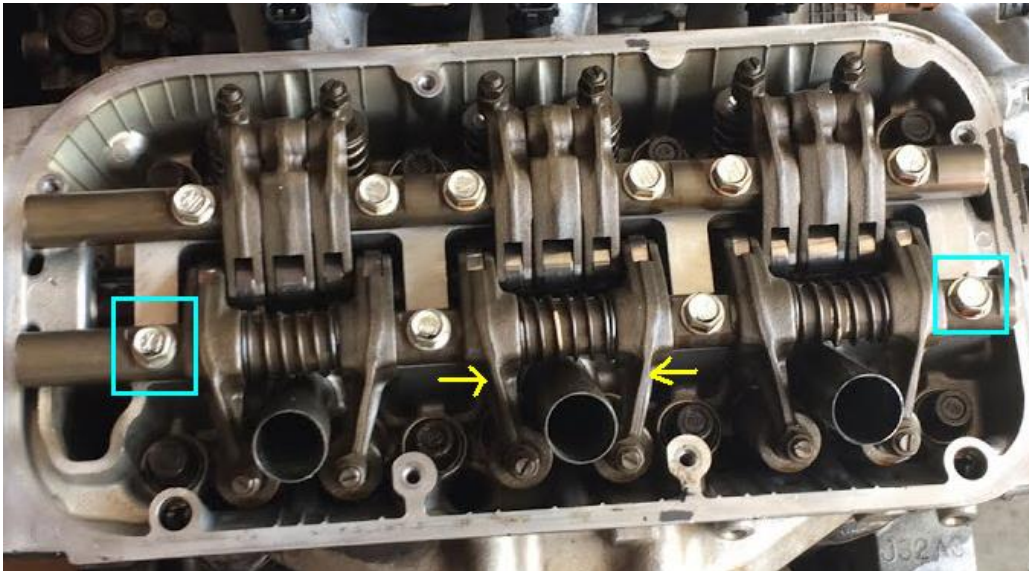
- 1) Installation of exhaust rocker arm assembly is challenging due to the expanding springs between the rocker arms. In order to facilitate installation tightening arms to each other with a soft wire will compress the spring (yellow arrows) and make an installation easier. (Remember to install the exhaust arms first!) Also, temporary use of two longer M8 bolts (from the plenum) can help guiding the rocker arm shaft to its position (install them in place of the outside bolts)

Tightening torque is 16 foot pounds.

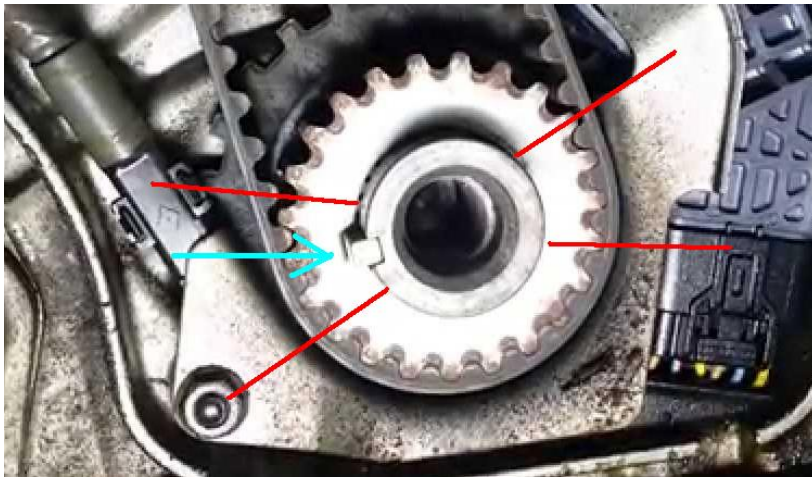
After obtaining Lisle heavy socket coupled to the Porter–Cable 120V impact gun, I began the tear down of the timing belt drive. As a good habit, I've match marked one rib of the crank bolt relative to the harmonic balancer. The bolt came right out (perhaps because the past service technician had under tightened the crank bolt using ordinary impact). I've also noted that the key for the crank timing gear had been installed upside down in the slot. The crank has stopped at 9 o'clock position (safe zone) for cam adjustment.

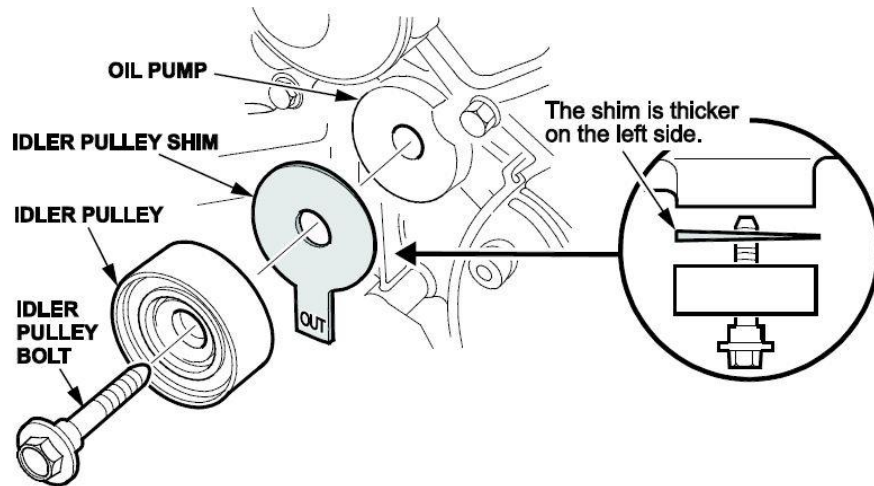
The issue number one has been covered by TSB 08-031; the owner confirmed the presence of the noise. Inspection of motor mounting bracket revealed relief made to accommodate a shim which probably had been discarded by previous service technician.

The very narrow belt width (20 mm compared to 36 mm on Avalon) made it prone to walk on the pulleys as well.

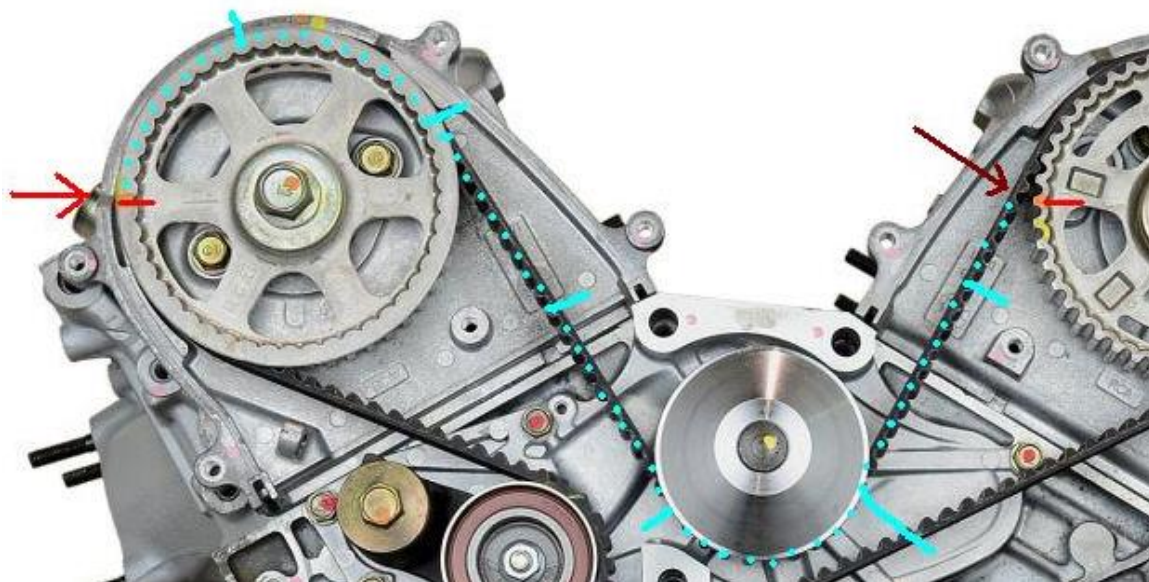
I resolved an issue number two by analyzing high resolution images of J series engines with timing belt exposed downloaded from the rebuild engine retailers' websites [3].

The front view on engine is clear enough to visualize the timing belt teeth and timing marks; using the MS Paint allows easy tooth count. When both cam sprockets are in time, there should be **64** belt teeth between timing marks on the sprockets.

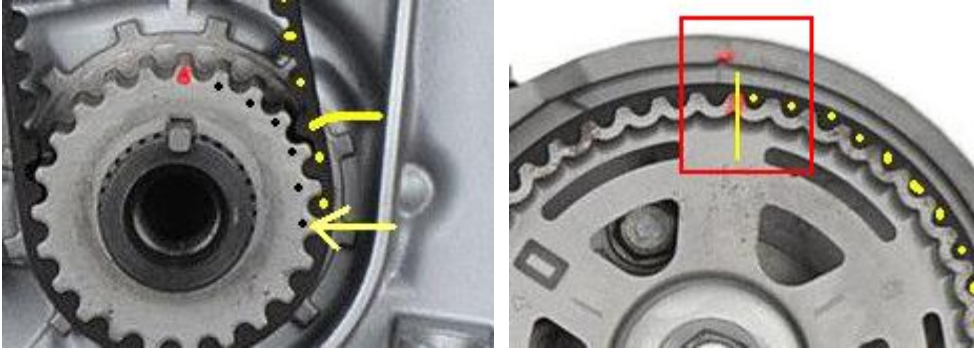
When the crank sprocket is aligned with the mark on the oil pump (tooth number zero, red mark), there should be **62** belt teeth (yellow dots) between crank sprocket tooth #6 (indicated by an arrow) and the mark on the front cam sprocket (red box). Important: use marks on the **sprockets**, not on the housing as a reference points for the tooth counting!

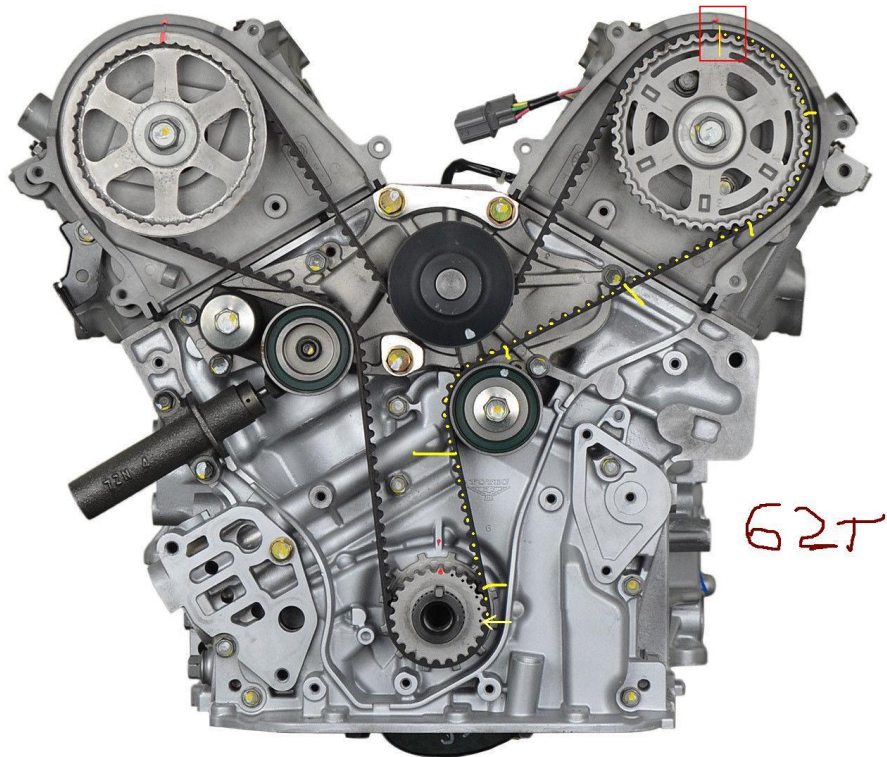
Other method is to use 1/4 inch wide gift wrapping ribbon paced square on the pulleys. Since most Japanese T belts are having tooth pitch of 8 mm, I fabricated the 20 teeth (16 cm long) rule which speeds up the tooth count. I should add that if old belt is intact and in time, it can be match marked to the sprockets before removal followed by transferring marks from old to new belt (it's also important to mark direction of the belt rotation to prevent mirror" installation). Installing the new or used belt without making reference marks may allow too much slack between the sprockets causing one pulley to be retarded relatively to the other ("I've done everything right and my marks did not line up!")

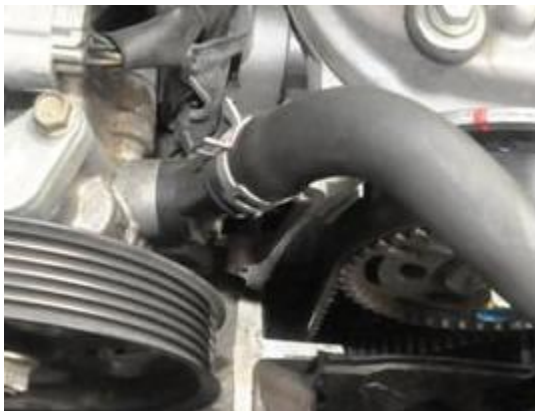
- 5) Remove crank position sensor (swing aside) and crank sprocket before knocking down the water pump
- 6) The vintage power steering hose between the reservoir and pump broke spilling the fluid; I recommend replacing this hose during the job if it feels hard or looks brittle. Overall, items number 3 and 4 added more than an hour to the job!
