Hood Skin Flutters

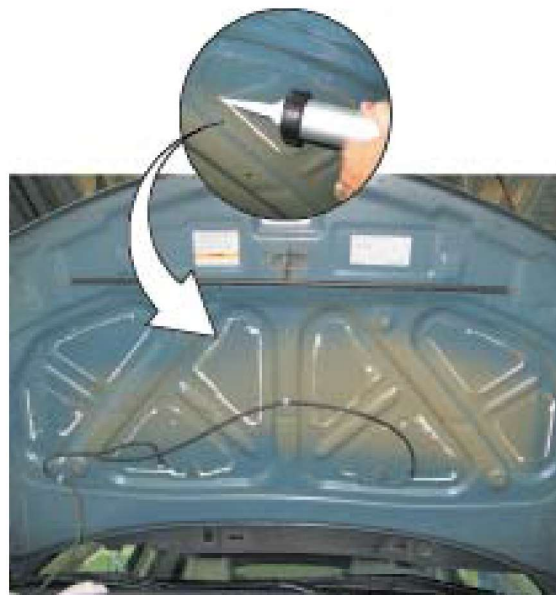
The hood skin flutters when the vehicle is driven at highway speeds.

The sealant between the hood skin and the hood frame may be out of position.

1. Remove the hood insulator:
 - Refer to page 20-196 in the *2007 MDX Service Manual*, or
 - Online, enter keyword **INSULATOR**, and select **Hood Insulator Replacement**.
2. Cover the entire engine compartment with a blanket or large fender cover.
3. Inject sealer or sealant between the frame and the skin in the eight areas shown. Be sure to follow the manufacturer's instructions.

NOTE: Do not paint the sealer or sealant. The insulator will cover all of the repaired areas.
