Applies To: **2007–11 MDX** – ALL  
**2009–10 RL** – ALL  
**2009–11 TL** – ALL  
**2010 TSX V6** – ALL  
**2010–11 ZDX** – ALL

June 7, 2011

## MID or Navi Shows a Check Engine Oil Level Message, Low Oil Pressure Indicator May Be On

(Supersedes 09-012, dated January 15, 2010; see REVISION SUMMARY)

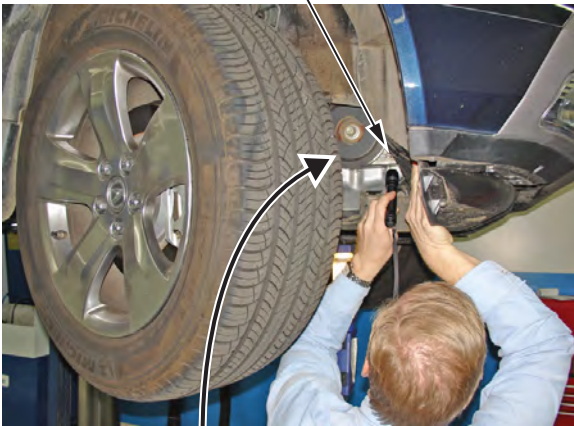
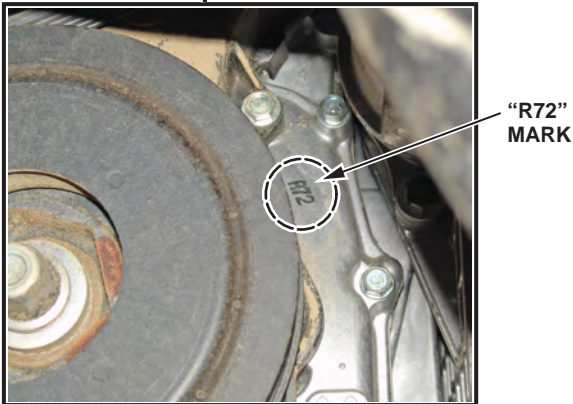
Look for an "R72" mark on the right side of the oil pump.

1. Start the engine, turn the steering wheel fully to the right, then shut off the engine.
2. Raise the vehicle on a lift, and make sure it's securely supported.
3. *2007–08 MDX*: Detach the front clip from the right front inner fender. Pull back the edge of the inner fender, and look for an "R72" mark on the right side of the oil pump:
  - If the oil pump has the "R72" mark, use P/N 37240-R72-A01 for the new engine oil pressure switch.
  - If the oil pump does not have the "R72" mark, use P/N 37240-RDM-A01 for the new engine oil pressure switch.
