Right Rear Wheelwell Area Clicks, Taps, or Ticks

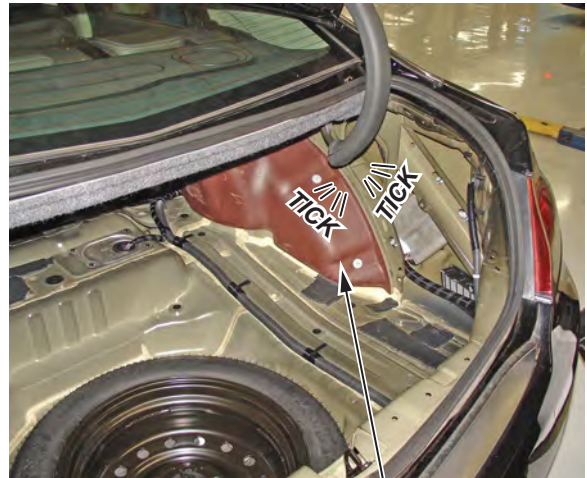
RIGHT REAR WHEELWELL

Do you hear a clicking, tapping, or ticking noise from the right rear wheelwell area?

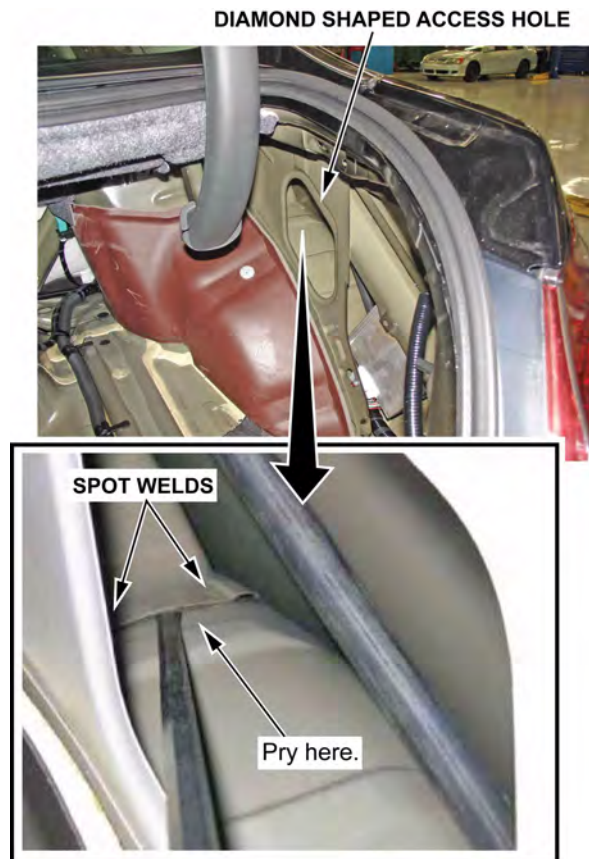
There is insufficient clearance between the right rear inner wheelwell stiffener and the wheelwell arch.

- Reach through the diamond shaped access hole, and force a flat-tipped screwdriver or a pick between the inner wheelwell stiffener and the wheelwell arch.

- Separate the two panels to create a gap. Make sure not to separate the two spot welds.
