Applies To: **2009–11 TL – ALL**
2012 TL – From 19UUA8...CA008260 thru 19UUA9...CA002617

September 15, 2011

Upper B-Pillar or Moonroof Area Clicks, Rattles, or Taps

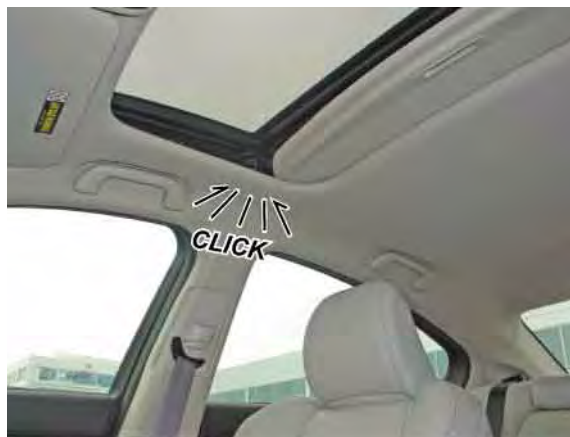
The upper B-pillar or moonroof area clicks, rattles, or taps on one or both sides.

There is insufficient clearance between the metal body panels in the upper B-pillar area.

Depending on the source of the noise, add sealer between the body panels, or increase the clearance between the body panels.

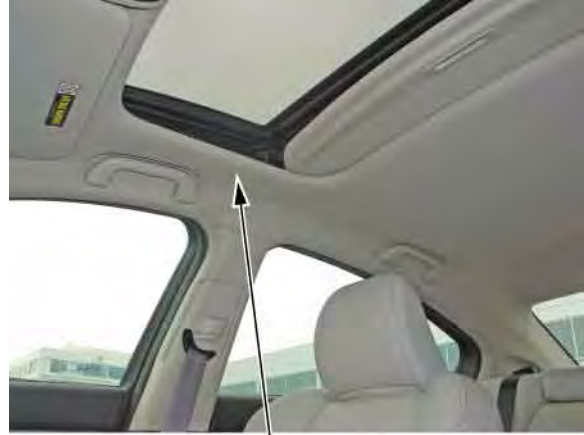
NOTE: This repair addresses the noise located between the roof side rail stiffener and the roof skin.

The noise is located here.

4. Use a 10 mm or 3/8 in. diameter Rotabroach Hole Cutter to drill a hole into the roof side rail stiffener, next to the most forward dimple spot. Do not drill deeper than 1 mm, or you may damage the roof skin.

5. Add sealant into the hole that you drilled in the roof side rail stiffener and fill the cavity marked in red.

6. Apply additional sealant between the roof side rail stiffener and the roof skin to fill from the other side of the cavity.

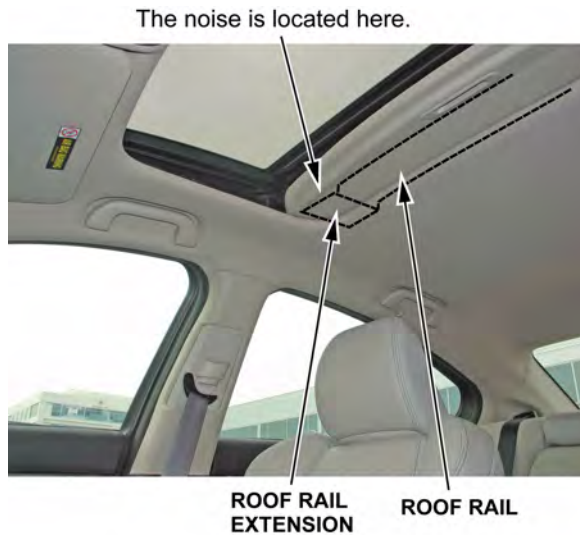
NOTE: This repair addresses the noise located along the rearward edge and corner of the sunroof opening between the roof rail and the roof skin.

4. Apply sealant between the roof rail panel and the roof skin panel. Starting at the corner of the roof side rail stiffener, apply the sealant for 104 mm. Fill the cavity marked in red.

5. Use your finger to spread and smooth the sealant over the gap.

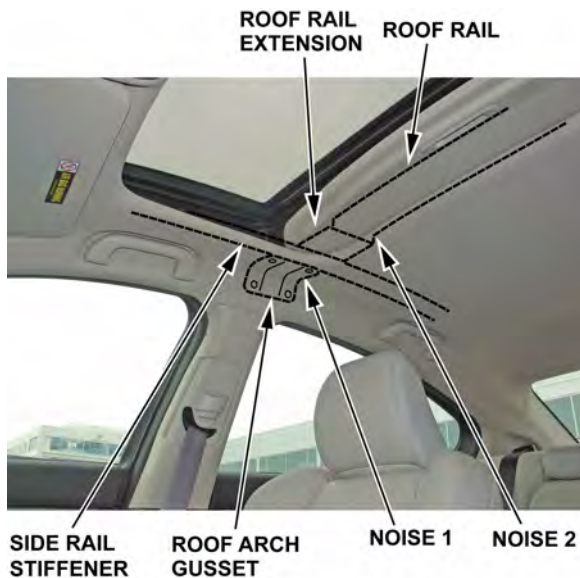
- **Noise 1** – located at the roof arch gusset
- **Noise 2** – located at the roof rail, underneath the rail extension, where the roof side rail stiffener contacts the roof rail
