Applies To: **2010 ZDX with Navigation** –
From VIN 2HNYB1H..AH500001 thru 2HNYB1H..AH501820

Audio and Navigation Systems Reboot by Themselves

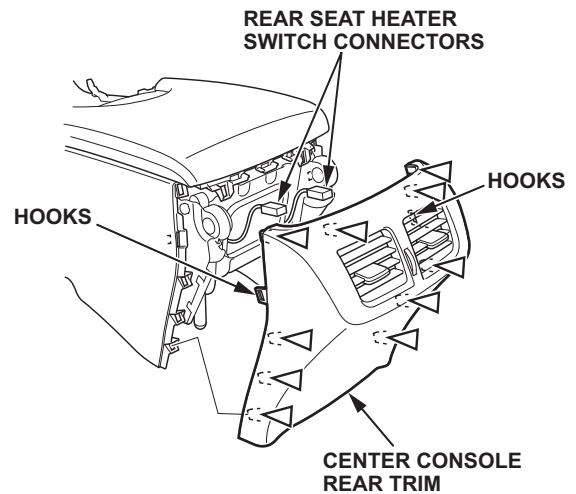
- Starting at the bottom, gently pull out the center console rear trim to detach the clips and release the hooks.

NOTE: If the vehicle is equipped with a rear seat cushion heater, disconnect the rear seat heater switch connectors.

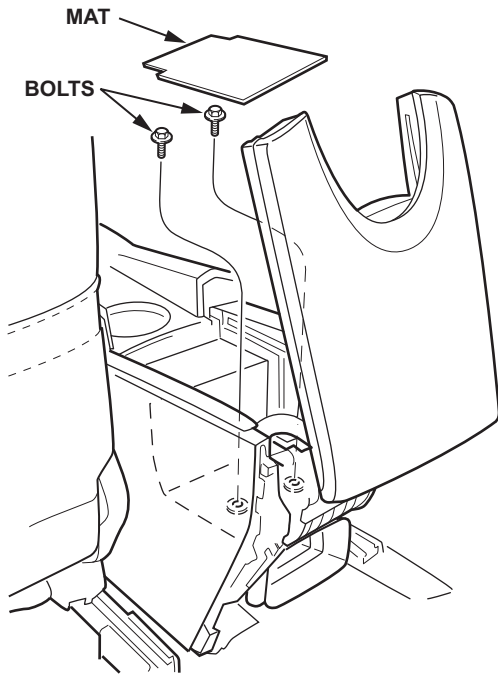
2. Open the center console, and remove the center console tray and mat.

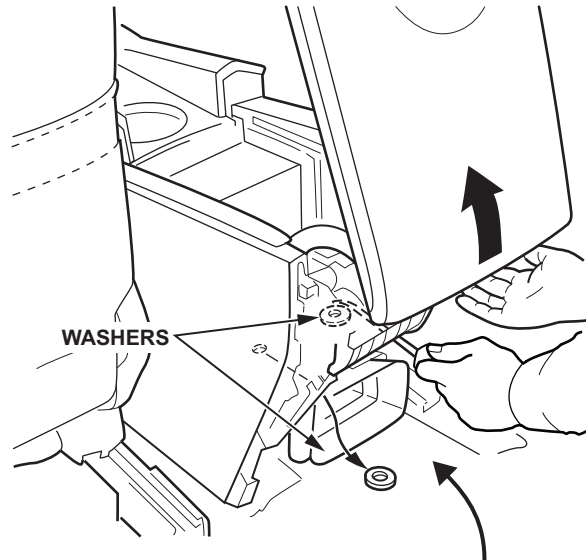
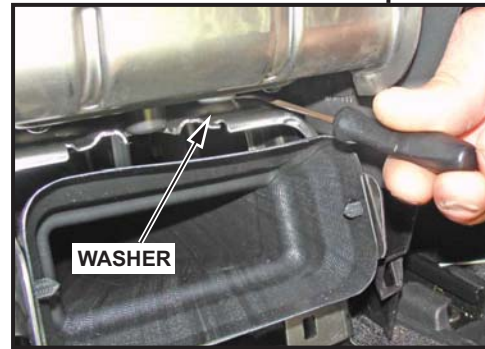
The two plastic washers located in the center console interfere with the audio and navigation system body ground.

3. Remove the two bolts securing the rear of the center console.

4. Lift the rear of the center console just enough to slide a pick or screwdriver in, and remove the two plastic washers.

Remove the two plastic washers in the center console to improve the body ground.
