SRS Indicator Is On with DTC 71-11

The SRS indicator is on with DTC 71-11 (open in driver's seat position sensor).

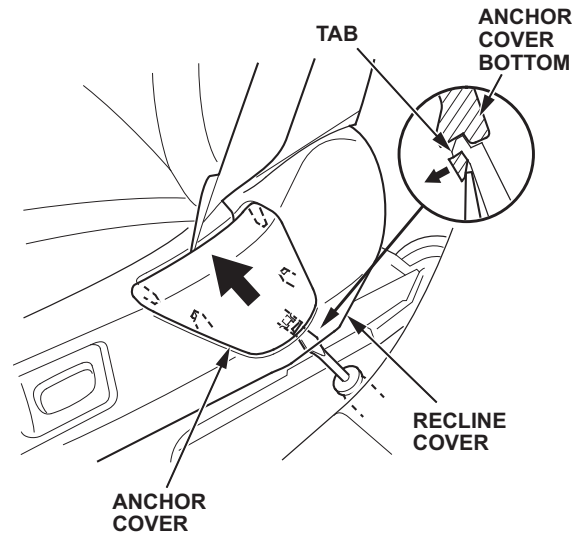
2. Slide the driver's seat all the way forward, and adjust the seat to its maximum height. Carefully pry up on the bottom of the anchor cover to release the tab, then remove it.

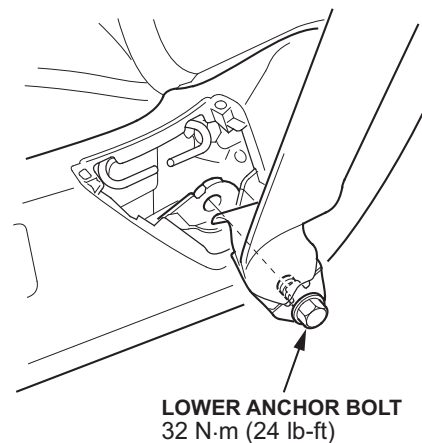
3. Adjust the seat to its minimum height, then remove the lower anchor bolt.

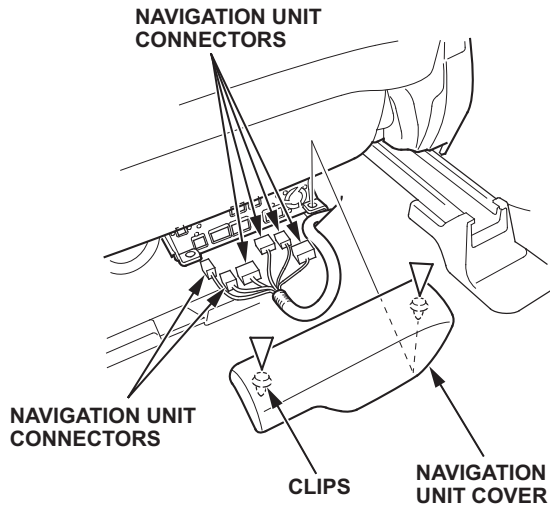
4. *With navigation:* Gently pull the navigation unit cover up to detach the clips, then remove the cover.

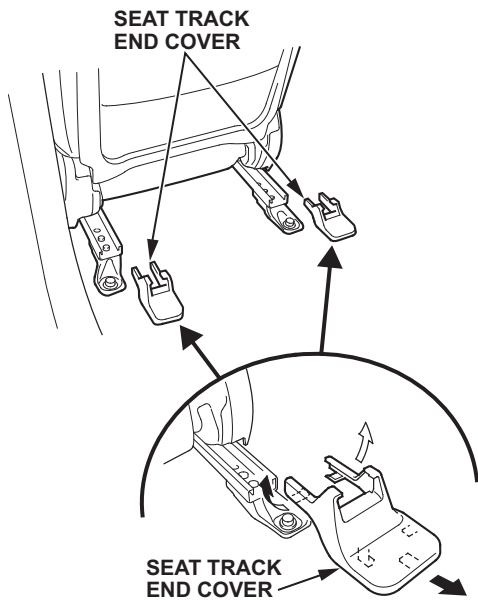
5. *With navigation:* Disconnect the navigation unit connectors.
6. Slide the seat all the way forward, and remove the inner and outer rear seat track end covers.

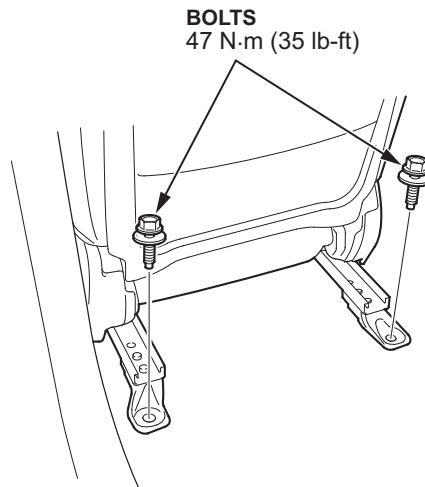
7. Remove the rear seat mounting bolts.

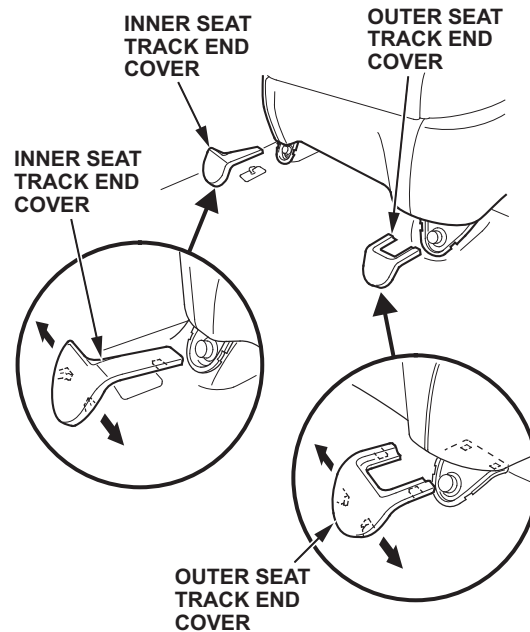
8. Slide the seat all the way back, and remove the inner and outer front seat track end covers.

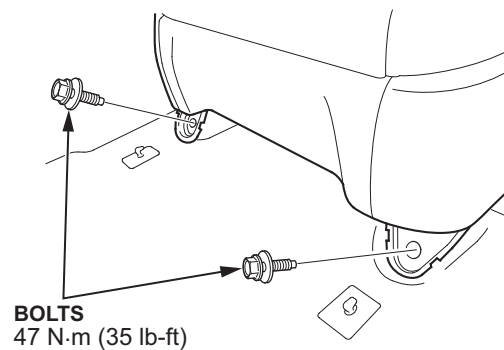
9. Remove the front seat mounting bolts.

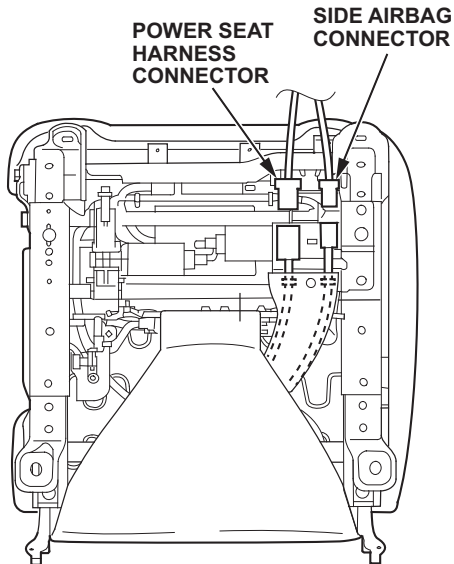
10. Do the battery terminal disconnection procedure, and wait at least 3 minutes before removing the seat.
11. Lift up the driver's seat, then disconnect the power seat harness connector and the side airbag connector.

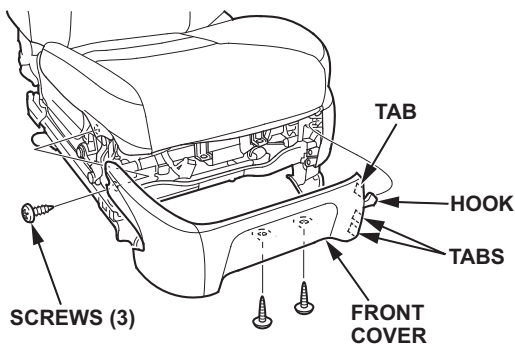
12. Remove the head restraint.
13. With the help of an assistant, carefully remove the seat.
14. *With navigation:* Remove the navigation unit (two screws).
15. With the seat on a flat bench, remove the three screws, release the hook and the tabs, then remove the front cover.

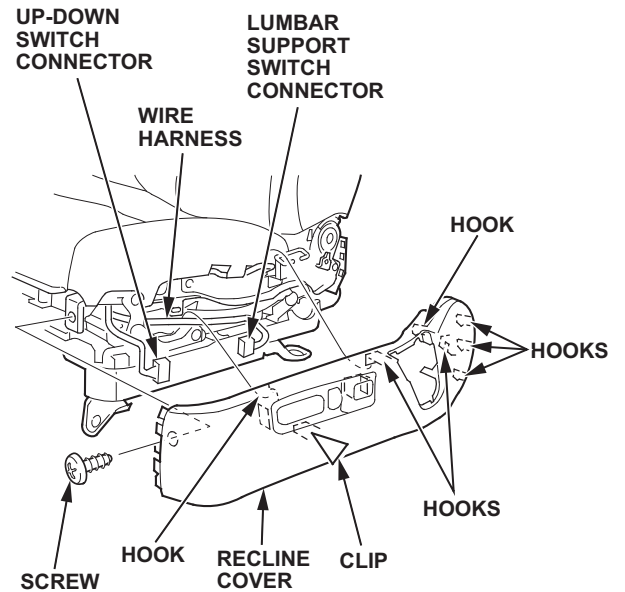
16. Remove the recline cover:
 - Remove the screw, and detach the clip and hooks.
 - Pull the cover up, then disconnect the two connectors.

20. Reconnect the recline cover connectors, and reinstall the recline cover.
21. Reinstall the front cover.
22. With the help of an assistant, carefully place the seat back in the vehicle.
23. Reinstall the head restraint, and reconnect the power seat connector and side airbag connector.
24. Reinstall the driver's seat mounting bolts, and torque them to **47 N·m (35 lb-ft)**.
25. Reinstall the seat track end covers.
26. *With navigation:* Reinstall the navigation unit cover.
27. Reinstall the lower anchor bolt, and torque it to **32 N·m (24 lb-ft)**.
28. Reinstall the anchor cover.
29. Do the battery terminal reconnection procedure.
30. Clear the DTC with the HDS.

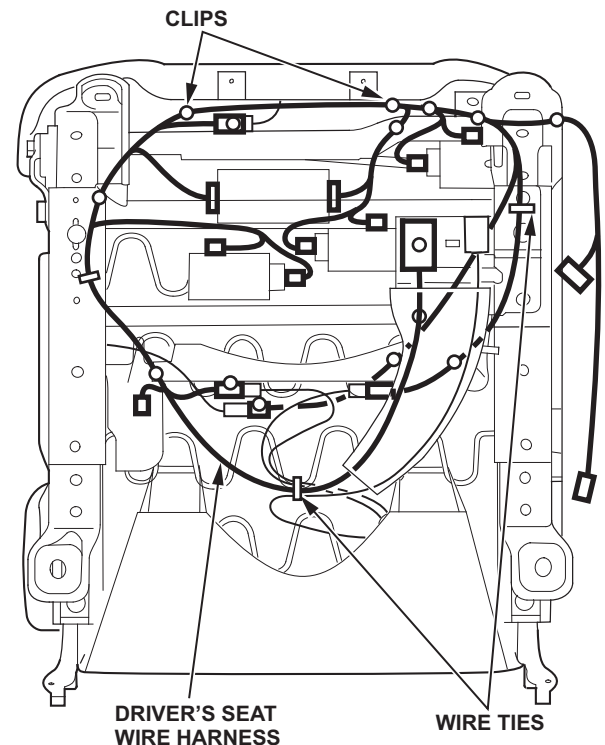
17. Remove the driver's seat wire harness (16 connectors, 12 clips, and 3 wire ties).

18. Install the new driver's seat wire harness, (16 connectors, 12 clips, and 3 wire ties).
19. *With navigation:* Reinstall the navigation unit.
