Turbo variable flow boost control arm eyebolt and pin replacement. To remove play in the pivot point for variable flap boost control the eyebolt and pin must be replaced, both will be worn. P2263 code if these parts are worn too much.

Repair Notes- pin replacement, turbo in-car

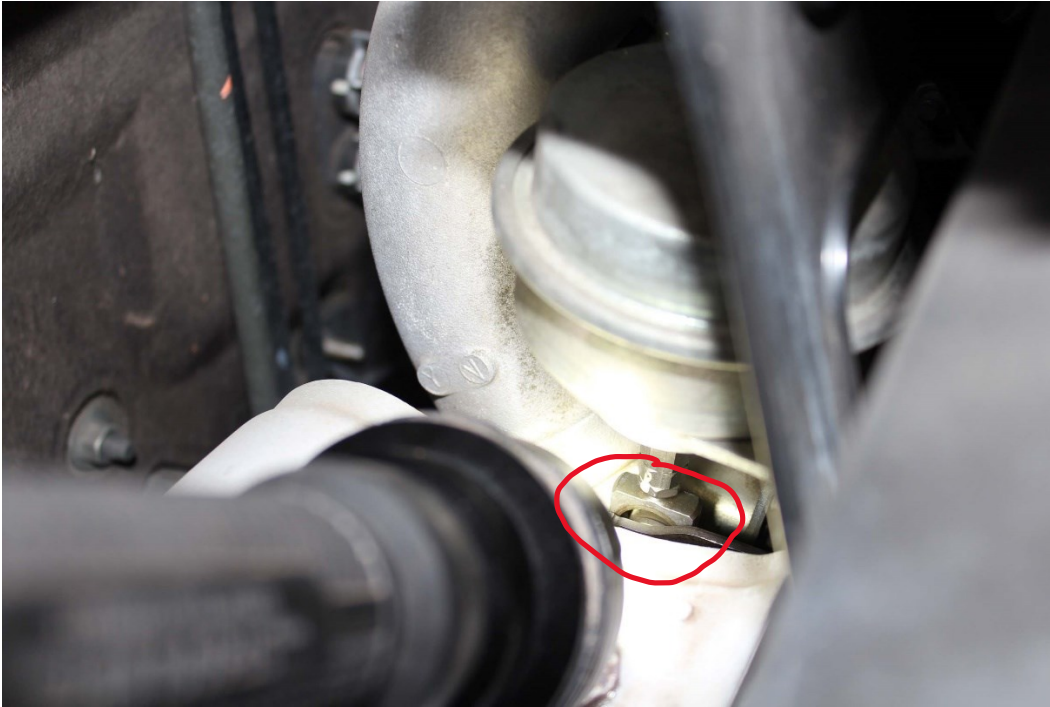
To check for eyebolt/pin wear look here; view from the right side of the engine compartment, between engine and firewall. There is a spring-loaded force from the actuator shaft pulling the eyebolt upward so wear will show as a gap between the pin and top part of the eyebolt.

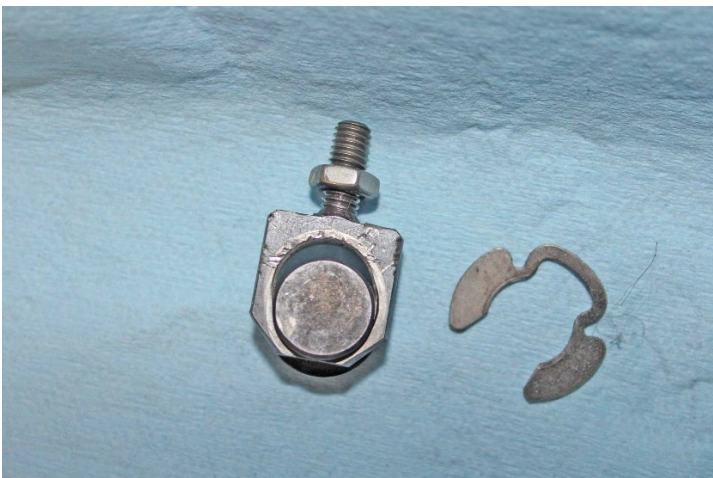
Below is a close look at the visible gap between the eyebolt and pin. Both the eyebolt and pin had ~2mm of wear so 4mm of total play.

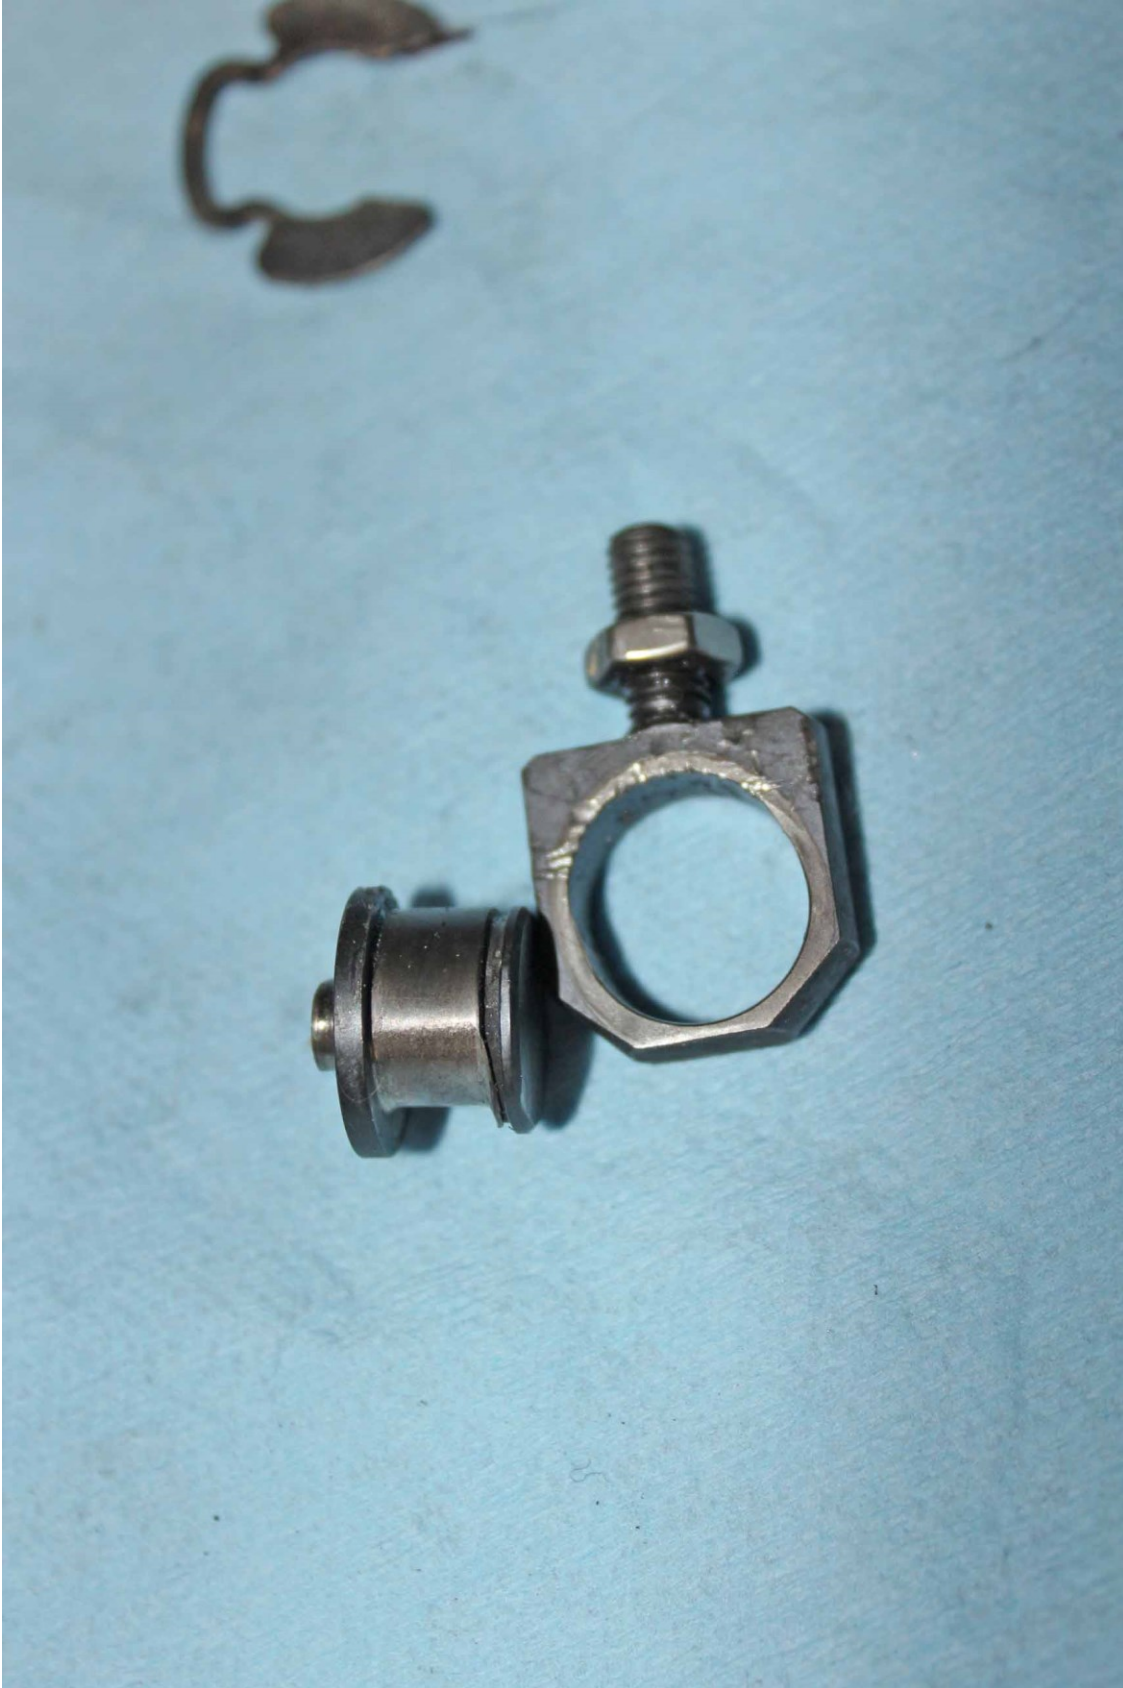
Here you can see the wear pattern of the eyebolt and pin. Marks on the side of the eyebolt were from prying on the eyebolt to get the pin out of the linkage arm.

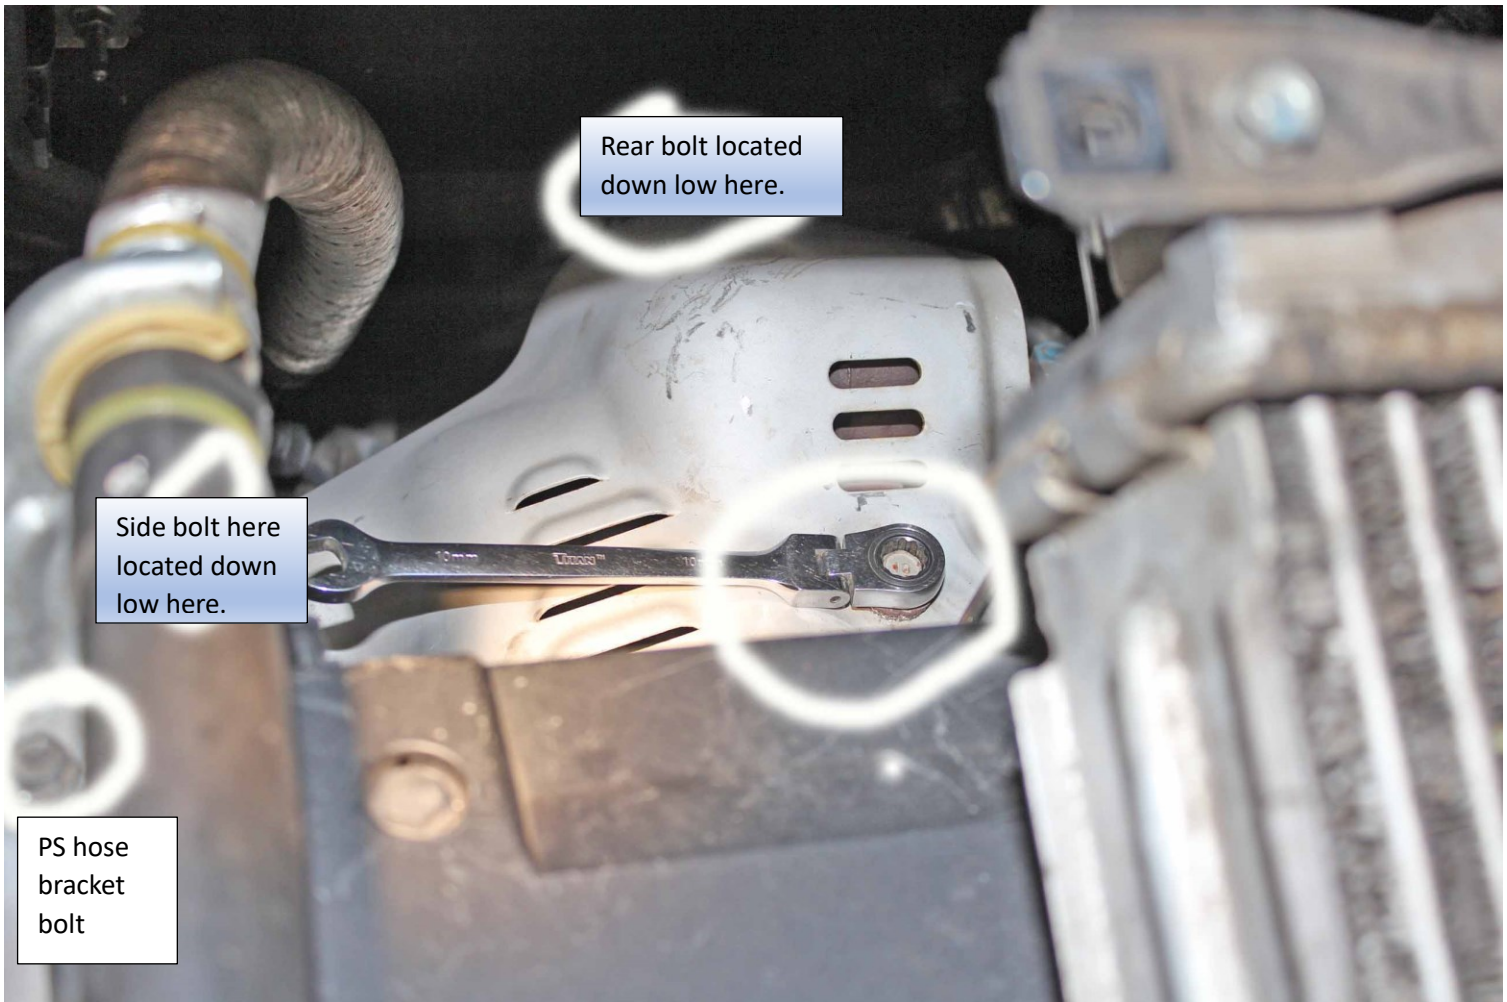
Remove power steering hose bracket and exhaust cover

To remove exhaust cover, remove one 10mm bolt, furthest left to remove power steering hose bracket, then remove 3 10mm bolts for the exhaust cover. Back and side bolts are removed and installed by feel, you can just reach down and feel for the bolt head and use a 10mm box end to loosen, 10mm flex head ratcheting box wrench shown on top bolt.

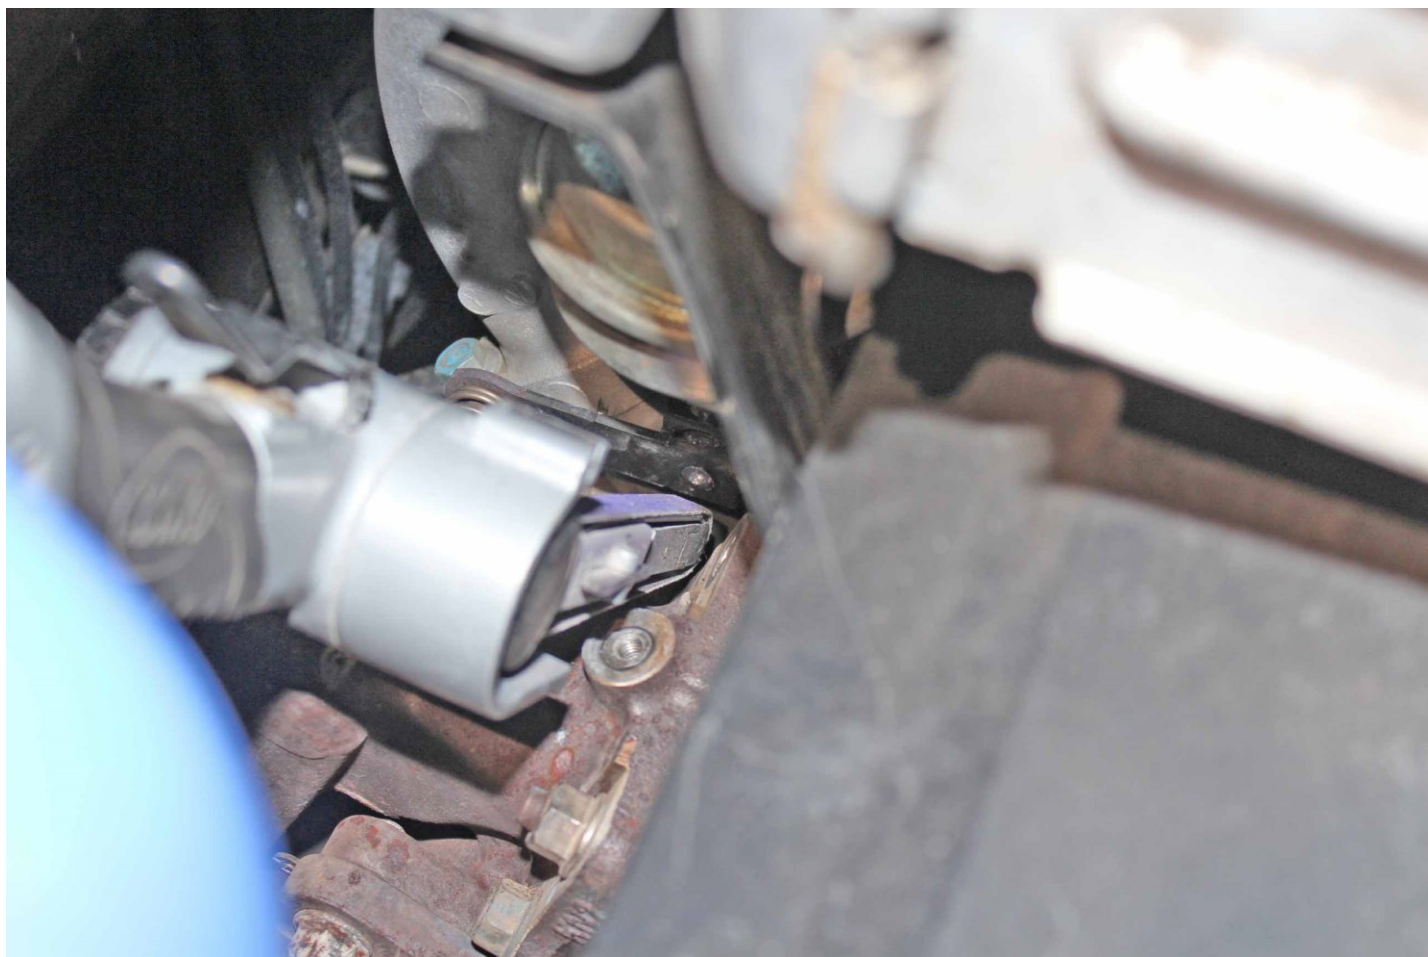
Grinding the rivet head off

Remove exhaust cover and one exhaust manifold bolt for access, see photo. Hand held belt sander used to file off the rivet head of the factory pin. Access to the rivet head is in a difficult position to grind down, this type of belt sander is an ideal tool to do the job, I was surprised how well it worked. Note the one exhaust bolt removed for better access.

With this in-car repair I'd say the belt type 3/8" X 13" handheld sander is almost a must have tool for this job. These tools can be purchased for as low as \$30 and can be used for many other future projects. This tool does a great job of quickly grinding away the rivet head and control is good. Keep the length of the at tool to 14 inches or under so go with the 3/8" X 13" belt size sander. A long shaft carbide burr tool could also be used and for a lower price than the belt sander but I doubt will do as good of a job or as fast as the belt sander. 3M 80 grit Cubitron II sanding belt, finer grit could be used.

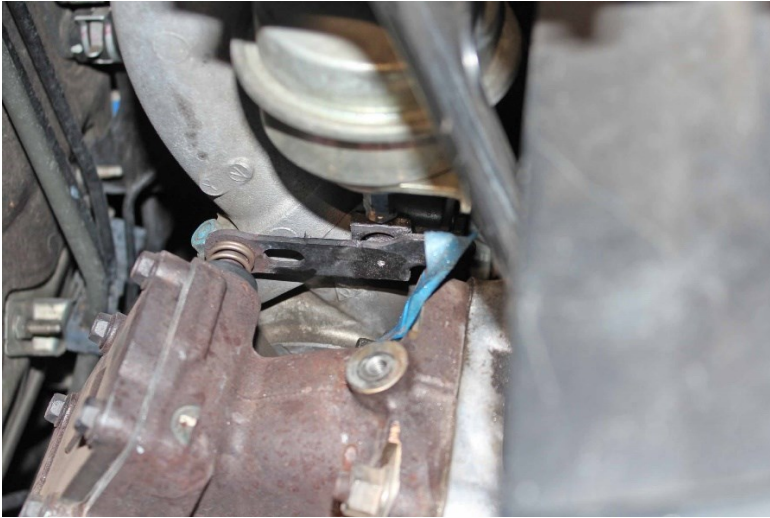
Getting the pin out of the linkage arm- the most difficult part of the repair

With the rivet head ground off the pin it's still held tightly in the linkage arm from being peened on at the factory. The 6mm round part of the pin shaft that goes through the linkage arm needs to be punched or pried out. I did attempt to drill out the center but there just wasn't room to get a drill bit in a good position so gave up on drilling. The pin is hard drilling too (stainless steel?). Tried to punch it out with no success and using too much force can damage parts so moved on. What eventually worked was heating around the pin area with a small Benzomatic butane torch and prying between the linkage arm and eyebolt with large screwdriver using a twisting motion.

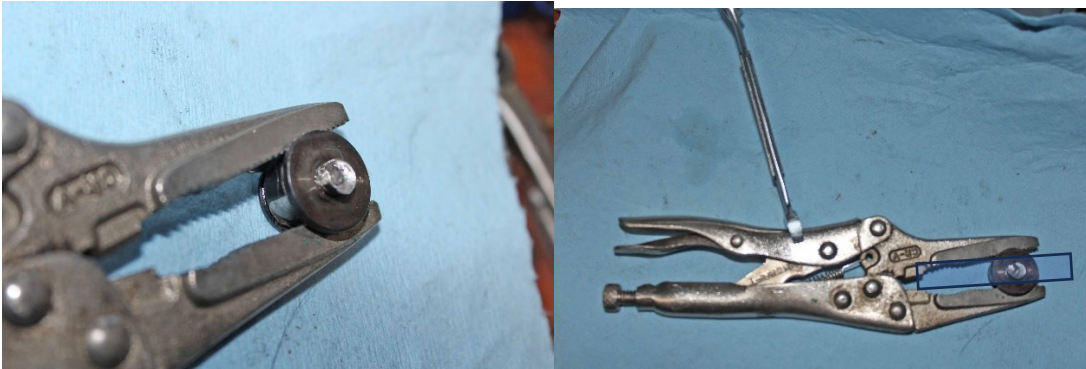
Above shows benchtop views of the Vice-Grips clamped on the pin and the use of wrench on the pliers for added leverage to put an up and down force on the pin to help loosen the pin in the linkage arm.

What is shown in the photos below, which is obviously not in the car but something I would have done differently to help remove the pin quicker, easier from the linkage arm. After the rivet head is ground off, clamp the 6 inch long nose Vice-Grip pliers tightly to the pin still on the arm, the Vise-Grip pliers will be parallel to the linkage arm. Apply some penetrating oil to the part of the pin still in the linkage arm and use the Vise-Grips to rotate the pin some in both directions if possible. With the pliers in this position and using an open end wrench on the pliers, the pliers can be twisted using the wrench to put force on the pin in a downward and upward direction to help loosen the pin within the linkage arm hole. This pin is a tight interference fit inside the linkage arm even after the rivet head is ground off.

To pry out the pin from the linkage arm; use a large screwdriver or small pry bar (recommend a 8 or 12 inch pry bar) and then insert the screwdriver or pry bar down in-between the linkage arm and the side of the vice grips pliers (see photos) and using a twisting motion with the screwdriver or pry bar, you will be prying against and in between the

linkage arm and pliers, this is done to apply a force on the pin to extract it from the linkage arm. Add another pair of vice grips or wrench to the screwdriver or pry bar shaft for added leverage. Use heat around the pin on the linkage arm if the pin still won't pry out of the arm. Note, the top outlet tube of turbo will need to be removed for better access with the Vice-Grip pliers.

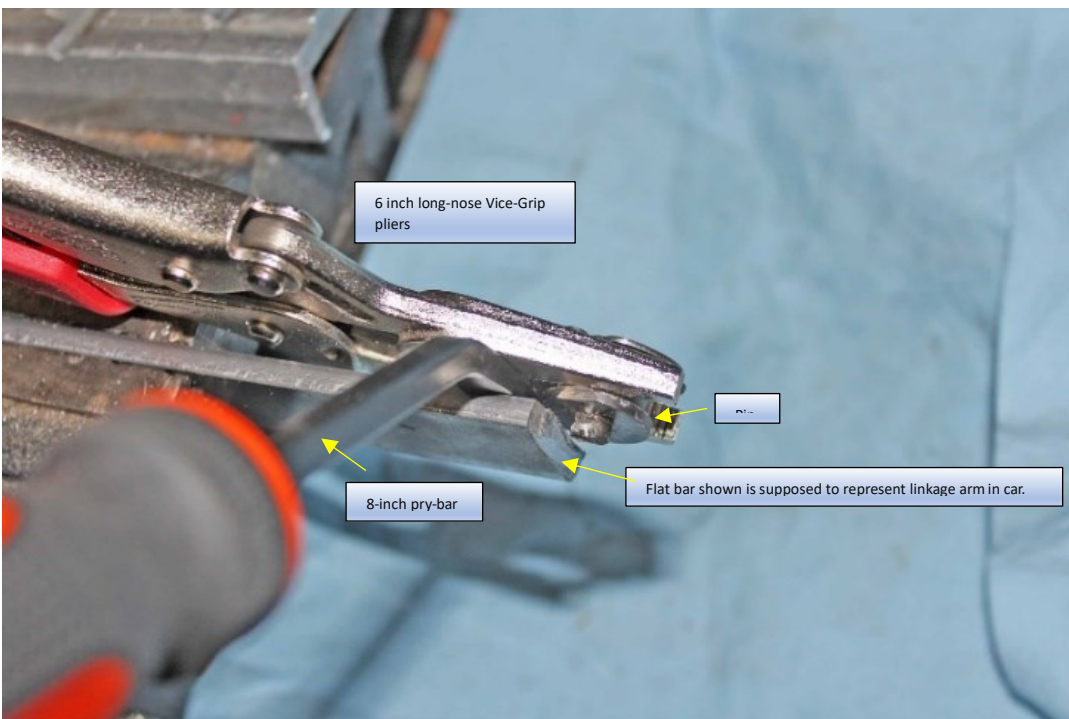
Below is a benchtop photo to show the position of the pliers when clamped onto the pin in the car. The pliers will be on the inside and parallel to the linkage arm. The pin in this photo is not flush with the plate as it would be in the car before removal. Pliers will be used to rotate the pin some back and forth and twist the pliers with a wrench to apply side force on the pin, this is all done to help loosen the tight fitting pin in the linkage arm even after the rivet head is ground off. The pliers will also be used as a surface for prying between the linkage arm and pliers. This is done to extract the pin from the arm. The pin c-clip should be put back on the pin to help hold the pliers in place during prying.

Above shows an 8 inch pry bar inserted between linkage arm (shown as a flat bar here) and Vice-Grip pliers, pry as close to the pin as possible to help extract the pin from arm. Use a wrench on the square shaft of the pry bar for even more leverage, which may be needed. Pry bar is recommended because of the offset and a better angle when inserting the tool to pry. The actuator diaphragm canister gets in the way when using a screwdriver.

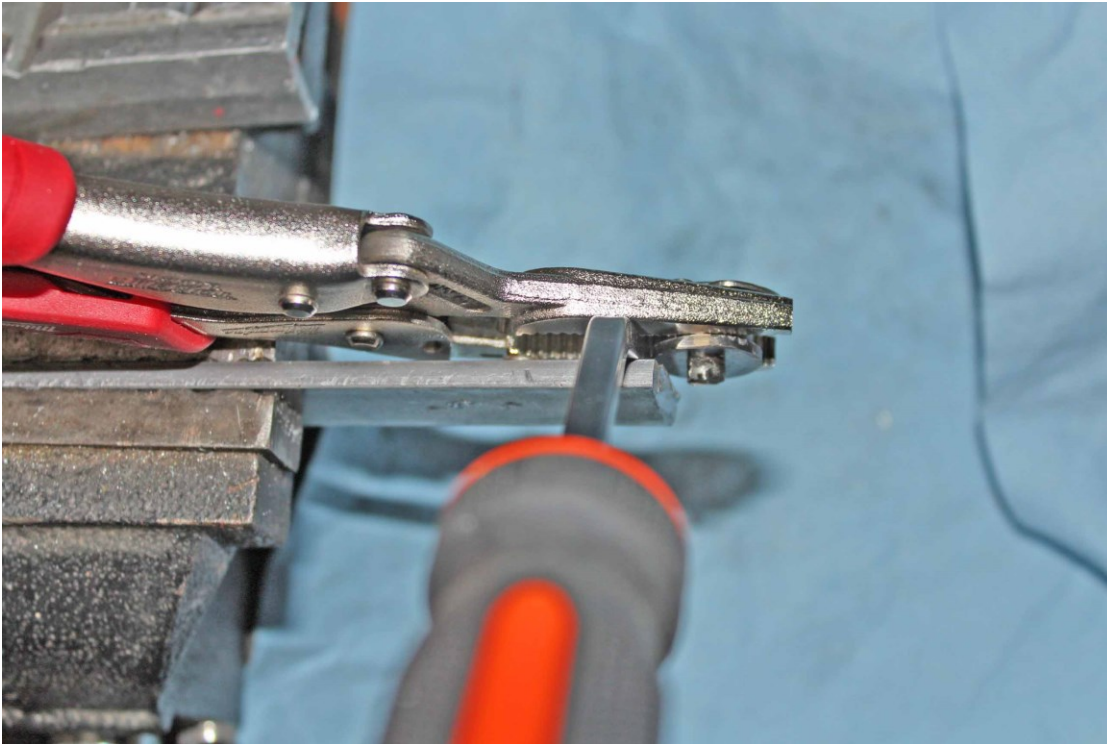
Above shows the pry bar position as you would see it while working on the car, flat bar represents linkage arm. Goal is to pry out the part of the pin that's still in the linkage arm. Pin shown here has already been removed and you can see the smaller diameter piece of the pin that's was pried out of the linkage arm.

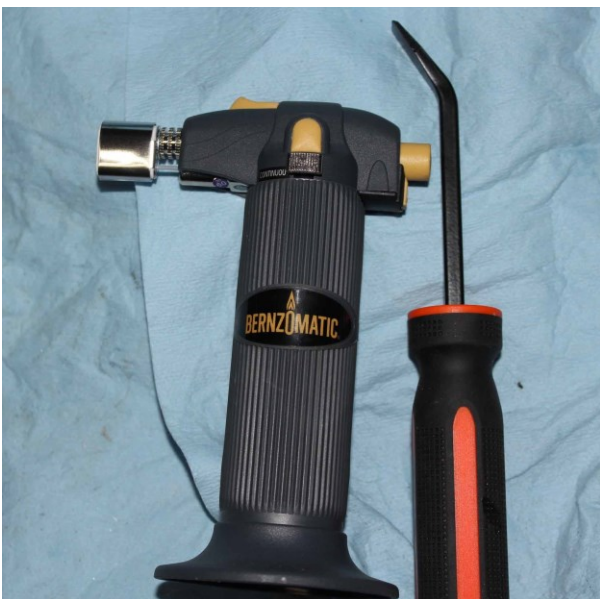
Above, highly recommended tools to have on hand. 8 or 12 inch pry bar with square shaft to use wrench for more leverage. Butane torch to heat the linkage arm around the pin. Shown below the 6" long nose Vice-Grips are a must have, a pair of them would be better.

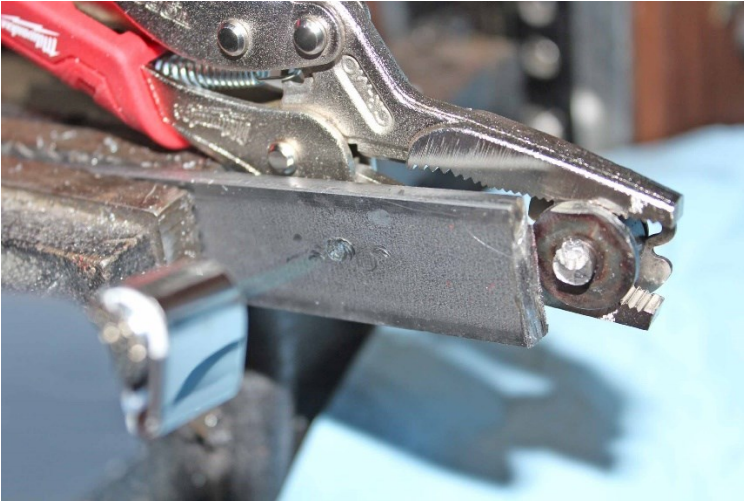
Above, hard to see the flame but showing the butane torch being used to heat up the area around the where the pin were would be in the linkage arm.

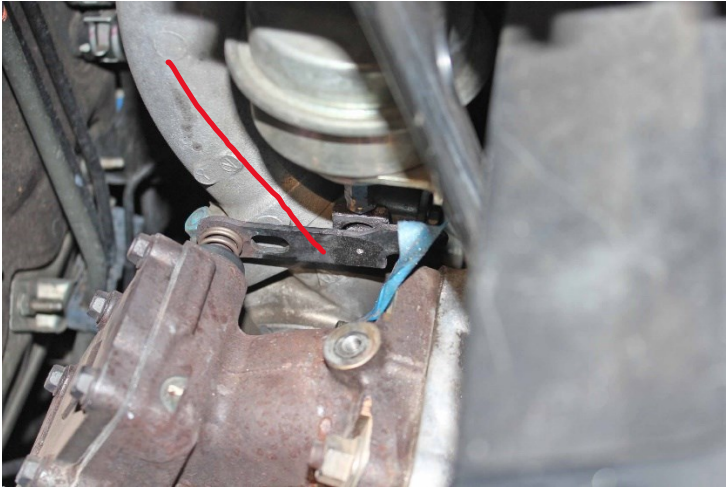
After the pin rivet head is ground off a plate can be clamped onto the side of the linkage arm with Vice-Grip pliers. The pliers will clamp on at an angle (red line) to the left of the actuator.

Here's another idea to possibly help remove the rivet from the linkage arm after the rivet head has been ground off. A small flat plate with a short bolt will be clamped onto the side of the linkage arm. The simple fabricated plate will have a short bolt that can be tightened to press out the rivet/pin.

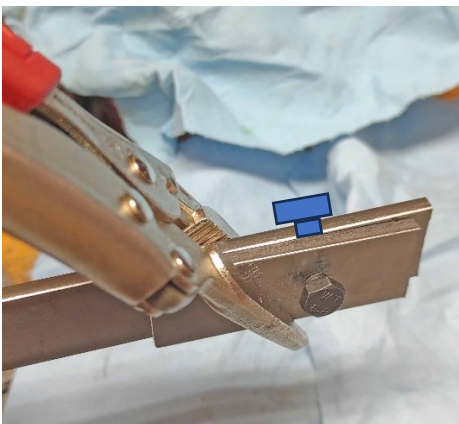
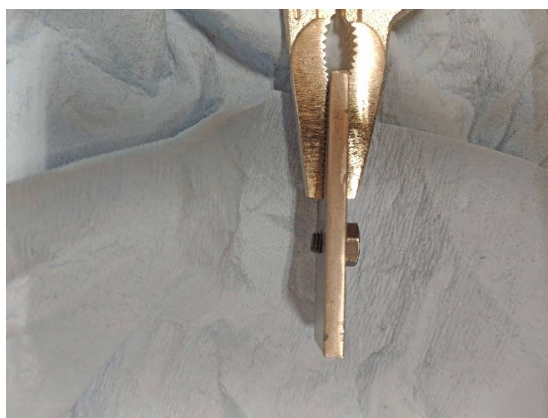
Below is a workbench example of how the plate will be clamped onto the linkage arm. The longer flat bar represents the turbo linkage arm and the shorter plate with a bolt would clamp on using 6 inch long-nose Vice-Grip pliers like shown here. The bolt will have to be carefully aligned directly over the remaining rivet shaft inside the linkage arm. The bolt would then be tightened to press the rivet/pin out of the linkage arm. The fabricated short plate just has a 5mm drilled hole, tapped for a 6mm short bolt. May or may not work, haven't tried this in an actual car yet. This may be a little tedious but it will be important to align the bolt carefully to only to press on the pin shaft in the linkage arm. If the bolt is misaligned the bolt will be pressing against the linkage arm and instead of the pin shaft. It's possible this may just flex or bend the linkage arm and the pin won't come out.

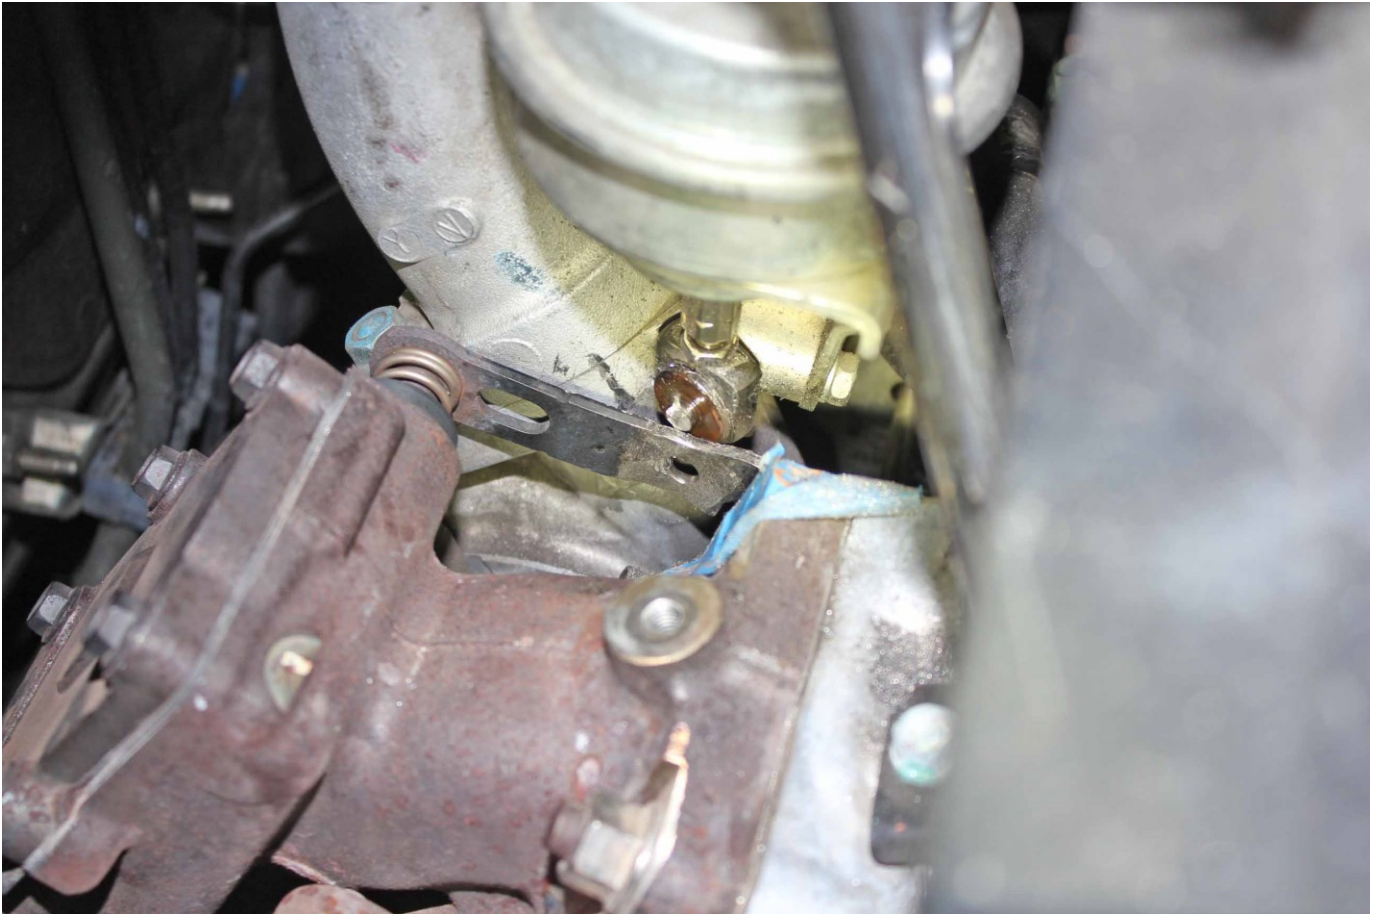
Key milestone in the repair- pin detached from linkage arm

After a long struggle I was finally able to pry the pin out of the arm. Other methods suggested above to hopefully lessen the struggle of getting this pin out of the arm. It's important not to damage other parts when removing this pin, the linkage arm can bend, the actuator arm can bend, it does take a considerable amount of force to remove this pin so care is needed to protect the other parts.

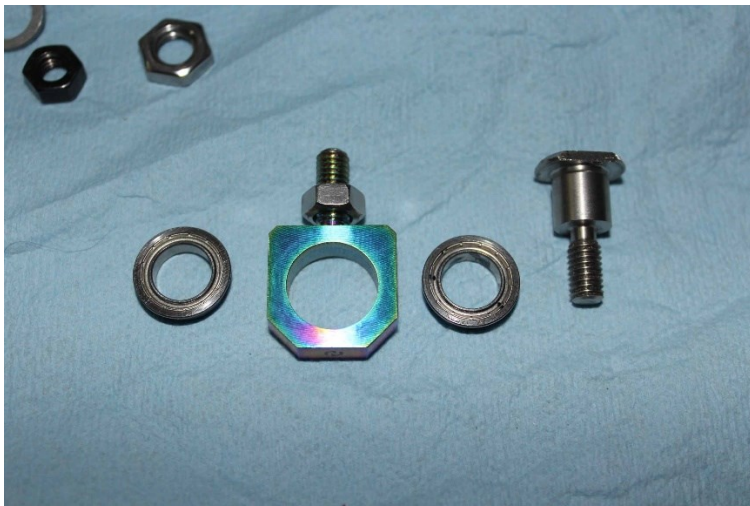
Above, new eyebolt, shoulder bolt and ball bearings for repair. Shoulder bolt head is cut down for clearance and flats ground on the head for a holding wrench. Some thread length was shortened for installation and clearance.

Before I knew there were custom made pins available for this repair I purchased some over-the-counter parts to replace the pin. Some modifications were needed for the shoulder bolt used, thinning the head and cutting off some threads for clearance. The parts purchased were a new eyebolt, a stainless steel shoulder bolt (10mm shoulder diameter, 10mm shoulder length, M6 threads) and two shielded stainless steel flange type ball bearings, 10mm ID, 15mm OD X 4mm width (includes 0.8mm flange). Not shown are a couple of washers used, a 2mm thick washer is used between the eyebolt and linkage arm to duplicate the width of the shoulder on the original pin, there's also a spacer washer on the other side.

The use of ball bearings seemed like a good idea at the time to prevent further wear but I'm not sure if the small bearings will hold up over time, the location of these parts are in an environment that gets very hot so it's a pretty harsh environment for any parts, we'll see how it goes. I did recently purchase the custom made pin for this repair from Joshua Fletcher as a backup if these parts fail, the pin is solid, simple and should be very reliable. He's on Facebook at group Acura RDX owners (stock or with mod's). Sure appreciate the effort on his part to create a replacement part for this repair. This repair can save a ton of money and headaches from not having to replace the turbo itself. I have experience with Mitsubishi turbos from owning a Volvo for many years. The Volvo turbo in the car I had didn't have the variable flow control flap but it is a similar Mitsubishi turbo and they're very reliable and long lasting in the Volvos.

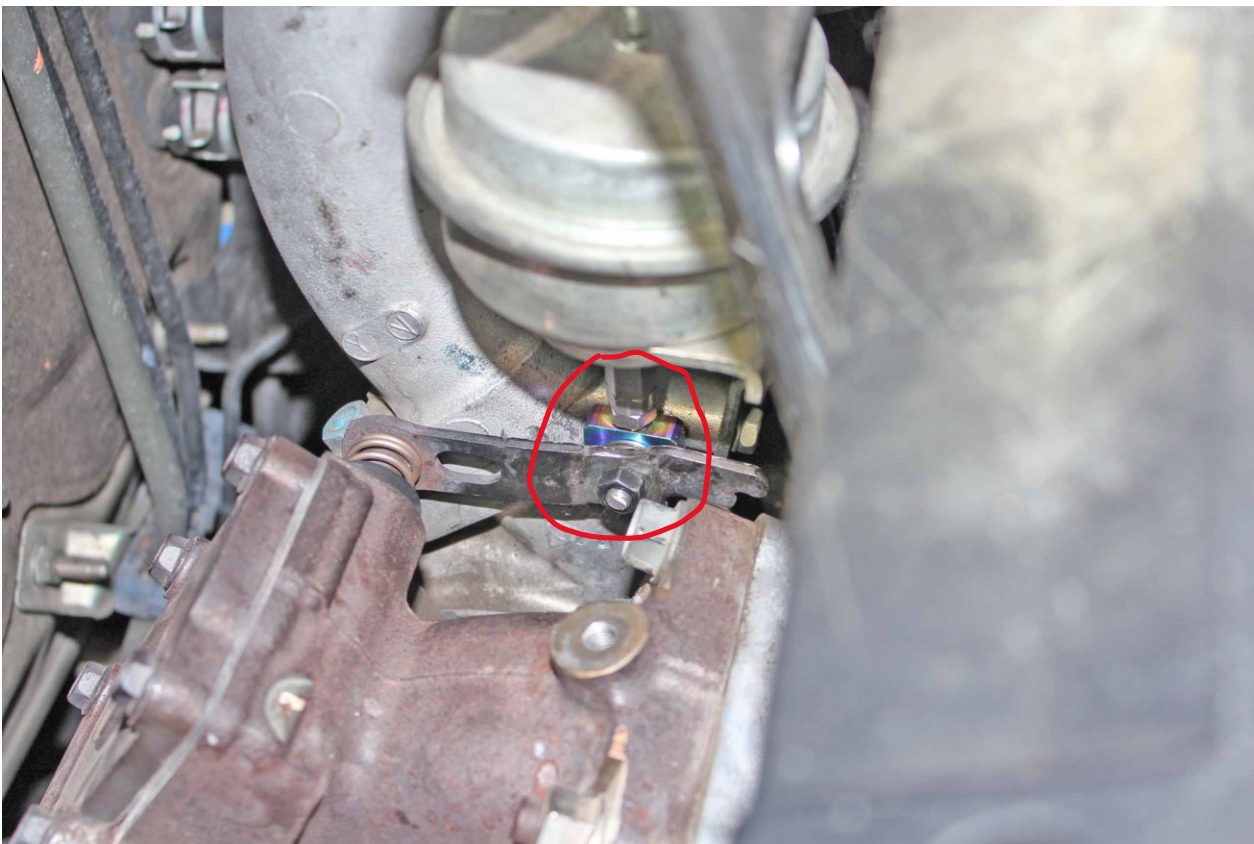
New parts installed. I did have problems using a wrench on the inside of the eyebolt to hold the shoulder bolt from turning when tightening the nut. I should have removed the curved top outlet piece to get better access to the bolt head with the wrench. Only two nuts to remove outlet tube but you should have a new gasket on hand to replace for reinstall.

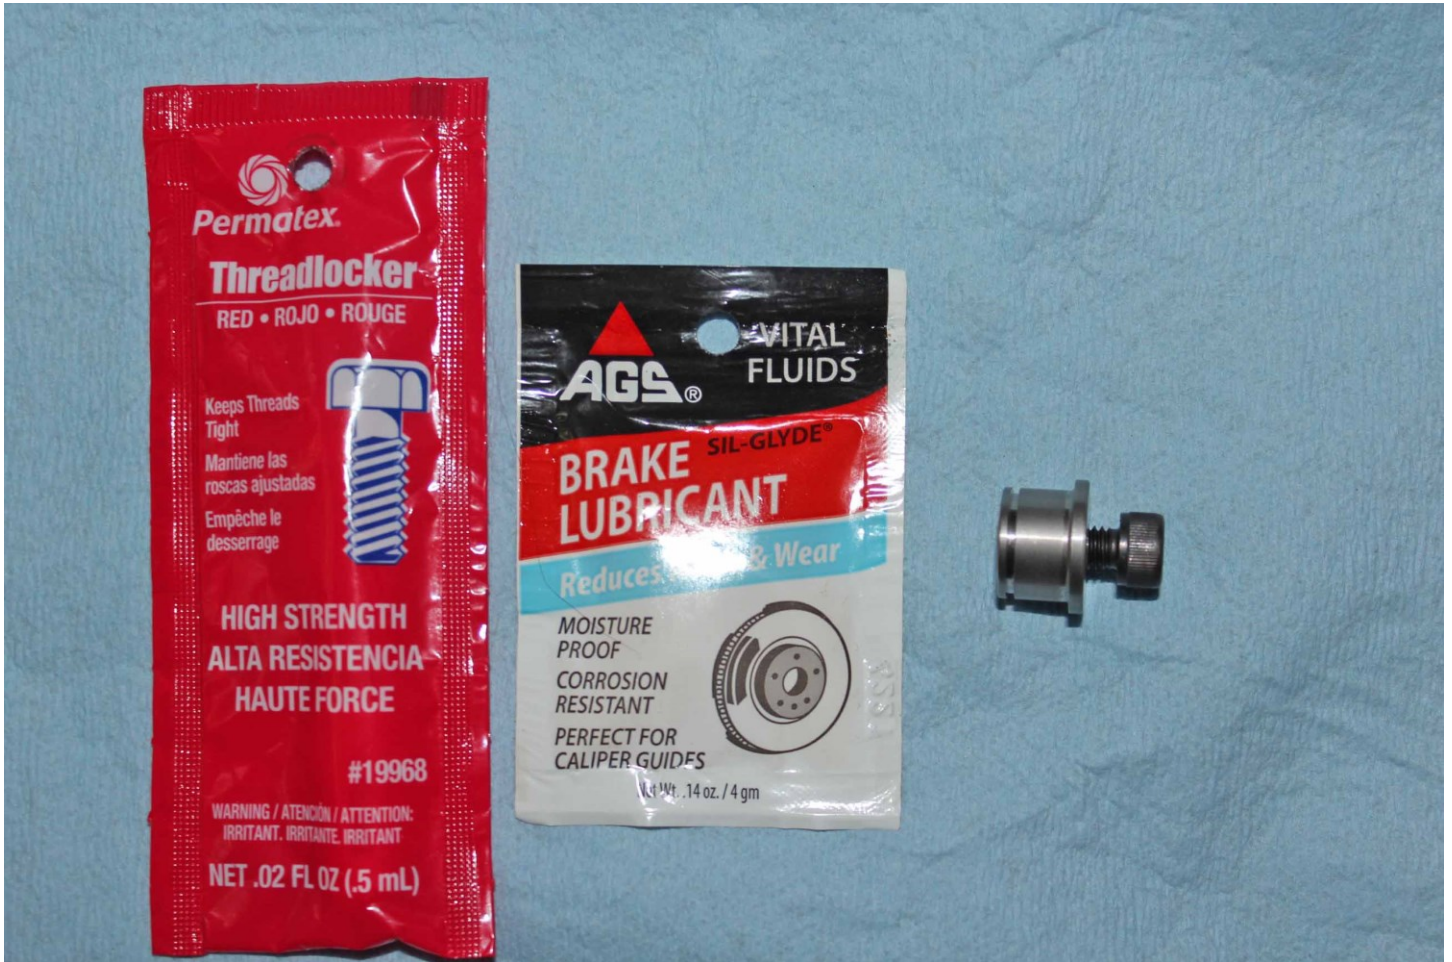
Here's the nicely made pin I just received from from Joshua Fletcher, Facebook group Acura RDX owners (stock or with mod's). This custom made pin is available through Joshua and he includes red threadlocker and some high-temp lubricant for a good repair.
