Fixing Overheated Honda Converters

Transmission Report

Volume 2, No. 3

Overheated Honda Converters/740 Codes

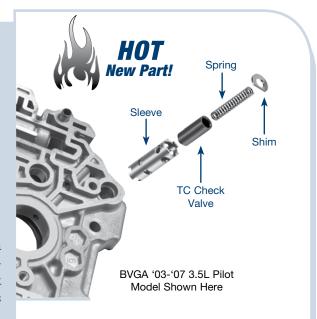
Part No. 98892-06K

An overheating torque converter is a common problem in Honda vehicles equipped with a four- or five-speed automatic transmission. This condition can be caused by a worn or stuck TC check valve, which reduces the pressure in the torque converter and leads to excess heat buildup.

Replacing the OE TC check valve with the direct replacement Sonnax TC check valve kit 98892-06K will restore the torque converter pressure and prevent valve sticking. Some new OE castings have been discovered to be machined with an edge remaining at the relief ports. This also can be used to salvage those castings.
