Acura RDX Infotainment Upgrade

Summary

Upgrade 2019-2021 unit to 2022-2023 unit, which requires the part numbers shown below. Reference: <https://acurazine.com/forums/3g-rdx-audio-bluetooth-electronics-navigation-455/retrofit-rdx-2020-infotainment-control-unit-1005545/>

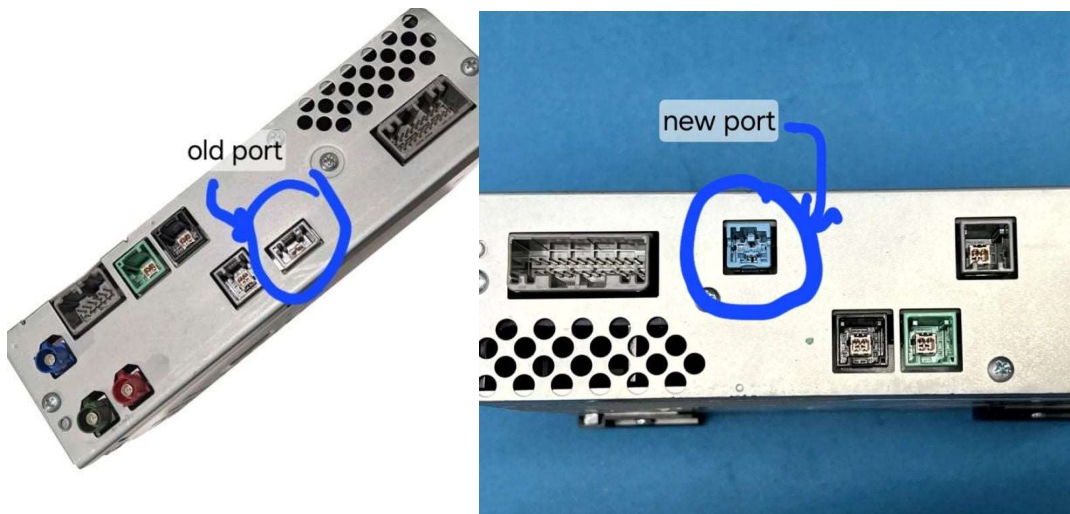
The plug for the new deck is more square and the other end had a newer rectangular plug (this is the end that will have to be replaced with the ordered parts).

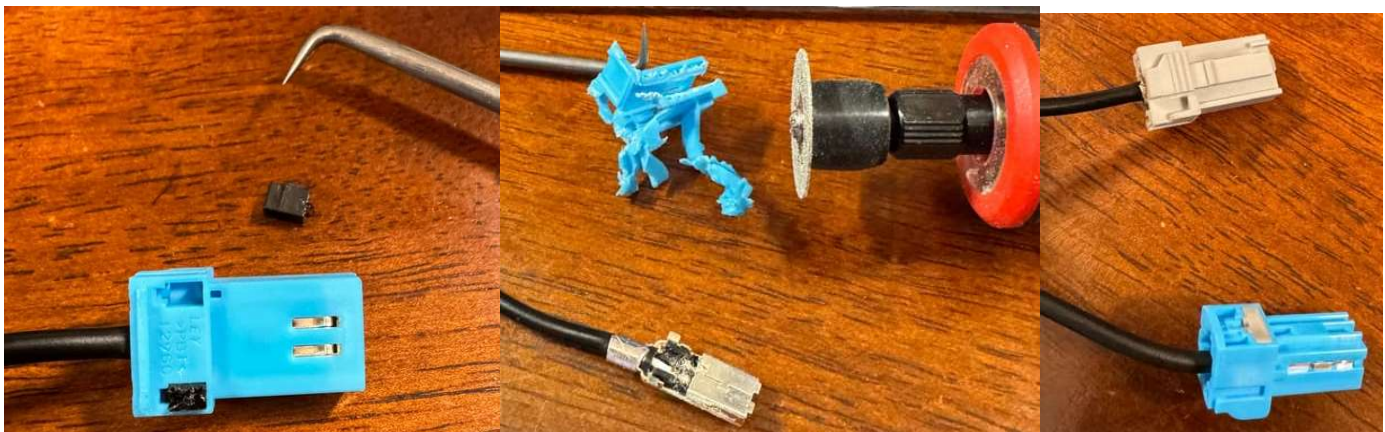
(1) Remove black pins from gray plug cap and pop it off with a screwdriver; (2) Cut off the sides to slide off the blue plug cap; (3) It only slides on one way; (4) Add the two black pins that come with it to lock:

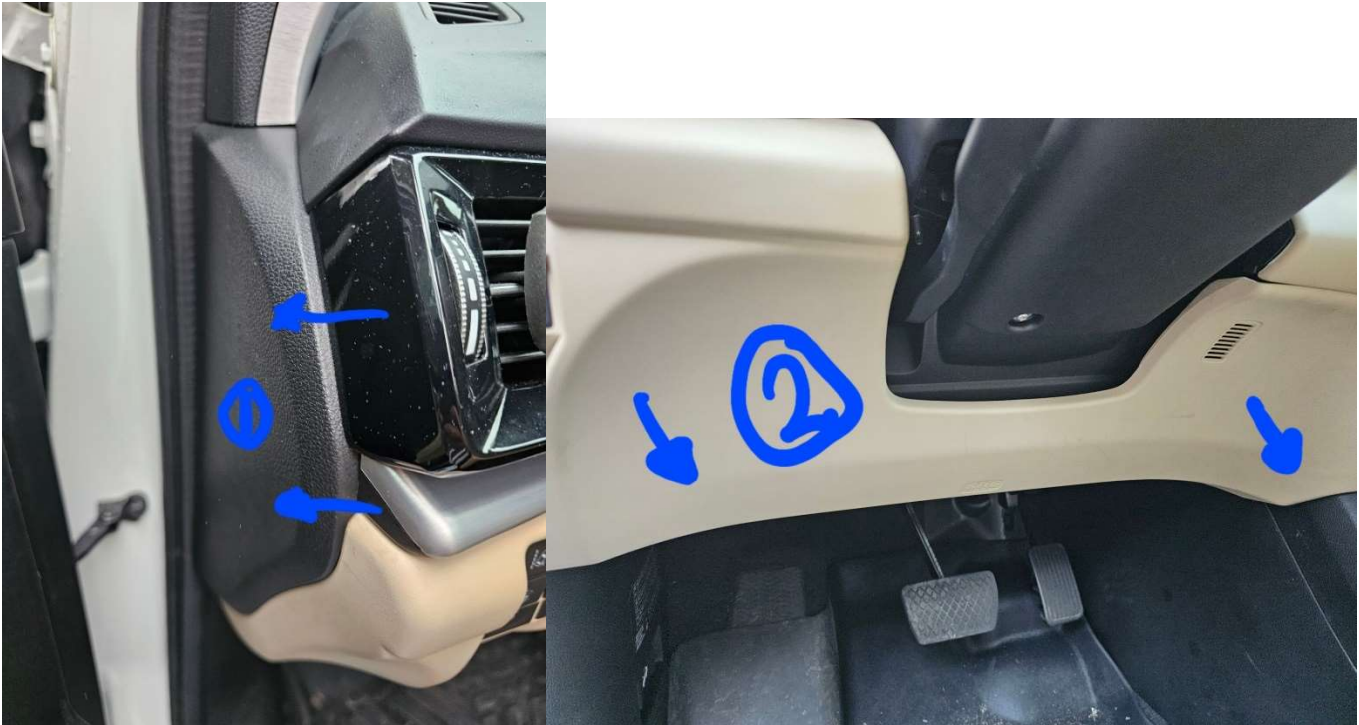
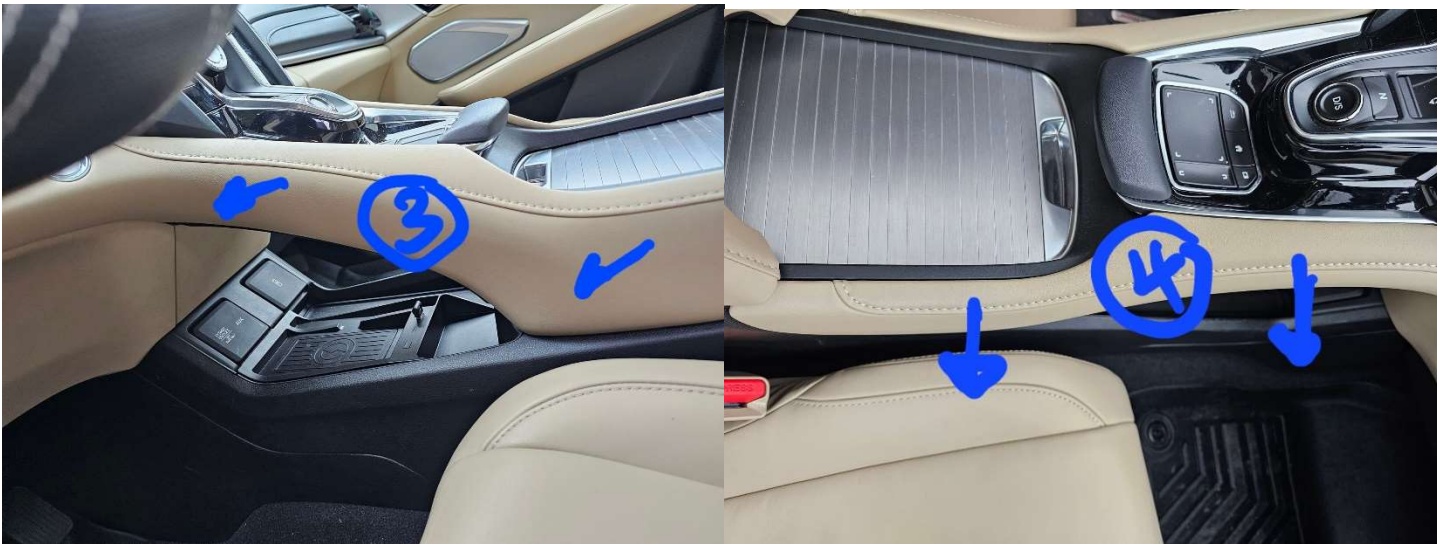
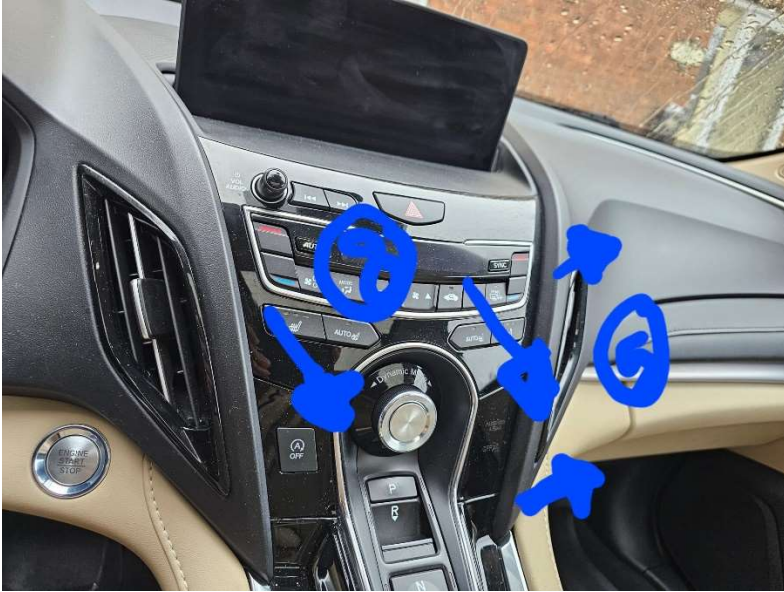
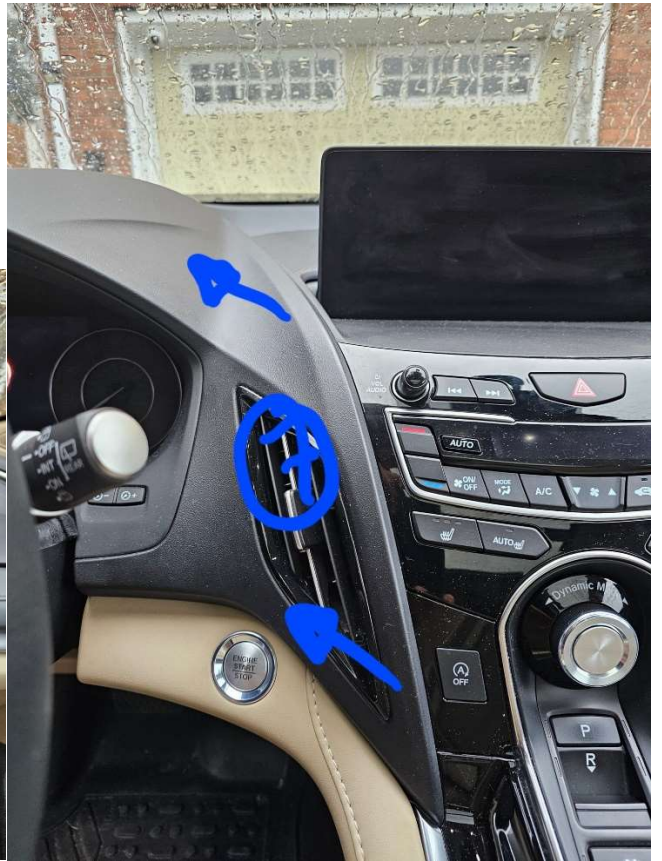
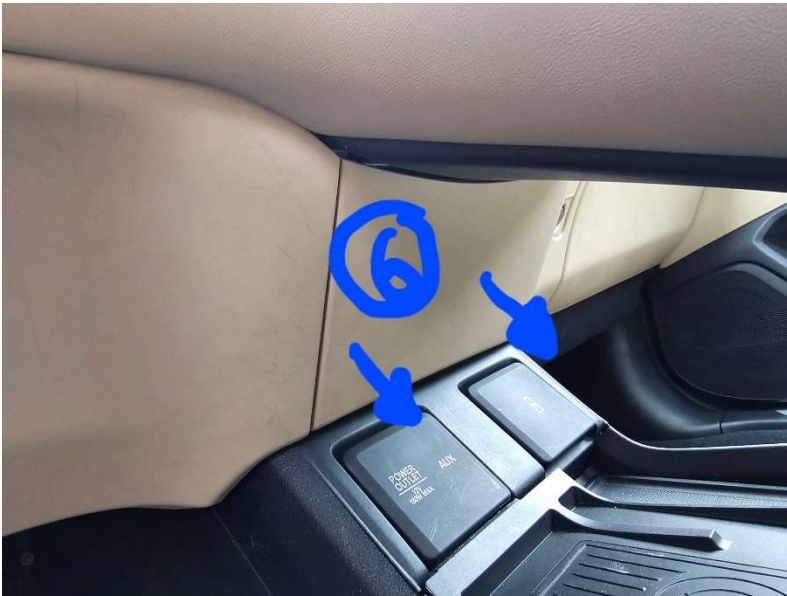
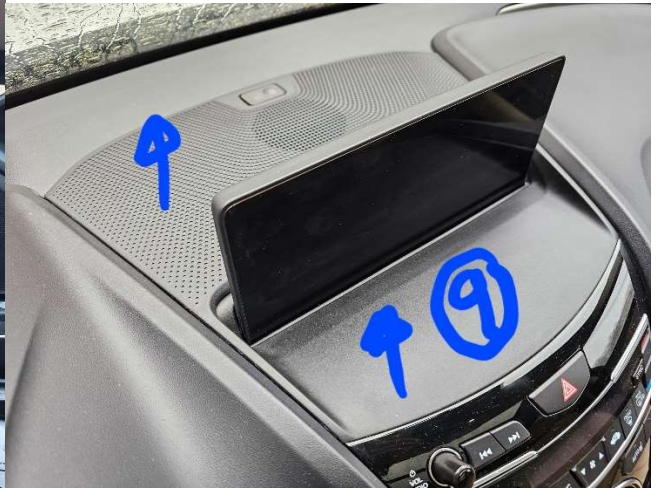
Here are some pictures of what you have to remove. The control unit is held in place with 3 screws: 2 screws at the top, and you can access them if you remove the A/C dash control. The lower screw is easy to access once you remove the cover for the control unit. Check the pictures and be careful and take care to avoid breaking any tabs. For #5 and #7 just lift it up a little bit to make it easy for you to remove the A/C control.

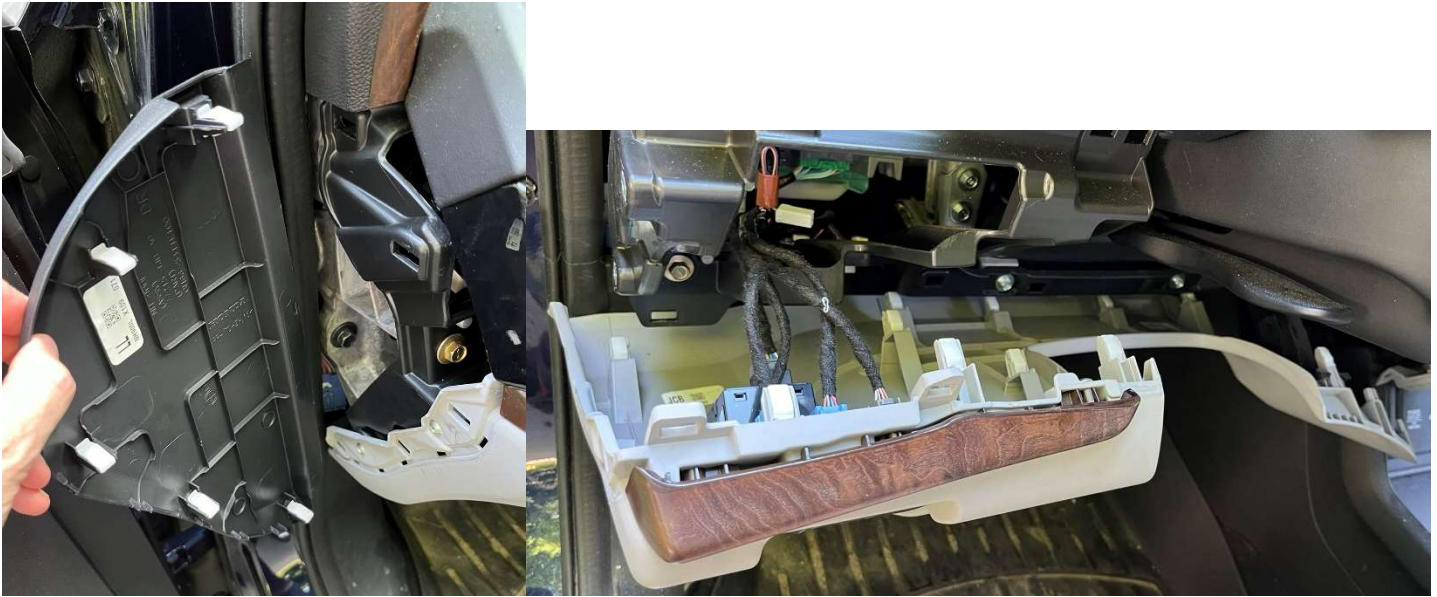
Left picture: Tabs on #1 and two screws you must remove before pulling #2. Right picture: Tabs on #2.

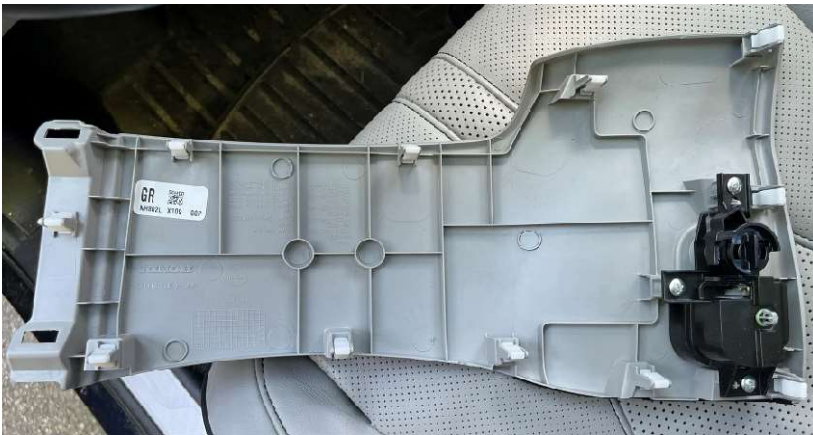
Tabs on #6:

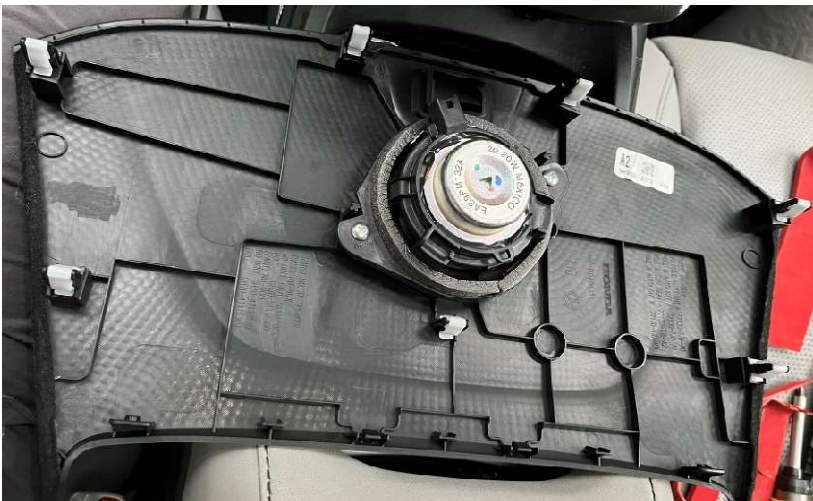
Tabs on #9, some of which are all black and very tight, so be patient:

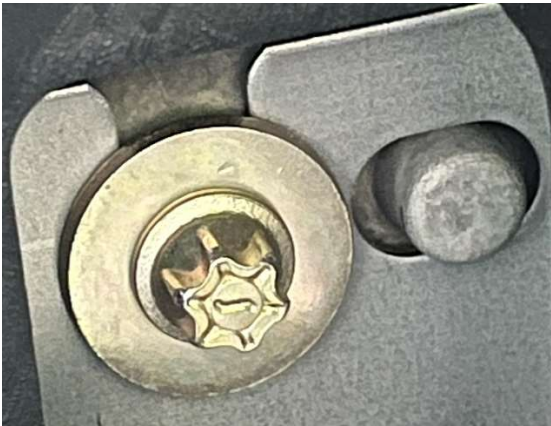
Close up of one of the three bolts that holds the radio in place (a 1/4 inch socket works on these):

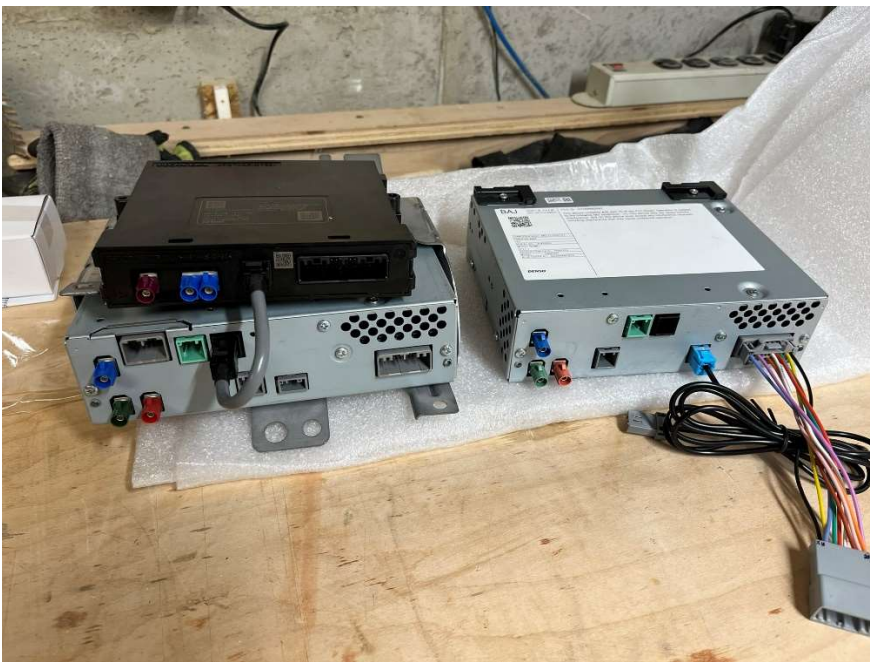
Left: Old radio. Right: New radio with 2 new cables. This is before black unit and metal cage was transferred.

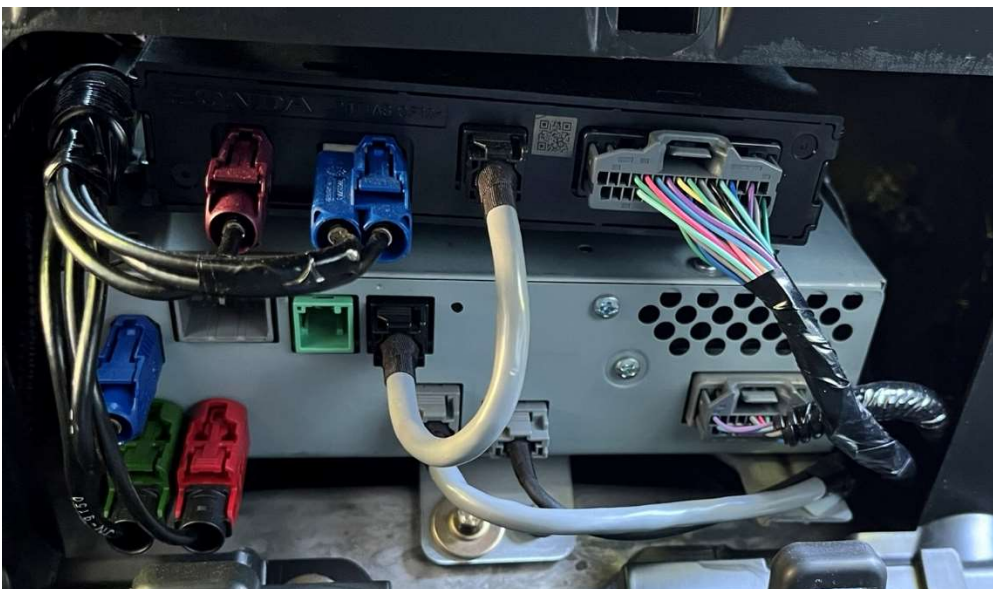
Old unit before removal:

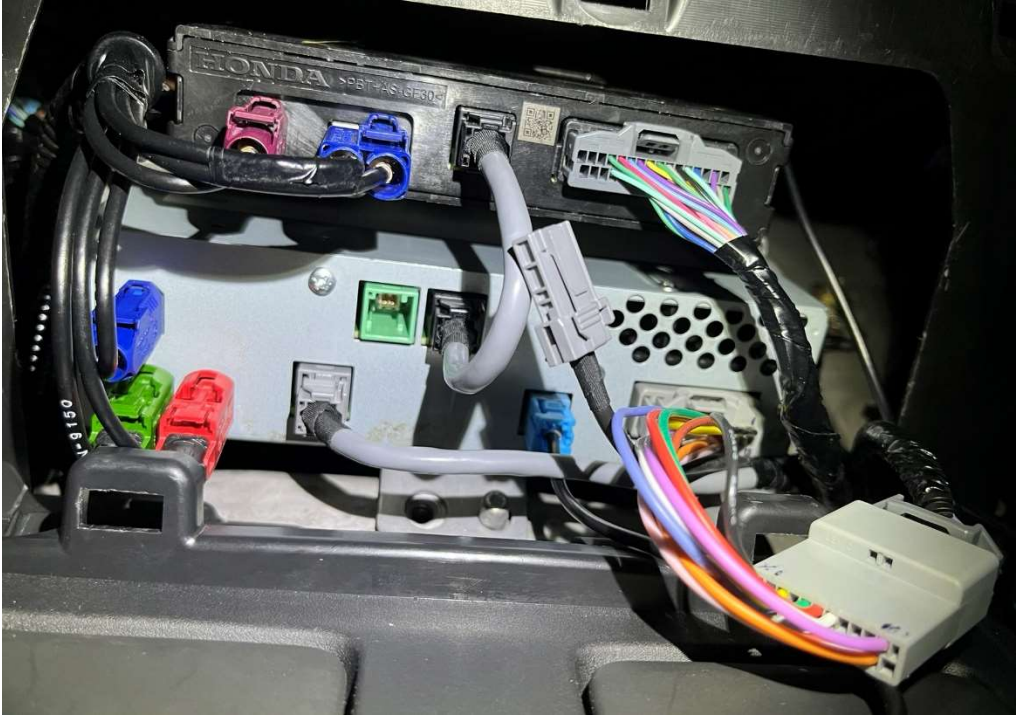
New unit after rough installation. Note that the gray wire on the bottom is very tight because it's located farther to the left than on the old radio.

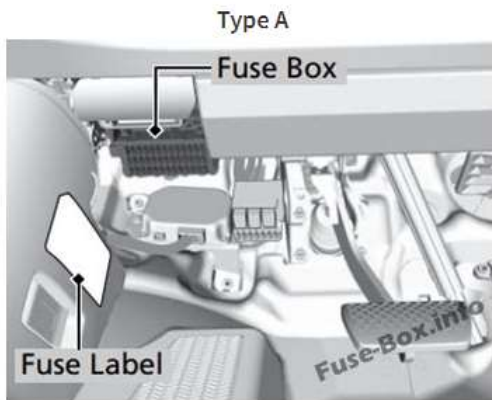
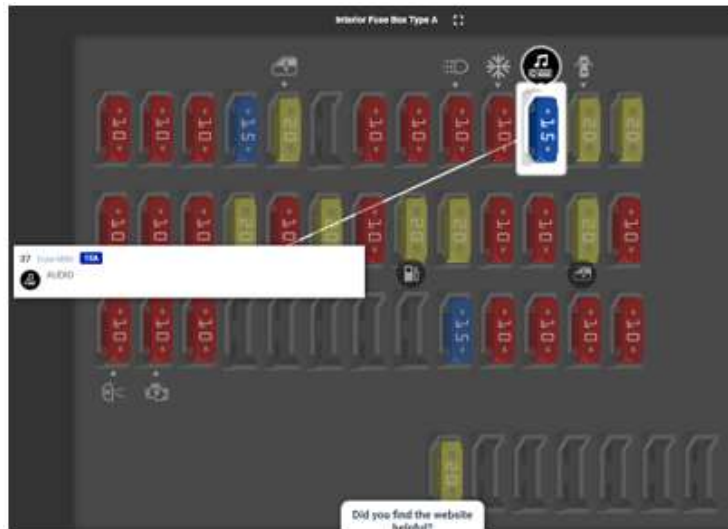
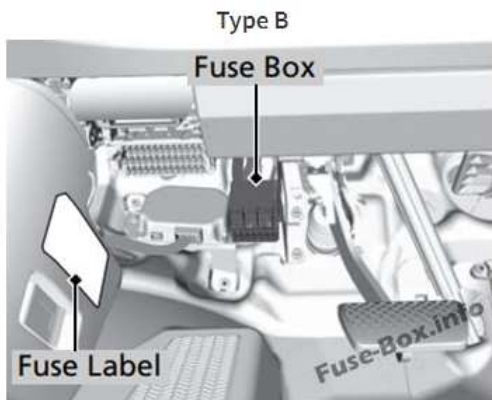
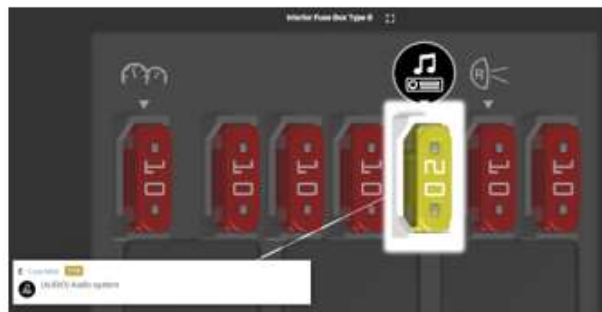
Location of Audio Fuses

I managed to blow the 15A fuse due to some bad soldering, so I'm showing its location below.
