Fuel Cap Warning Message Is On Without DTCs

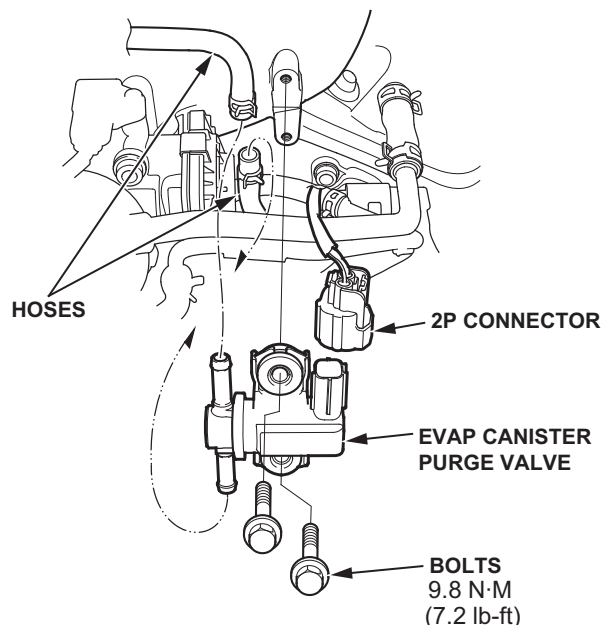
NOTE: The EVAP canister purge valve is located near the throttle body.

- Disconnect the two hoses and the 2P connector from the purge valve.
- Remove the purge valve (two bolts).
- Install the new purge valve, and torque the bolts to **9.8 N·m (7.2 lb-ft)**.
- Connect the 2P connector and the two hoses to the new purge valve.
