Chirp From the Timing Belt Area

(Supersedes 08-031, dated May 21, 2010, to revise the information marked by the black bars)

2005–08 MDX – ALL

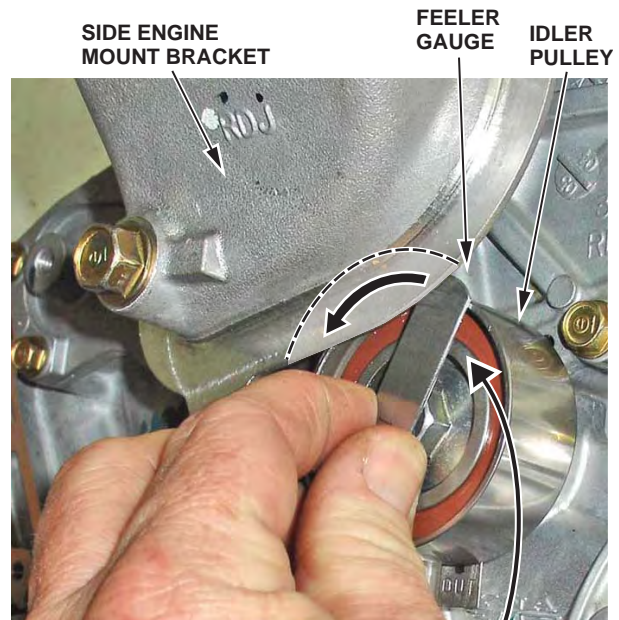
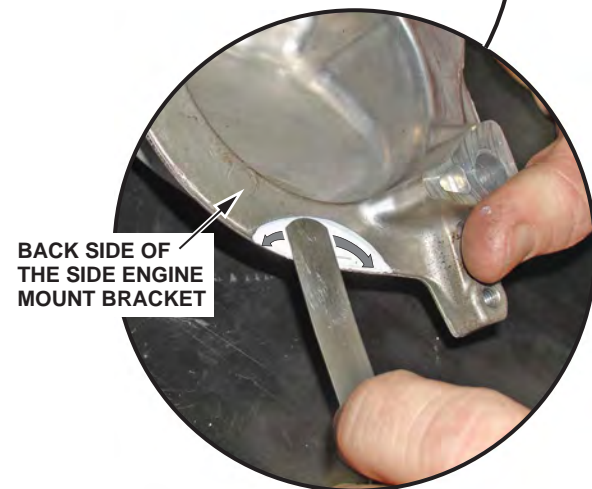
4. Remove the timing belt covers:
 - Refer to Section 6 of the appropriate service manual, or
 - Online, enter keywords **TIMING BELT**, and select **Timing Belt Removal** from the list.
5. Try to insert a 0.95 mm feeler gauge between the top edge of the timing belt idler pulley and the back of the side engine mount bracket overhanging the pulley. This measurement is used to determine if step 12 is required.

NOTE: Remove the feeler gauge from its holder to get a more accurate measurement.

12. If the feeler gauge did fit in step 5, go to step 13. If the feeler gauge did not fit in step 5, remove the side engine mount bracket. Using a die grinder with a 2-inch, 50-grit grinding disc (or equivalent) and the circular casting offset as a guide, grind the side engine mount bracket until the lip measures 2 mm thick with a caliper or micrometer.

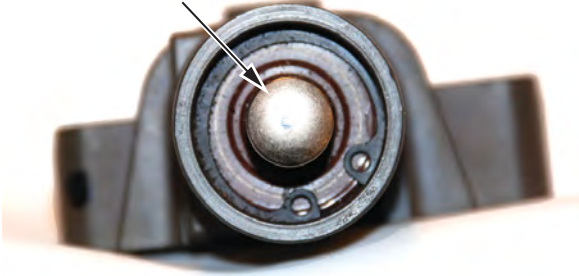
GOOD TENSIONER

NOTE: Remove the timing belt auto-tensioner, and inspect the tip of the piston for signs of damage. Test the tensioner by pushing it down against a flat surface. The tensioner should not compress. Replace it if it is damaged or if it compresses.

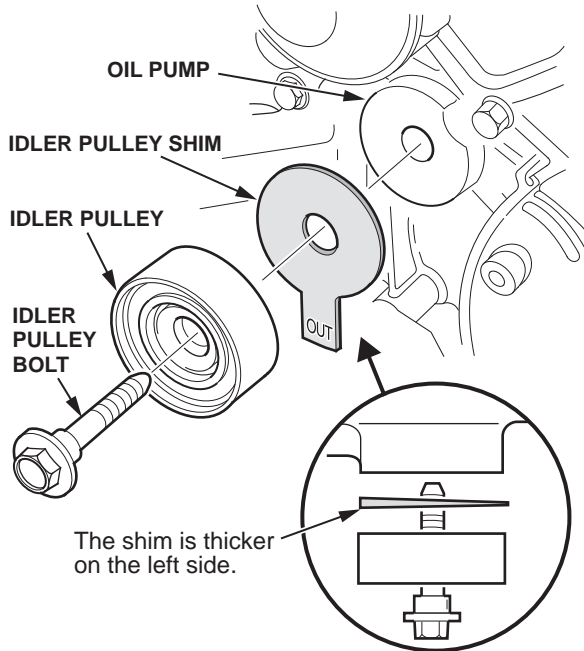
15. Place the idler pulley shim between the idler pulley and the oil pump housing, and loosely install the idler pulley bolt with Hondalock 1 applied to its threads. Make sure to follow the assembly instructions on the Hondalock 1 container.

NOTE: The shim is tapered from left to right. The word "OUT" is painted in white and stamped into the tang of the shim. It should be readable after the shim is installed.

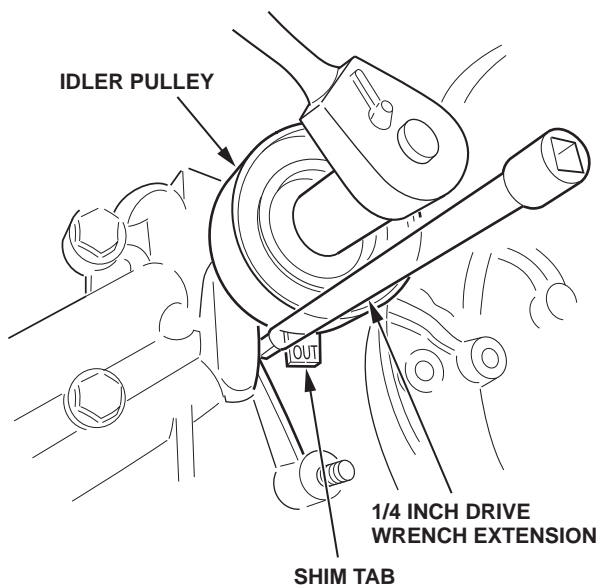
16. When tightening the idler pulley bolt, use the square end of a 1/4 inch drive ratchet extension to keep the shim's tab in the correct position. After you tighten the idler pulley bolt to **44 N·m (33 lb-ft)**, bend the shim's tab slightly towards the oil pump housing to keep it away from the idler pulley.

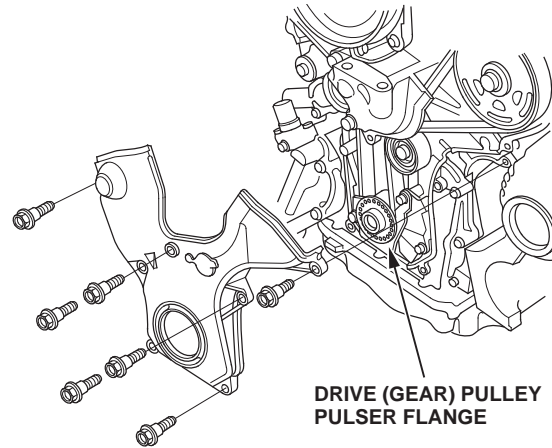
17. Install a new timing belt drive (gear) pulley:
