Rear Shelf Area Clicks, Taps, or Ticks

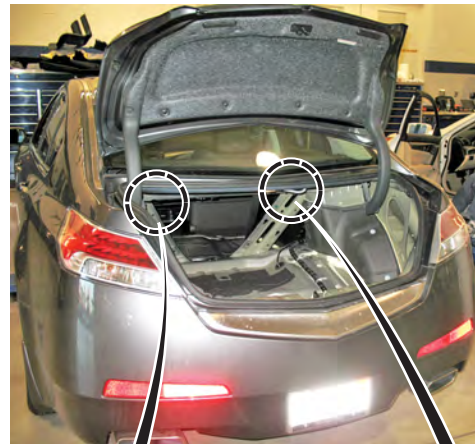
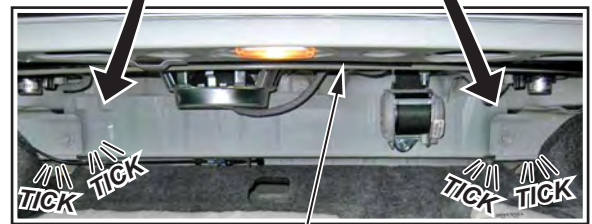
UNDERSIDE OF REAR TRAY

The rear shelf area clicks, taps, or ticks on one or both sides.

There is insufficient clearance between the metal body panels in the rear shelf area.

Do you hear a clicking, tapping, or ticking noise from the rear shelf area?

Create a gap between the metal body panels.

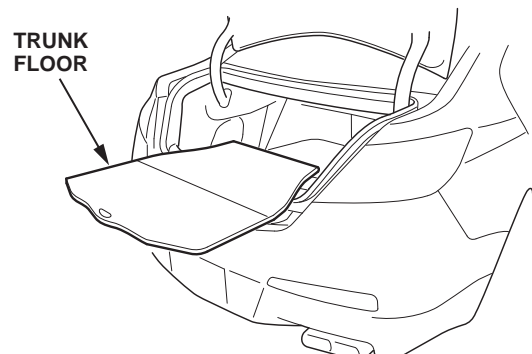
1. Remove the trunk floor.

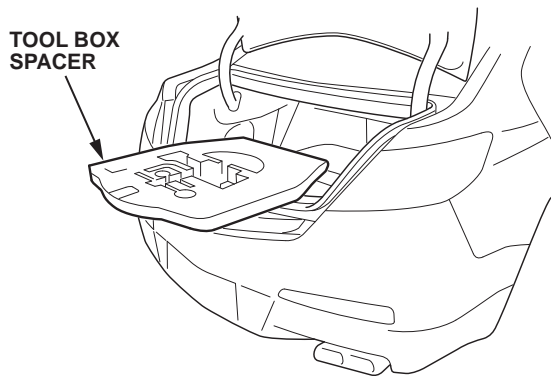
- Remove the tool box spacer.

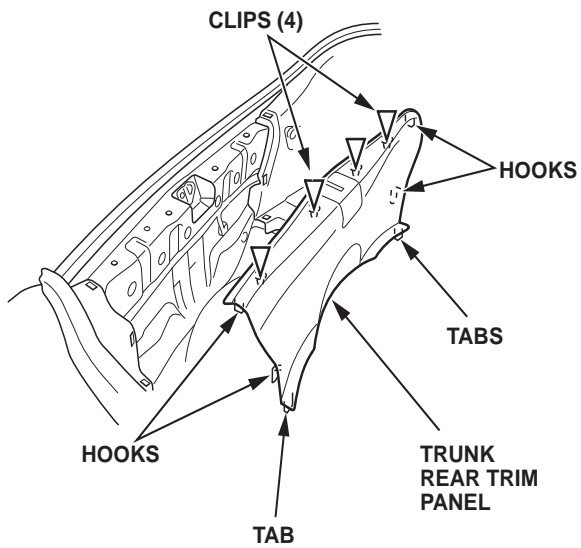
- Detach the clips, and release the hooks and the tabs by pulling up on the trunk rear trim panel, then remove the panel.

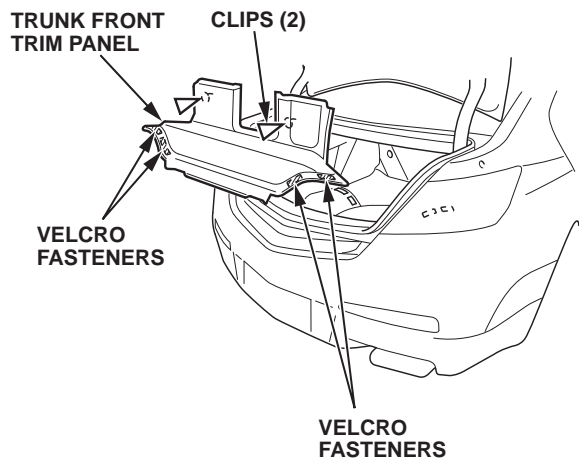
- Partially remove the trunk lid weatherstrip by pulling it off as needed.
- Detach the clips and release the Velcro fasteners, then remove the trunk front trim panel.

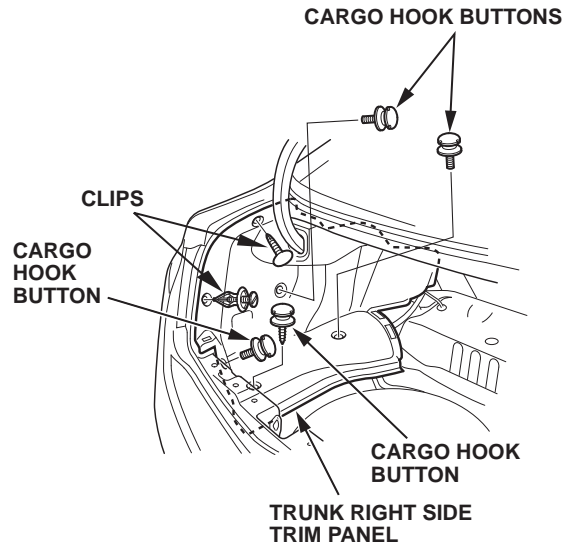
- Detach the clips and remove the cargo hook buttons, then remove both of the trunk side trim panels.

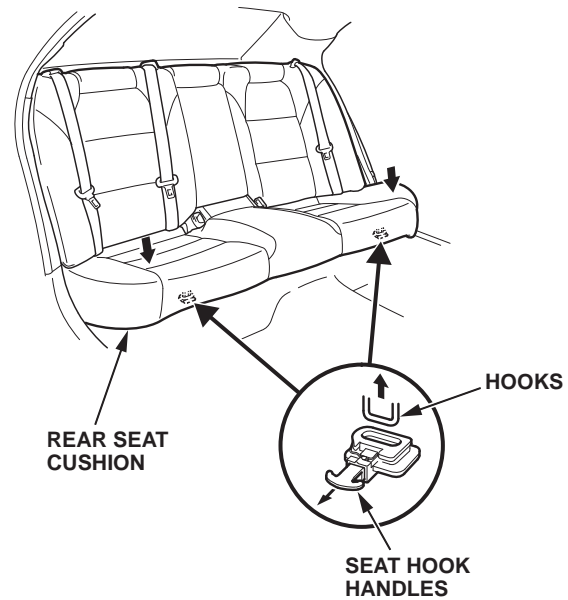
- While pushing down on the rear seat cushion, pull the seat hook handles to release the hooks.

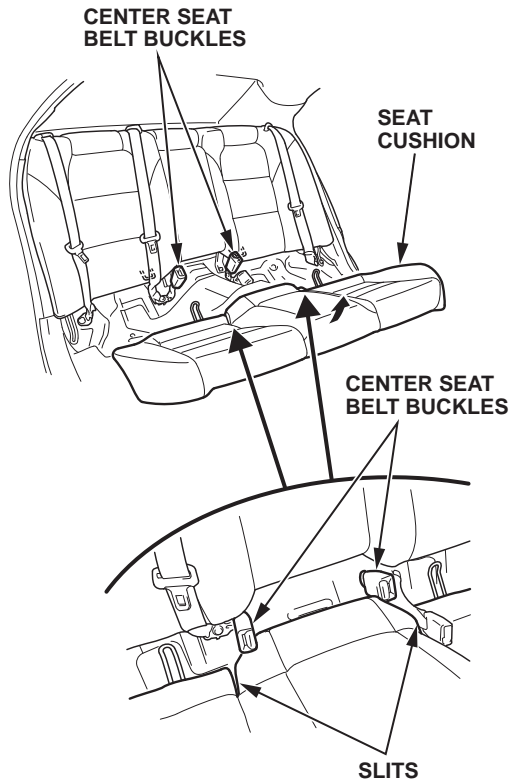
8. Remove the seat cushion, and release the center seat belt buckles from the slits.

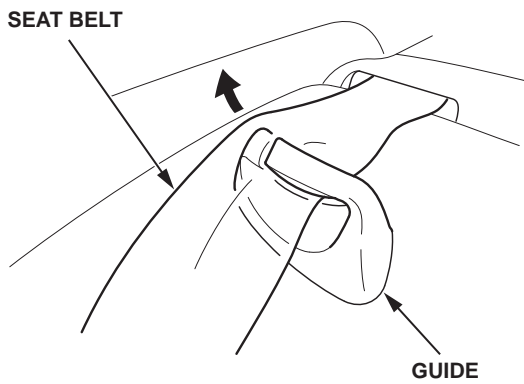
9. Release the seat belts from their guides.

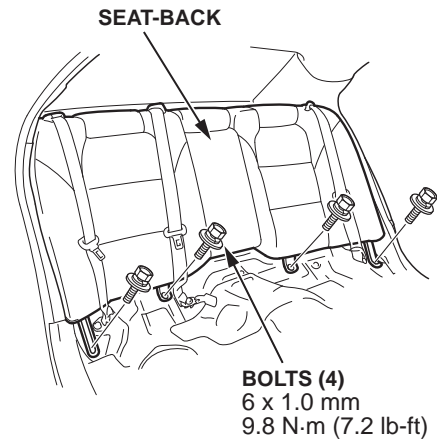
10. Remove the bolts from the base of the seat-back.

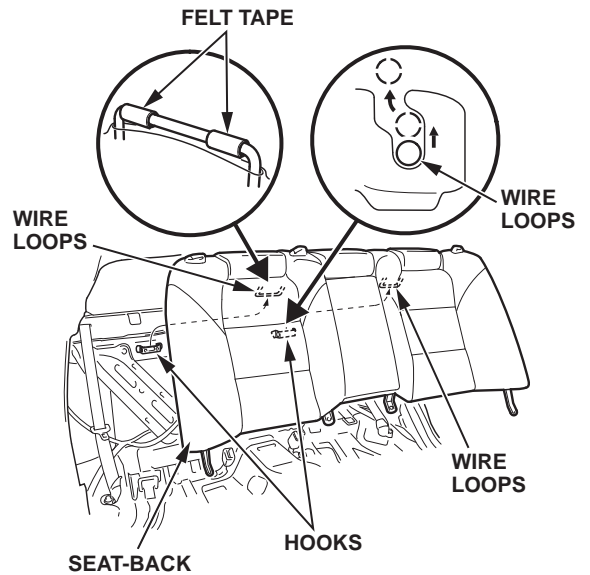
11. Lift up the bottom of the seat-back. Push on the seat-back while lifting it up to release the wire loops from the hooks on the body.

- Have an assistant help you when removing and installing the rear seat-back.
- Take care not to scratch the body or damage the seat covers.

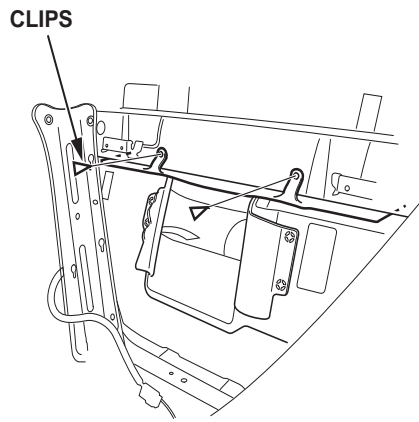
12. Detach the clips.

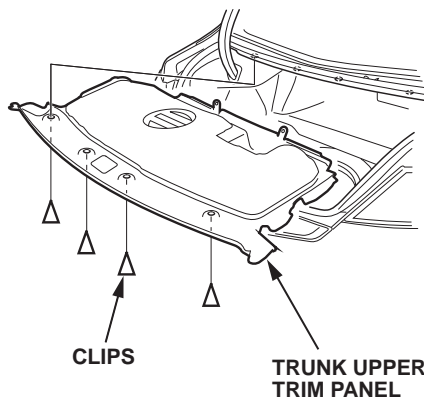
13. Lower the trunk upper trim panel to detach the clips, then remove the panel from the trunk compartment.

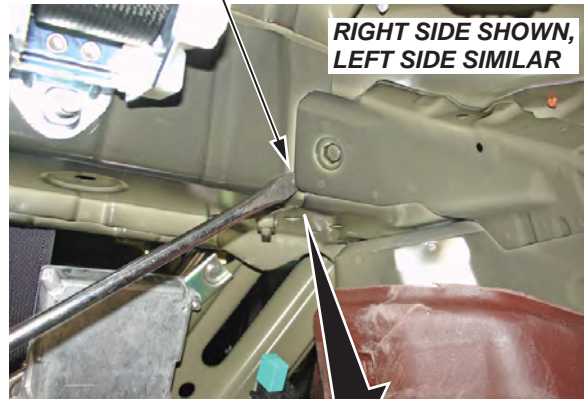
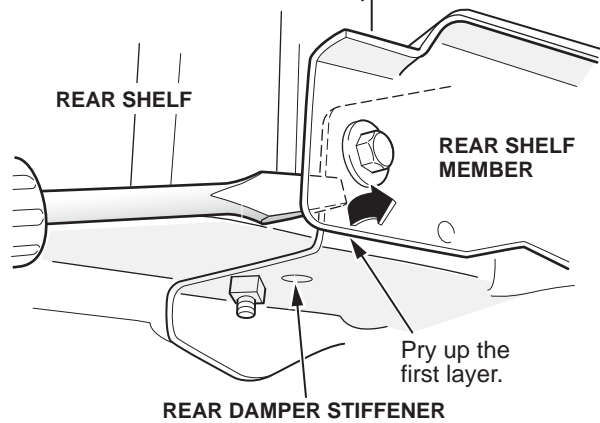
14. With the rear shelf bolt installed, place a flat tip screwdriver between the rear shelf member and the rear shelf metal panels. Create a gap to separate the panels. A hammer may be needed to get the screwdriver between the panels.

There are two layers of sheet metal to pry up.

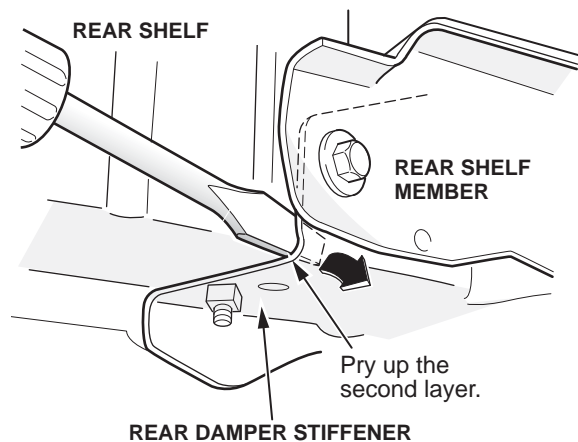
15. Place a flat tip screwdriver in between the rear damper stiffener and the rear shelf metal panels. Create a gap to separate the panels.

16. Spray motorcycle chain lube between the separated panels.

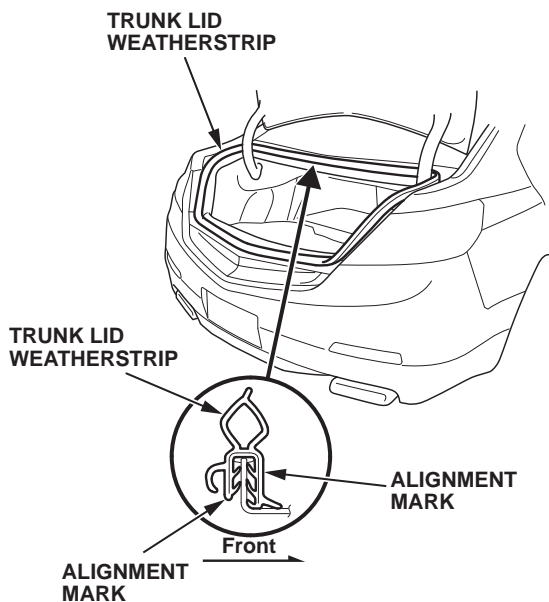
NOTE: Locate the painted alignment mark on the trunk lid weatherstrip. Align the painted mark in the center of the trunk lid opening, and install the trunk lid weatherstrip all the way around in the direction shown. Make sure there are no wrinkles in the weatherstrip.
