10076 Version 4

Transmission End Cover Leaks (9-Speed A/T)

Supersedes 15-039, dated September 9, 2017, to revise the information highlighted in yellow

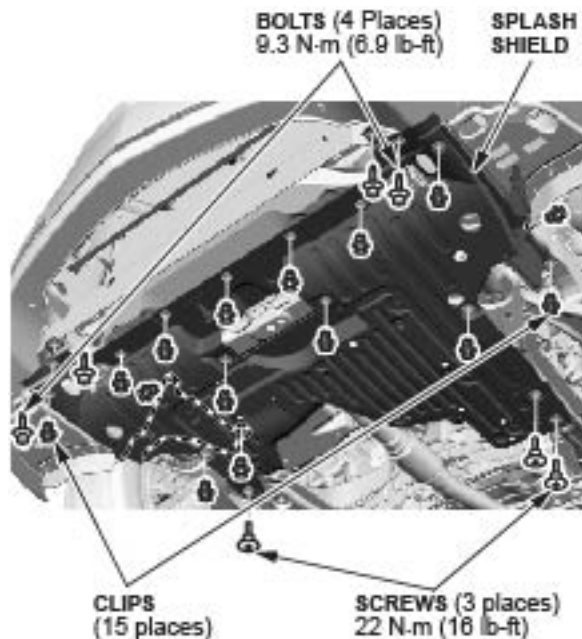
■ *TLX Only:* Remove the undercover.

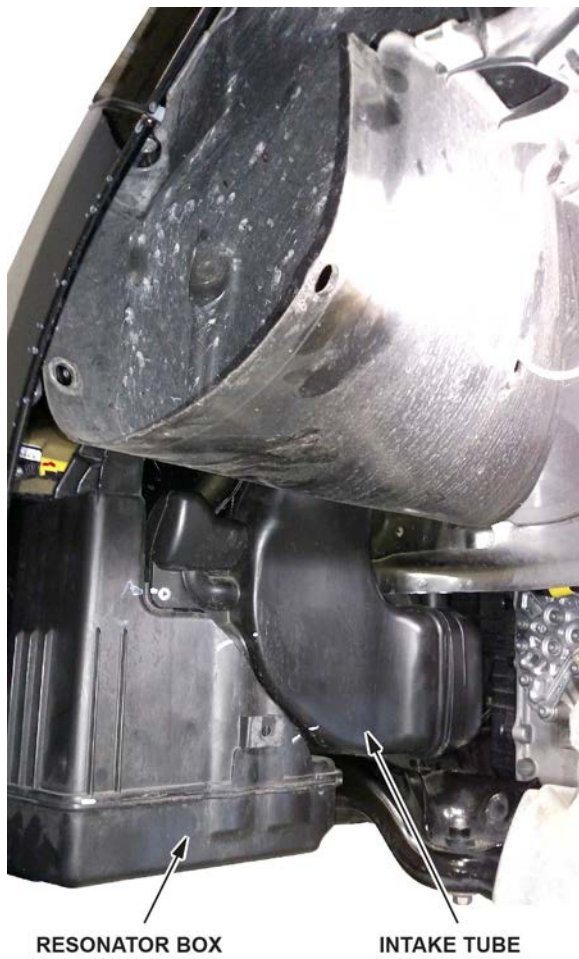
TLX Only: Remove the resonator box and move the intake tube.
