## Interior Trim Removal and Installation - Pillar Areas

## A-Pillar Trim

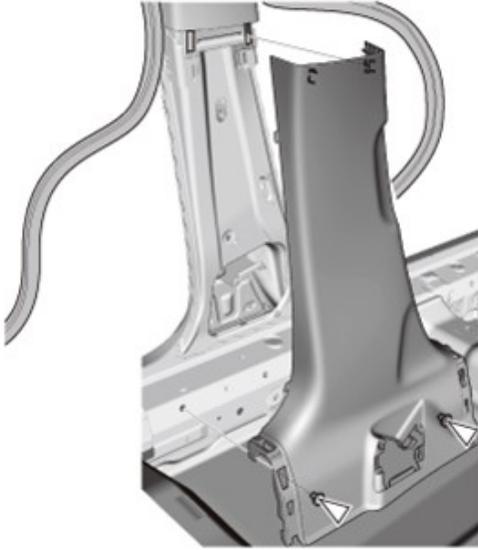
**6. B-Pillar Upper Trim - Remove**

1. Remove the B-pillar upper trim (A).
