Applies To: **1996-01 3.5RL – ALL**
2002 3.5RL – From VIN JH4KA9...2C000001 thru JH4KA9...2C006092

October 1, 2001

Intermittent Electrical Problems

(Supersedes 98-028, *Security System Sounds Intermittently*, dated September 28, 1998)

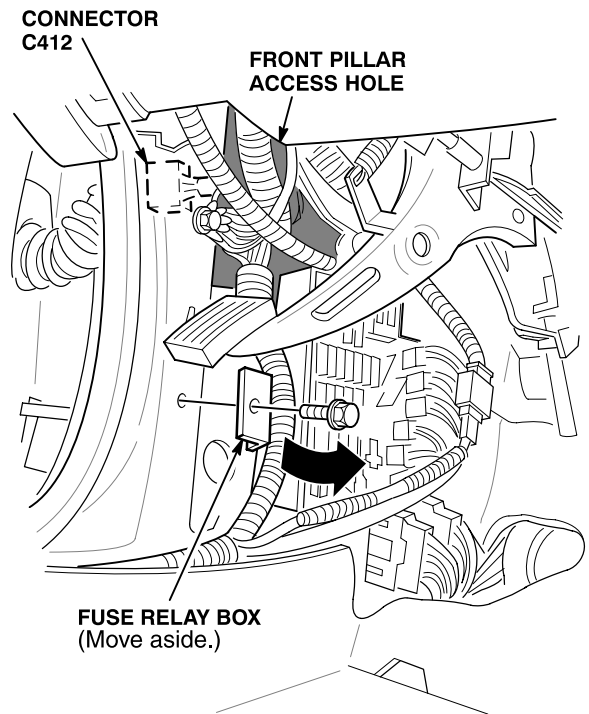
Water is leaking into the front pillars. The water is getting into the connectors for the under-dash fuse/relay box, the driver's multiplex control unit, or the door lock actuator, causing intermittent electrical problems.

1. Remove the driver's front side trim, foot rest, and kick panel.
2. Remove the under-dash fuse/relay box mounting bolt and the wire harness clip. Move the fuse/relay box toward the parking brake pedal to expose the front pillar access hole.

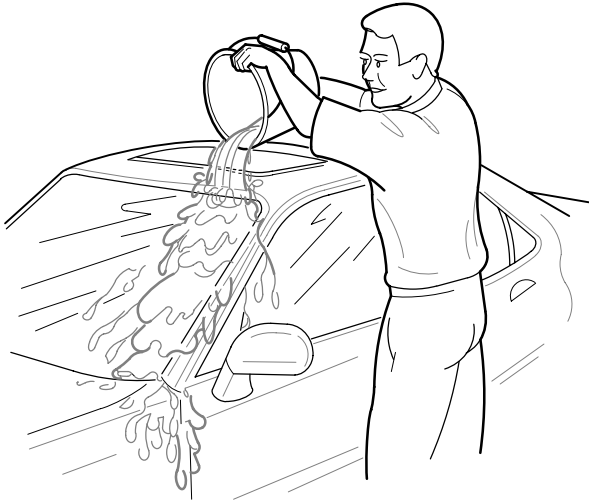
5. Through the access holes, inspect for water in the front pillars and on connectors C445 (passenger's side) and C412 (driver's side).
 - If you find a water leak, do REPAIR PROCEDURE A and REPAIR PROCEDURE B.
 - If you do not find a water leak, do REPAIR PROCEDURE A only.

3. Remove the passenger's front side trim and the kick panel.
4. Fill a bucket with 3 to 5 gallons of water. Pour the water on the windshield; empty the bucket in about 10 seconds.
