## Shift Pointers

**•Subject:**  
Erratic 2-3 shift, code P0780

**•Unit:**  
BAYA 5-speed automatic

# What's Causing Third-Clutch Failures in Honda Five-Speeds?

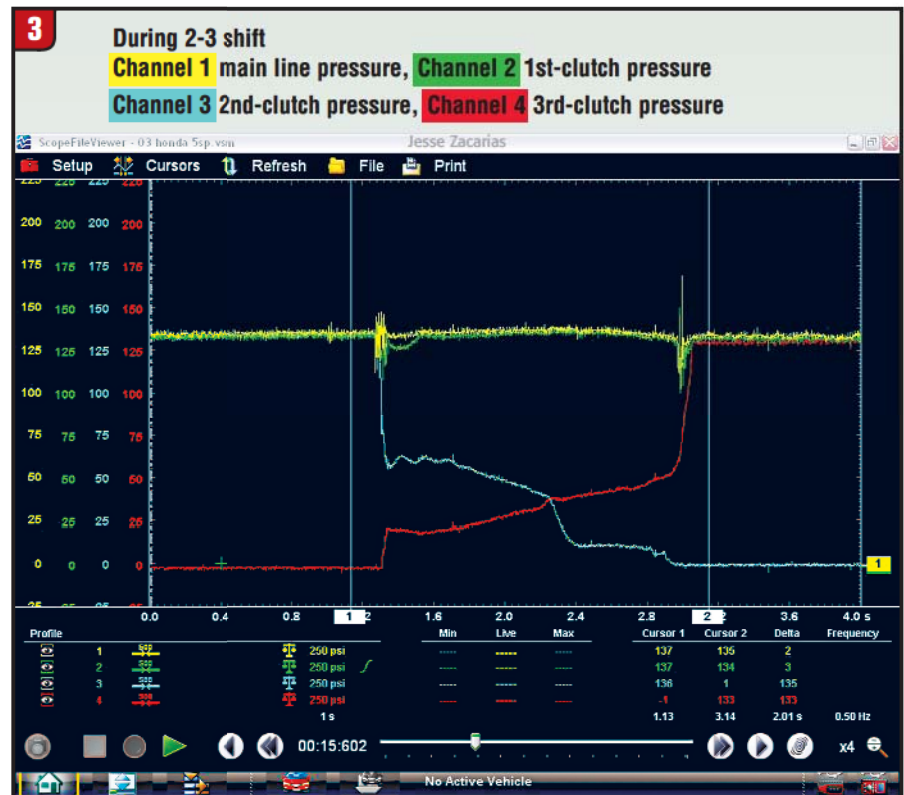
I connected our test equipment to the vehicle (Figure 2) to obtain as much data as possible. I obtained main line-pressure readings
