Applies To: **2009–11 TL – ALL**
2012 TL – From 19UUA8...CA008260 thru 19UUA9...CA002617

September 15, 2011

Upper B-Pillar or Moonroof Area Clicks, Rattles, or Taps

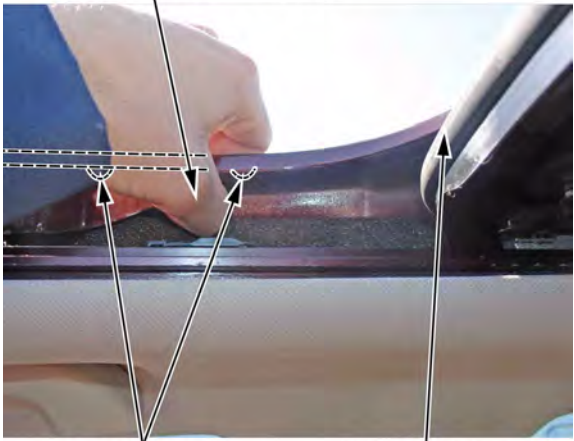
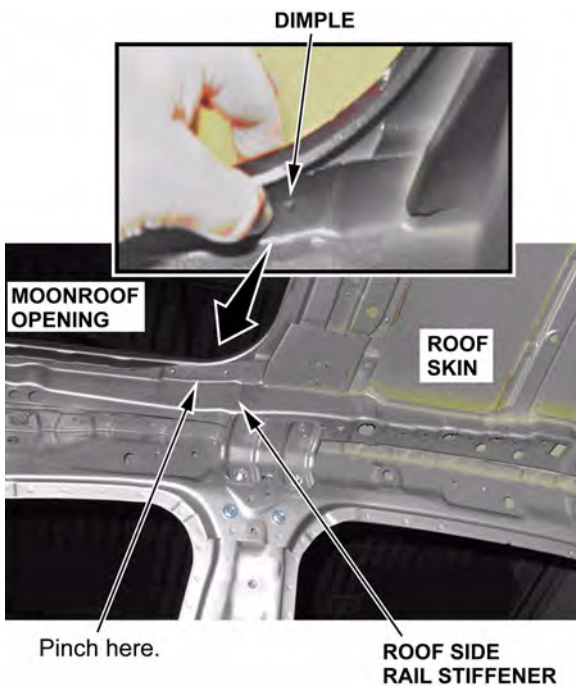
Pinch between the two dimples

DIMPLES ON THE UNDERSIDE OF THE SIDE RAIL STIFFENER

REAR OF THE MOONROOF OPENING

Yes – The noise is coming from between the roof side rail stiffener and the roof skin. Do REPAIR PROCEDURE A.

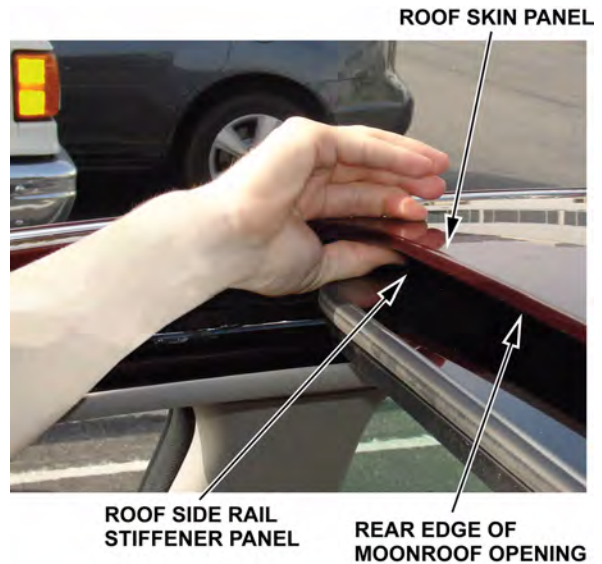
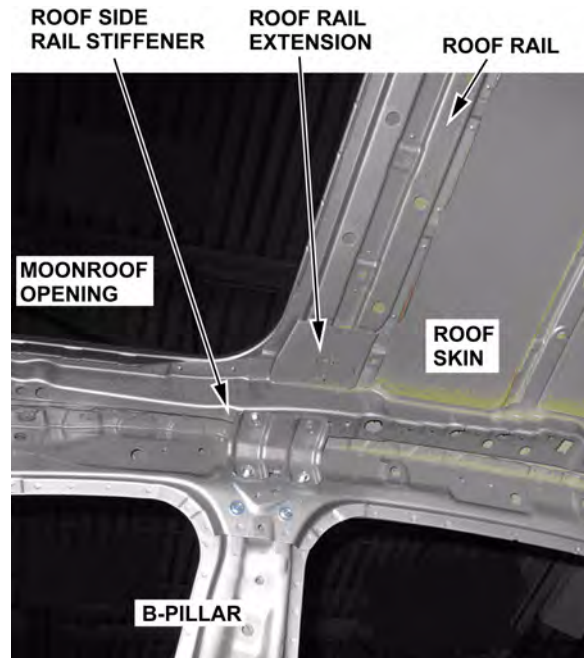
ROOF SIDE RAIL STIFFENER PANEL

REAR EDGE OF MOONROOF OPENING

Yes – The noise is coming from along the rearward edge and corner of the moonroof opening between the roof rail and the roof skin. Go to REPAIR PROCEDURE B.

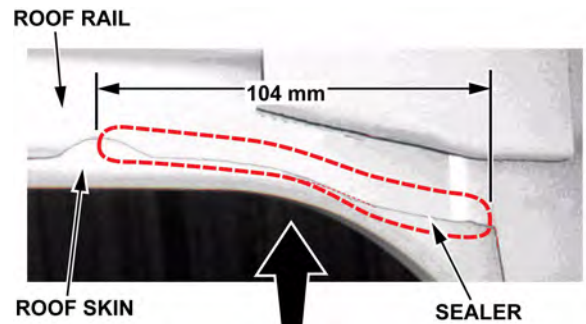
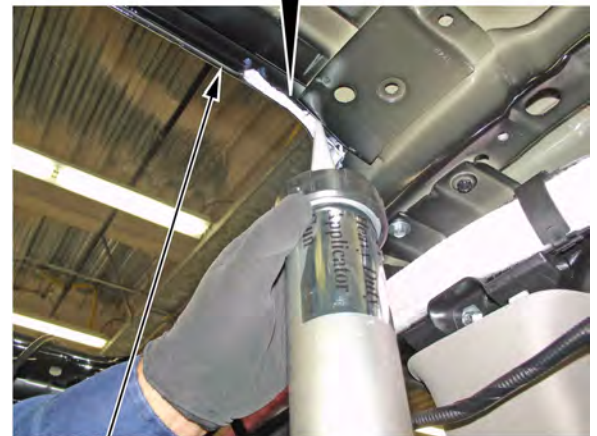
REAR OF THE MOONROOF OPENING

4. Apply sealant between the roof rail panel and the roof skin panel. Starting at the corner of the roof side rail stiffener, apply the sealant for 104 mm. Fill the cavity marked in red.
