Applies To: **2010–11 MDX** – Check the iN VIN status for eligibility
2010–11 ZDX – Check the iN VIN status for eligibility

Product Update: MID Shows BATTERY CHARGE LOW

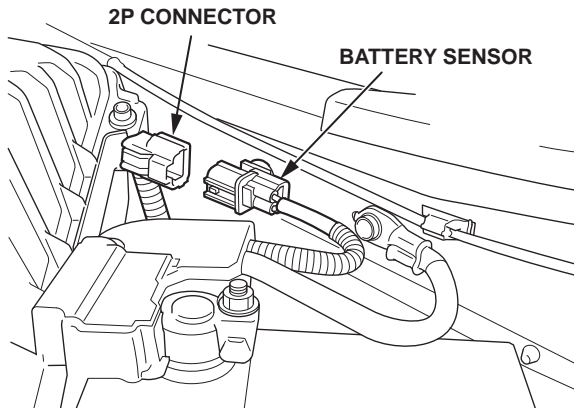
1. Turn the ignition switch to LOCK (0).
2. Disconnect the battery sensor 2P connector.

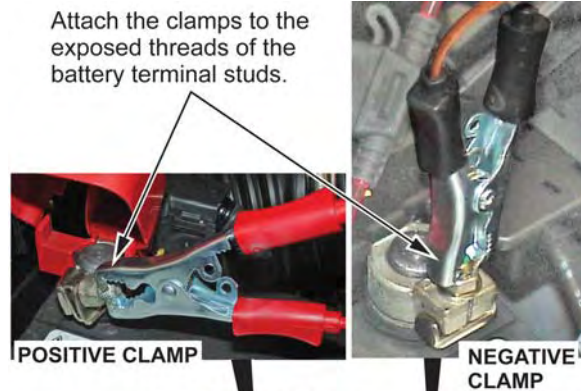
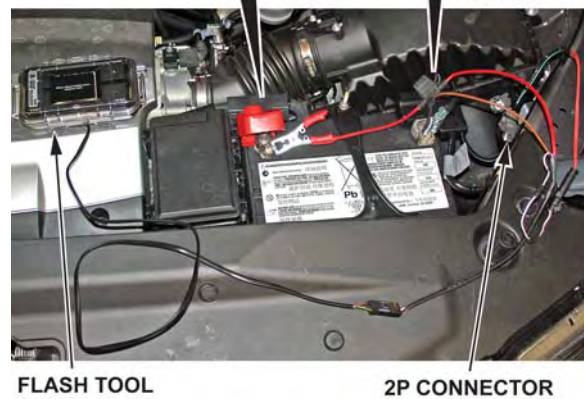
3. Connect the Flash Pack tool's positive clamp, then connect the negative clamp to the corresponding battery terminal studs.

NOTE: Make sure the clamps are securely on the battery studs. If the clamps slip off while updating the software, the battery sensor will be damaged.

Attach the clamps to the exposed threads of the battery terminal studs.
