Troubleshooting

Glass Height Adjustment

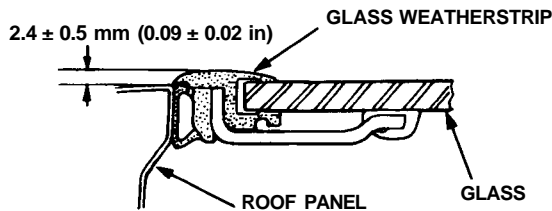
The roof panel should be even with the glass weatherstrip, to within 2.4 ± 0.5 mm (0.09 ± 0.02 in) all the way around. If not, open the glass fully, and:

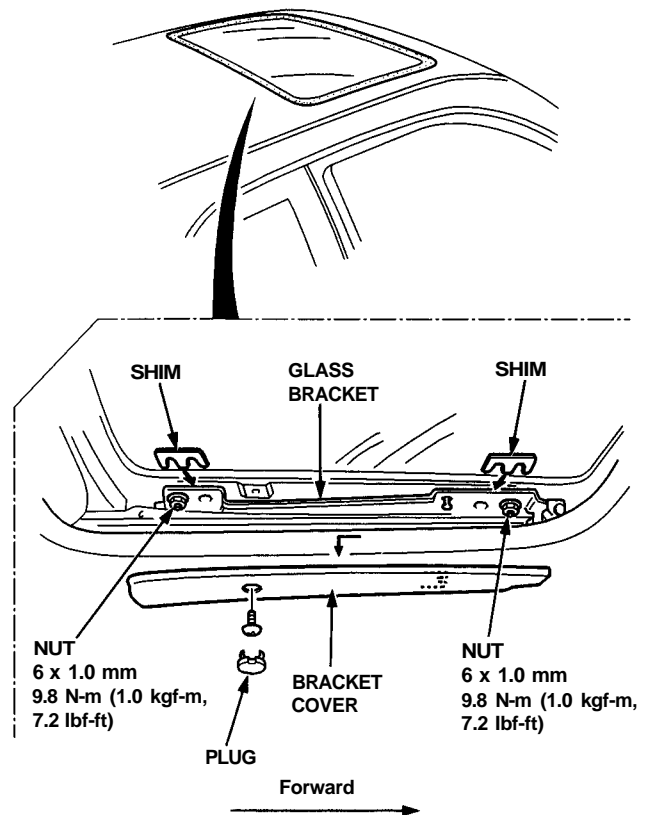
1. Remove the bracket cover.
2. Loosen the nuts, and install the shims between the glass frame and glass bracket as shown.

**Shim thickness: Front max. 3 mm (0.12 in)
Rear max. 2 mm (0.08 in)**

3. Repeat on opposite side if necessary.
