Applies To: **2012 TL 2WD** – From VIN 19UUA8...CA000001 thru 19UUA8...CA008239  
**2012 TL SH-WD** – From VIN 19UUA9...CA000001 thru 19UUA9...CA002516

## MID Shows BATTERY CHARGE LOW

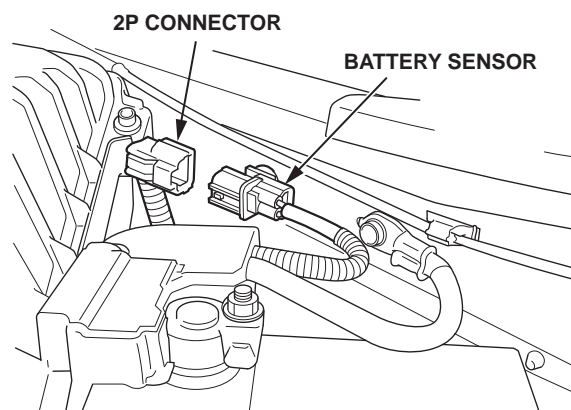
1. Turn the ignition switch to LOCK (0).
2. Disconnect the battery sensor 2P connector.

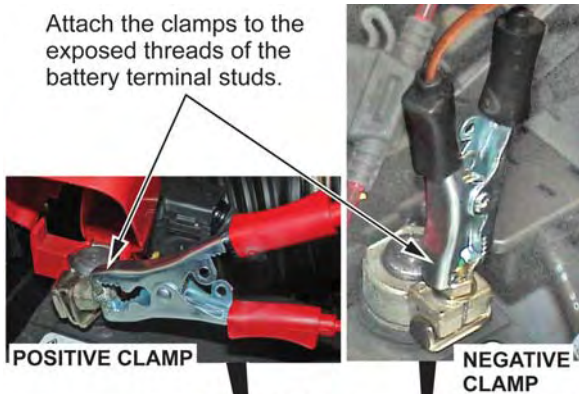
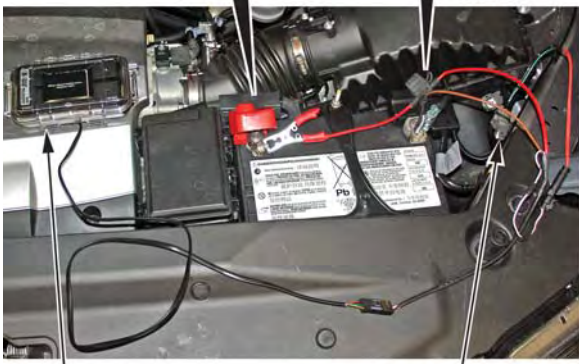
3. Connect the Flash Pack tool's positive clamp, then connect the negative clamp to the corresponding battery terminal studs.

NOTE: Make sure the clamps are securely on the battery studs. If the clamps slip off while updating the software, the battery sensor will be damaged.

Attach the clamps to the exposed threads of the battery terminal studs.
