History: Gen7 V6 5AT. There was a lot of talk on various forums concerning possible faults these can cause when they go out of tolerance. I've seen two transmissions rebuilders recommend replacing them every 5 years or so as part of a preventive measure. Apparently to help prevent clutch pack damage. Quoted rationale was that as they age they signal the PCM to extend the lockup time or transition time between gears and therefore would result in excessive wear and heat. There were a few reports of harsh shifting, vague shifting, vibrating roughness when shifting and very slow engagement from P-D or N-D being reduced by their replacement.

Pressure Switches.

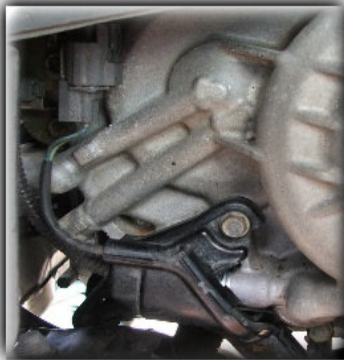
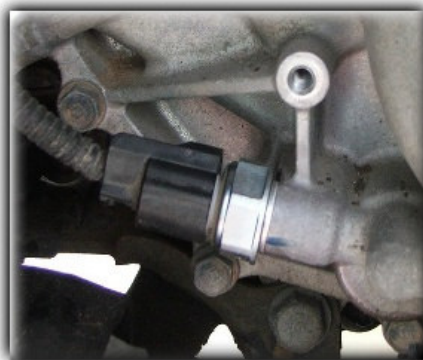
Remove two bolts holding the protective cover (shown on the left). The 3rd gear P-switch is underneath this cover. The wiring for the ATF temperature sensor runs through the cover, don't force the cover around. The hardest part is getting the wiring connector for the ATF temperature sensor apart. This must be undone before the protective cover can be safely moved to one side

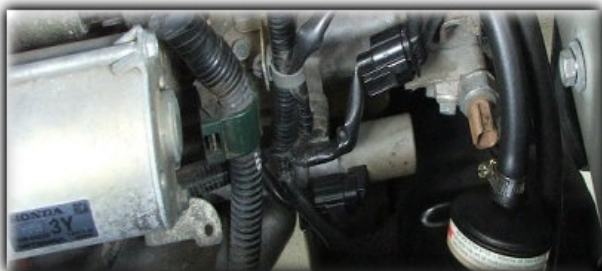
Look Inside a pressure switch

The 4th gear P-switch is located below the battery and low towards the chassis rail.

It's the Tan coloured device in the picture; the lead has been unplugged from the end for a better view of the switch.

The 4th gear Pressure switch is on the front of the transmission. It can be reached along with the 3rd gear pressure switch by removing the left front wheel.

If you have trouble reaching the 4th P-switch from the side then you may need to remove the battery shelf and remove the switch from the engine compartment.
